Root Cause Analysis Of Machine Stator Failures

**J. E. Timperley
Doble Engineered Strategies
Doble Engineering Company**

This paper discusses the basic methods for root cause analysis of large rotating electrical machine stator failures. Several in service and test failure examples are presented.

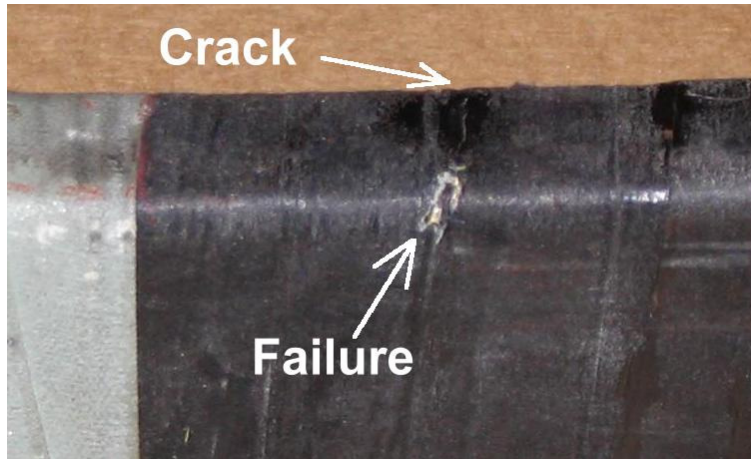
The failure exit point was quickly located just inside the core near the top. There appeared to be a crack in the conductive armor tape near the failure. There were no other abnormalities present on the surface of the specimen. The remaining stator coils were able to withstand the desired overpotential test.

FIGURE 1: A stator coil failed during the final acceptance overpotential test.

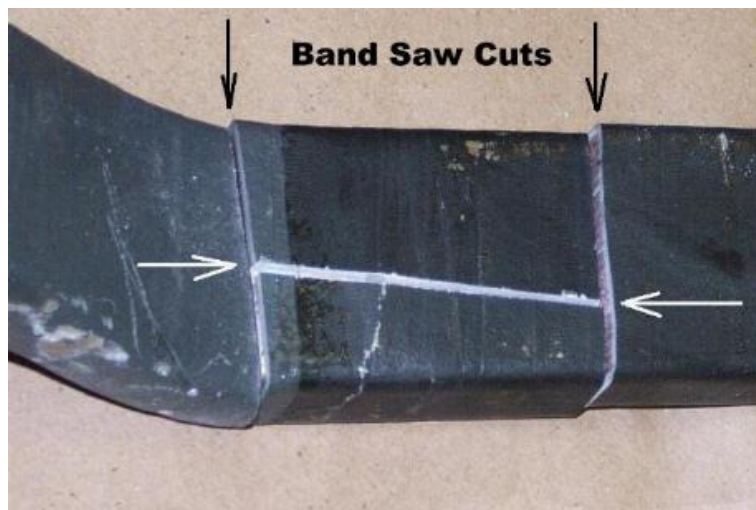
FIGURE 2: Black arrows show cuts made to isolate the failure site. White arrows show the cut that permits insulation removal from the sample.

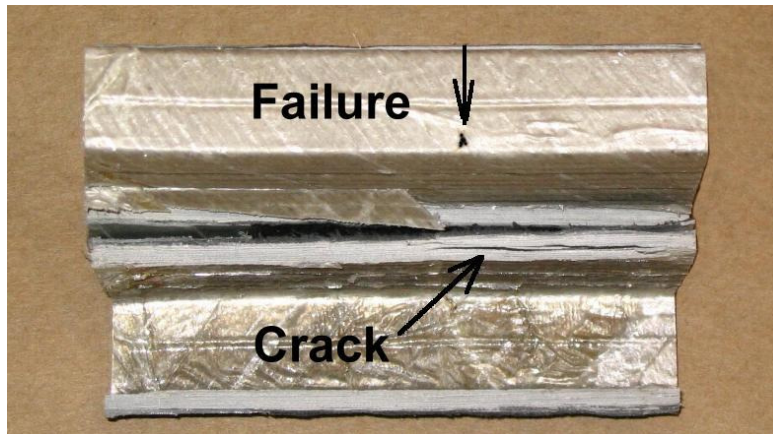
FIGURE 3: Groundwall insulation was easily folded away from the conductor stack.

A telltale black puncture spot indicated this failure started at the conductor stack edge. This is a high voltage stress area and many failures start at a corner. It was also apparent the surface crack penetrated through all tape layers at this location and was the cause of the dielectric failure. Another problem was also uncovered. Groundwall insulation tape layers were well bonded together but not bonded to the conductor turn tape.

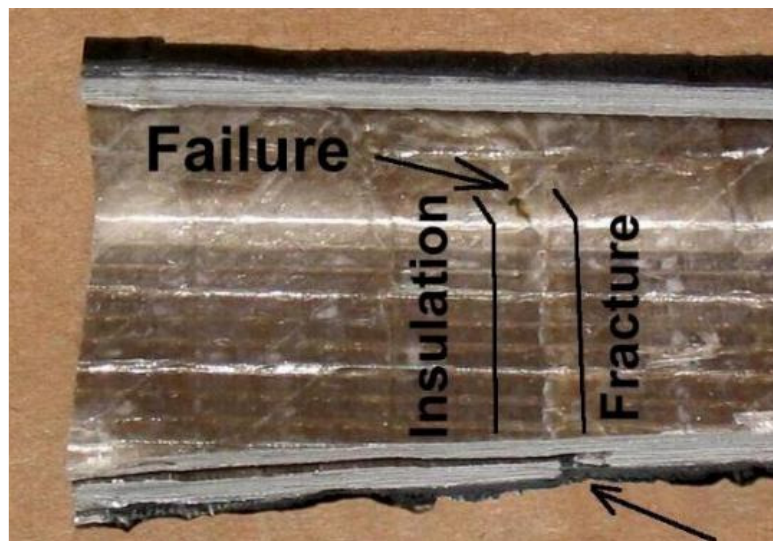
FIGURE 4: In this view we can see the fracture completely circled the coil insulation.

With an insulation fracture across as well as along the groundwall insulation it is apparent the coil endarm was twisted during installation. A weak resin bond between conductor stack and groundwall insulation was not adequate to prevent mechanical then electrical failure of groundwall insulation.

ROOT CAUSE: Fracture of groundwall insulation during coil installation. Lack of bonding between tape layers was a major contributing factor.

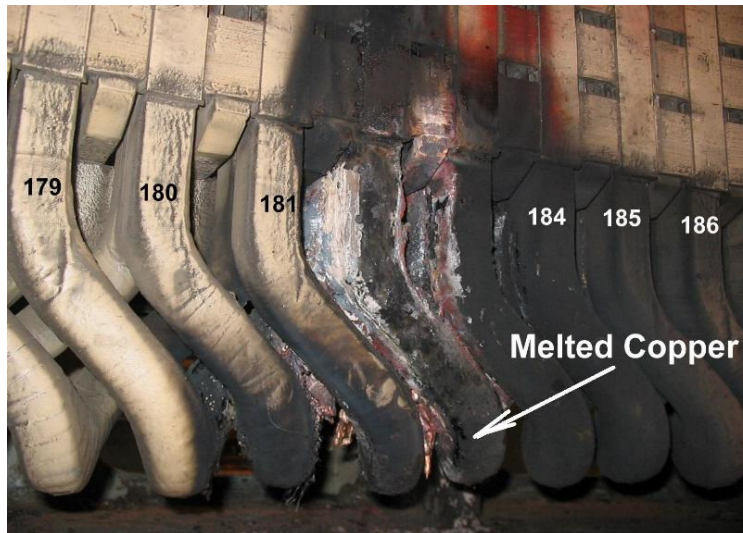
FIGURE 5: With the rotor removed stator winding damage was found to be extensive.

The failure burned for a period of several minutes and melted a great deal of copper out of slot 182. Coils against rotor rotation from the failure were not damaged. There was no damage to coils before coil 178. Coils after 182 suffered fire damage. The failed coil and adjacent damaged coils were removed and replaced with half coil splices.

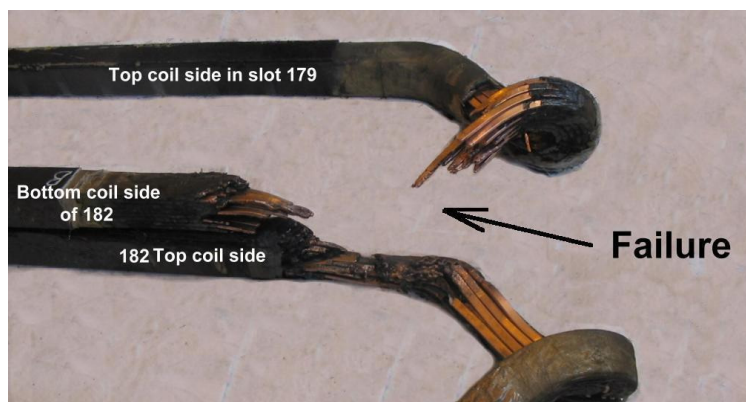
FIGURE 6: This failure created a sphere of missing copper. The center of this ball indicates where the failure originated in the bottom coil in slot 182.

The two coil sides involved in this failure were placed on a table and positioned as they were in slot 182. In Figure 6 we are looking from the back towards the machine bore. The failure appeared to have started on the first inside turns at the lower end arm of top coil 179 just below the core edge of slot 182. Circulating currents become very high and the melted copper shorts adjacent turns. The fault is maintained within the thick mica insulation until the pressure and heat burns into the top coil in slot 182. Phase 3 is now open. No ground fault developed. The generator is removed from service due to imbalance phase currents.

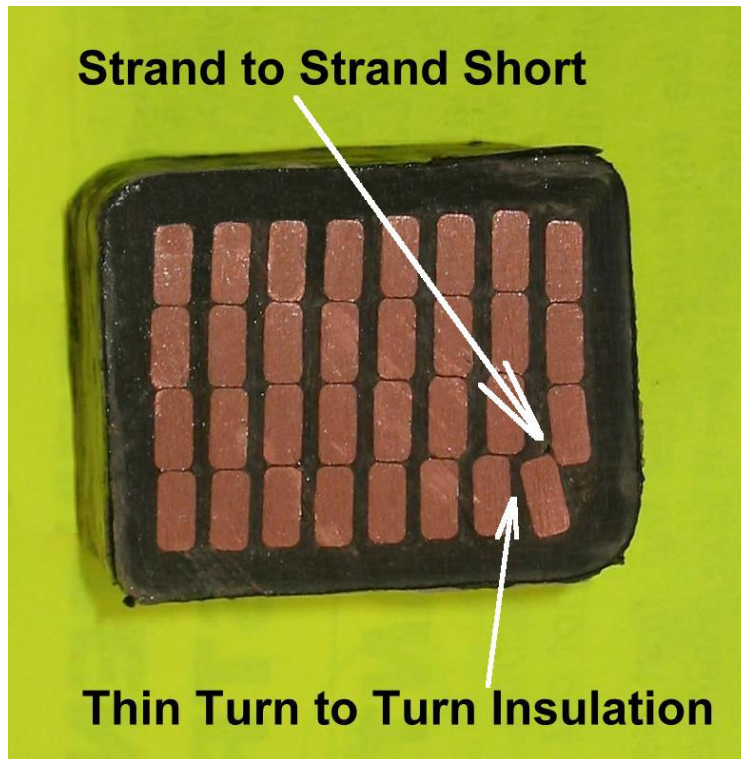
FIGURE 7: Dissection of adjacent removed half coils found strand defects and voids in the insulation.

Dissection of several removed half coils found two strands on the first turn crushed together and shorted. Note there is misalignment in the second turn strands as well. Voids are present at the interface between turn insulation and main groundwall insulation. There was also slightly thinner turn insulation between the first and second turns due to the twisted strand.

There were numerous voids and tape folds in the endarms but this is a low operating dielectric stress area where voids have little effect. This is not the case during a voltage surge when endarm turn-to-turn voltages can be very high.

ROOT CAUSE: A twisted conductor strand in the original construction may have resulted in a strand-to-strand short resulting in localized heating. Thinner turn-to-turn insulation may have also been present at this location. A lightning surge failed the coil due to the original defects and time related deterioration of turn-to- turn insulation in this one coil. Winding replacement was recommended.

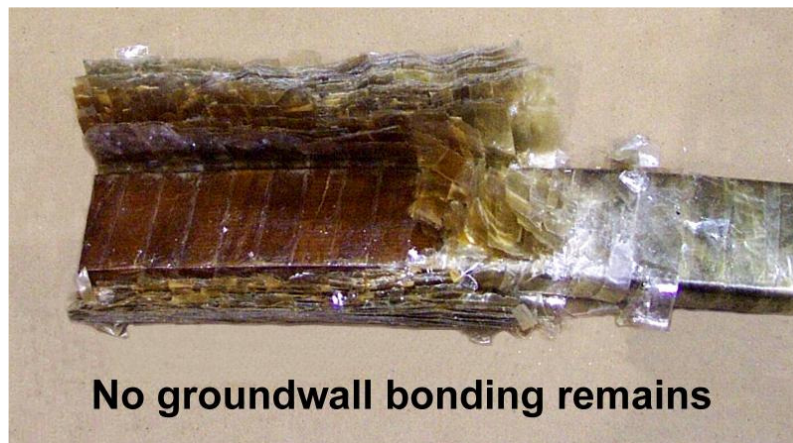
FIGURE 8: Dissection of the failed stator bar found no bonding between tape layers.

This generator was constructed with the first synthetic resin polyester bonded groundwall insulation. None of the original polyester resin remained to bond layers of mica flake insulation after 50+ years of service. The resin had returned to the original constituent oils.

ROOT CAUSE: Time related deterioration of the base resin. Rewinding all eight similar generators was recommended.

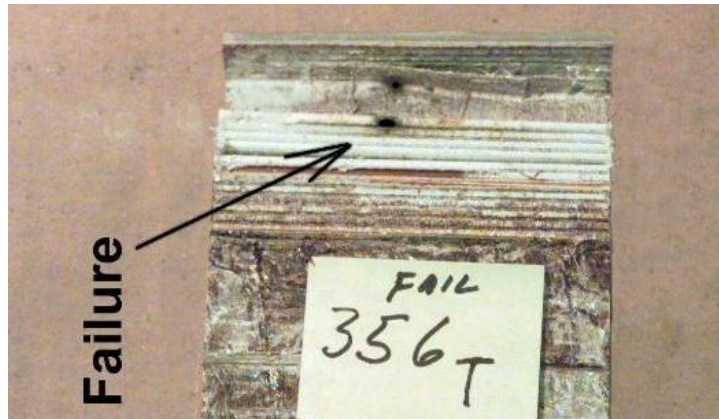
FIGURE 9: This test failure started at a corner of the top turn conductor stack.

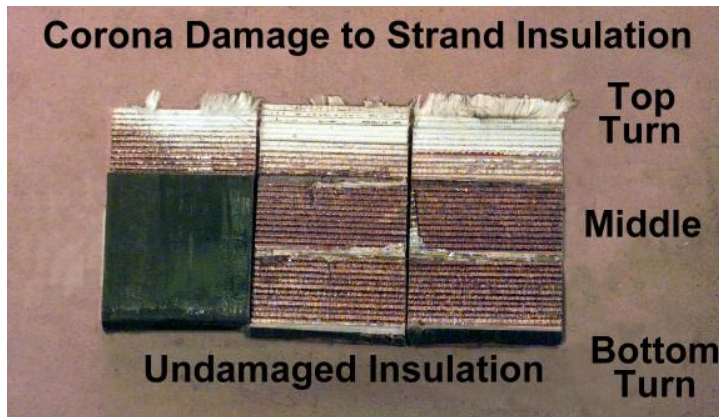
FIGURE 10: Additional cuts along the failed coil found internal corona had destroyed most strand insulation on the first turn near the machine bore.

The top most stator winding conductors operate at the highest temperatures and ozone deterioration is accelerated by the increased temperature. There was some minor damage to the middle turn and no strand insulation to the bottom turn. Loss of strand insulation will create circulating currents and the increased losses add additional heating. Eventually a turn-to-turn failure develops and the coil fails.

ROOT CAUSE: Age related internal corona activity destroyed the strand insulation and weakened adjacent groundwall insulation. Rewinding both similar pump-generators was recommended.

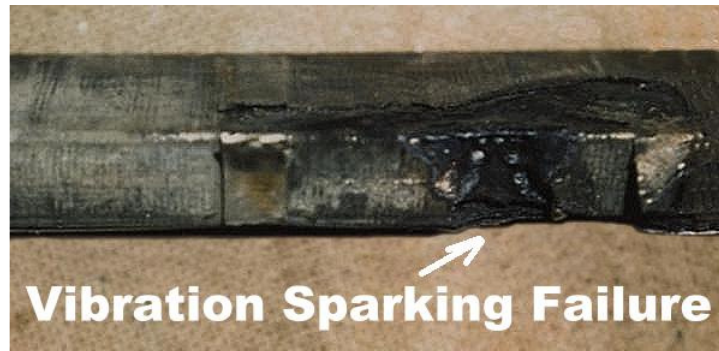
FIGURE 11: These motor coils appeared to have rodent damage in the slots.

A series of new 7000 hp, 4 kV motors experienced multiple stator coil failures after three years service. The filler strips and side packing were of a material not able to withstand the operating temperatures. The coils became loose and there was minor vibration in the slots. Pitting and erosion of the bottom of the bottom stator coils resulted from vibration sparking.

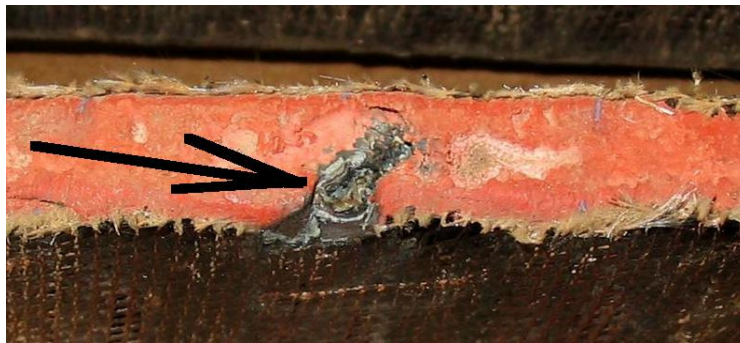
FIGURE 12: The motor coil failure location was apparent. Note all varnished glass armor tape is gone on the bottom of this coil.

This was a dielectric failure starting at an edge of the conductor stack then progressing straight through the insulation. There was no obvious deterioration of the rubber insulation other than on bottom edge of some samples. There appeared to have been in service coil movement and the resulting vibration sparking removed small pieces of insulation. There was severe time/temperature related mechanical strength deterioration of the glass armor tape and black varnish coating. There were numerous voids between the conductor stack and the groundwall insulation. The bond between the red silicone rubber and the conductor stack was gone in many locations. This permitted copper vibration within the insulation, the resulting vibration sparking on the higher voltage coils reduced insulation thickness.

Materials other than the red rubber had the typical thermal deterioration associated with 30+ years of service. Deterioration of the silicone rubber insulation thickness resulted from movement between the top and bottom coils in the slot. This resulted in abraded armor tape and vibration sparking of the insulation causing the test failure.

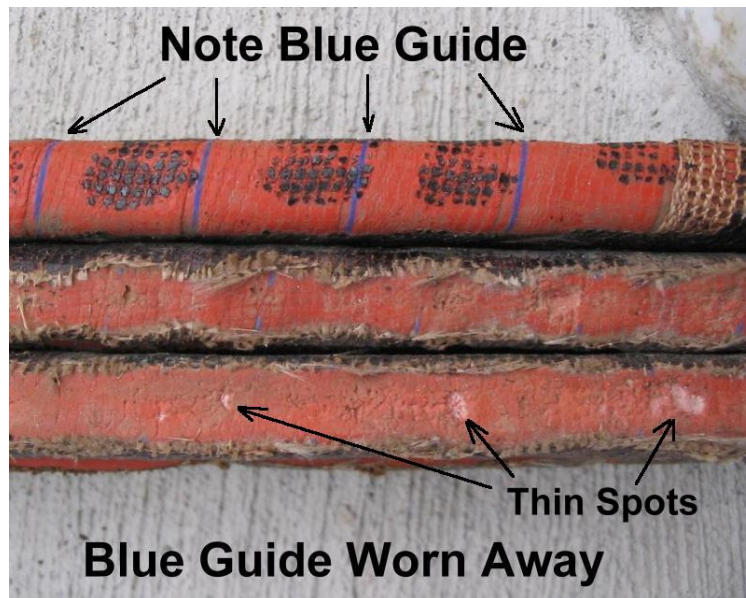
FIGURE 13 Three coils placed side-by-side show the progression of vibration damage on the bottom coil sides.

When glass armor tape was removed from one coil the blue tape overlap guide was apparent (first coil). With the second coil the in-service coil vibration has removed the armor tape and some of the red rubber tape. In the third coil thin spots in the rubber are present but a failure had not yet developed.

ROOT CAUSE: These two failures occurred 30 years apart but in both cases slot filler materials had deteriorated and permitted coil movement. Vibration sparking deterioration was faster than the usual mechanical abrasion of groundwall insulation. Rewind all similar motors was recommended.
