# INVESTIGATING COPPER SULFIDE CONTAMINATION IN A FAILED LARGE GSU TRANSFORMER

Lance Lewand, Doble Engineering Company

## INTRODUCTION

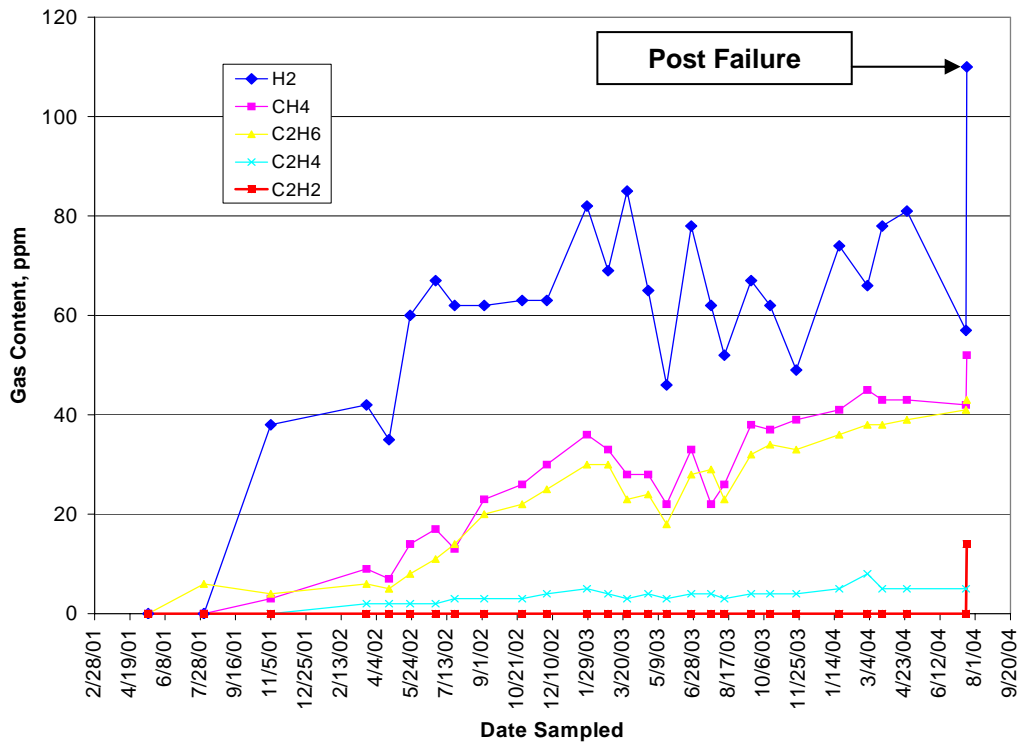
Gassing Trend of GSU Transformer  
FIGURE 1

The gassing pattern is a typical one for GSUs in that there are some heating gases present but not of sufficient concentration to raise any alarms or take remedial action. A sample taken the day before the failure actually shows a slight decrease in combustible gases (Figures 1 and 2) and still significantly far below any level that would be of concern. The acetylene content of 14 ppm would be of concern but that was only present after the failure occurred.

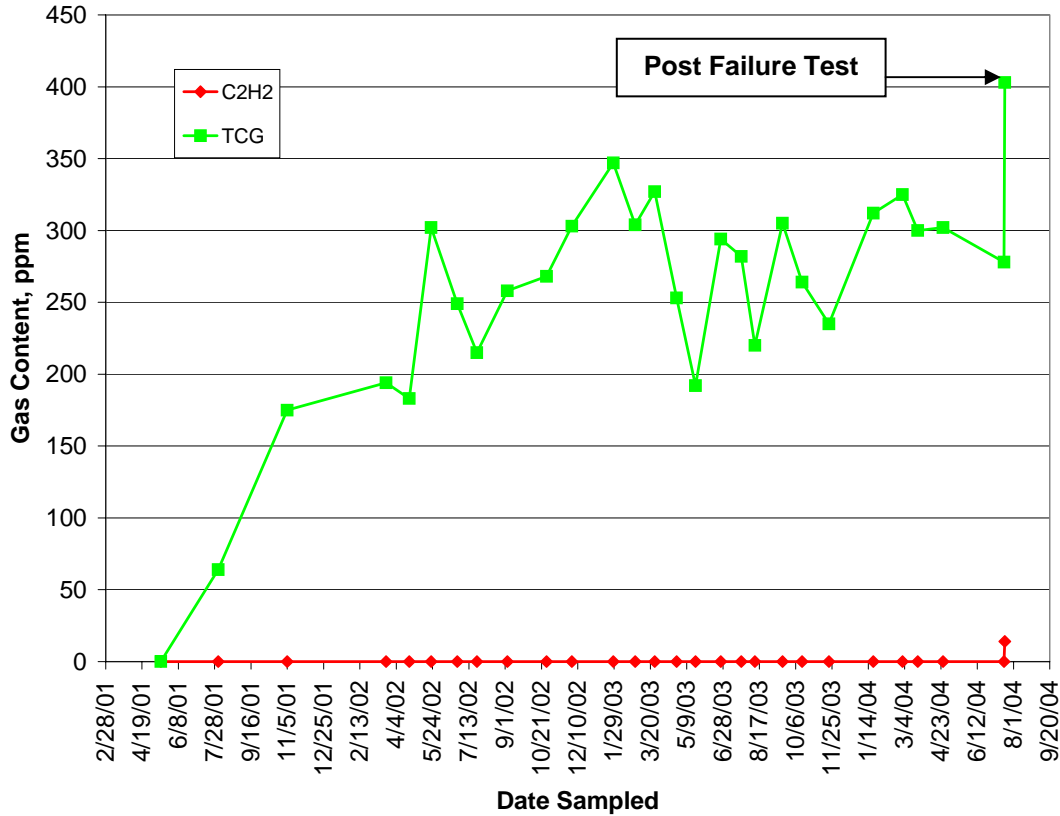
**FIGURE 2**

**Total Combustible (TCG) and Acetylene (C<sub>2</sub>H<sub>2</sub>) Gas Content**

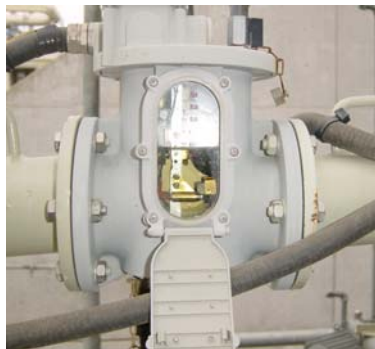
**FIGURE 3**

Besides tripping the circuit, there was no outward signs of transformer failure except for the Bucholtz relay. A visual inspection of the Bucholtz relay mounted on the transformer did indicate a major event occurred in that the relay was half filled with gas (Figure 3) which in service should be completely filled with oil.

**Picture of Bucholtz Gas Relay (Found half filled with Gas)**

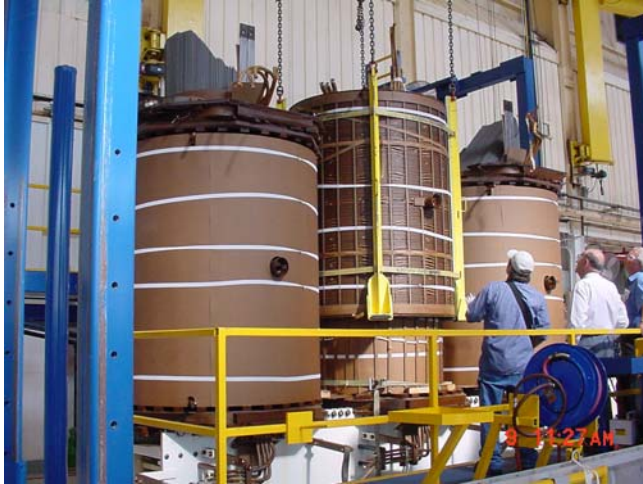
After failure, the transformer was transported to a transformer repair facility where it was un-tanked. The failure investigation isolated the failure to one phase and the teardown of that phase began (Figure 4). The actual failure was isolated to disks 95 through 97 (starting from the bottom). This area represented the upper third of the winding, (see Figure 5). The failure consisted of a puncture that left a hole through the inner most portion of the disk (Figures 6 and 7).

**Removal of Failed HV Winding  
FIGURE 4**

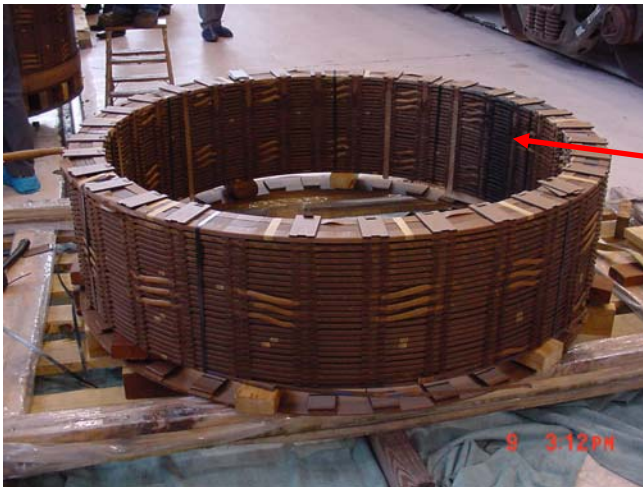
**Area of Failure  
FIGURE 5**

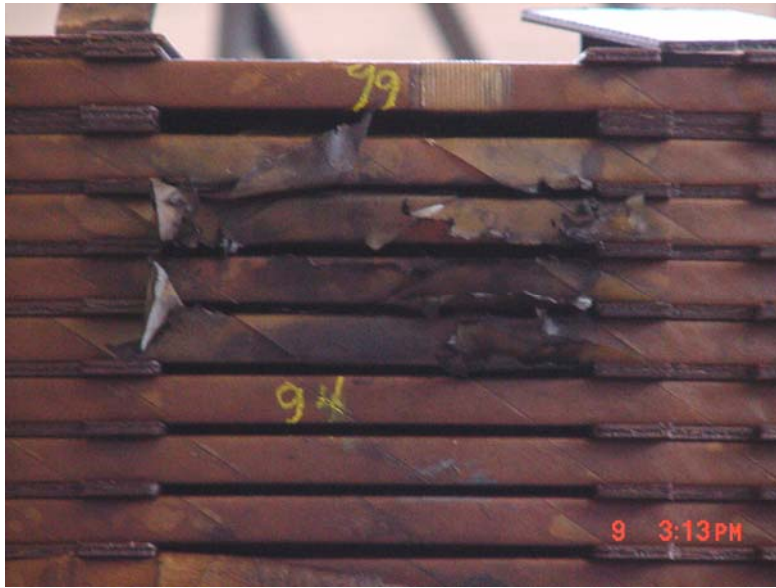
**Disks 95-97, Burnt Region  
FIGURE 6**

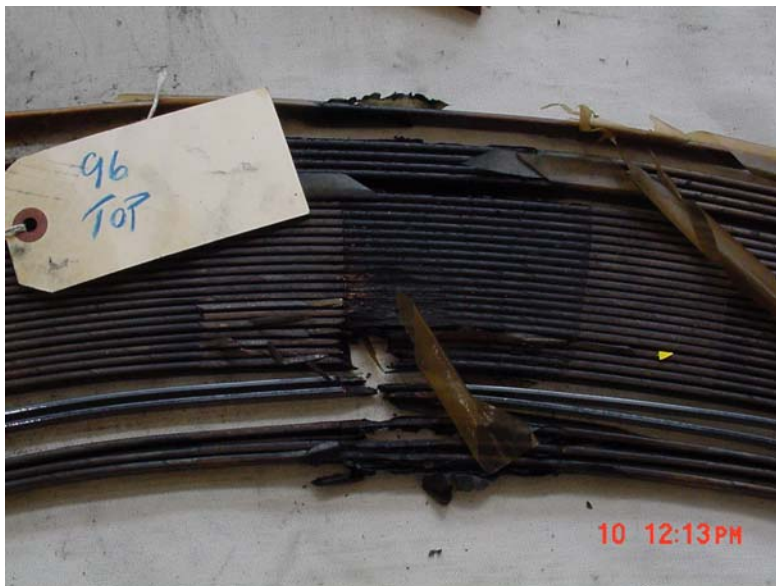
**Hole in Disk 96  
FIGURE 7**

The results of the furanic, phenol and cresol compounds do not indicate any advance or abnormal aging of the cellulosic insulation. Even though there was a clear indication of failure (Figure 7), the amount of material involved in the failure was very small and would not have increased the byproduct concentration significantly.

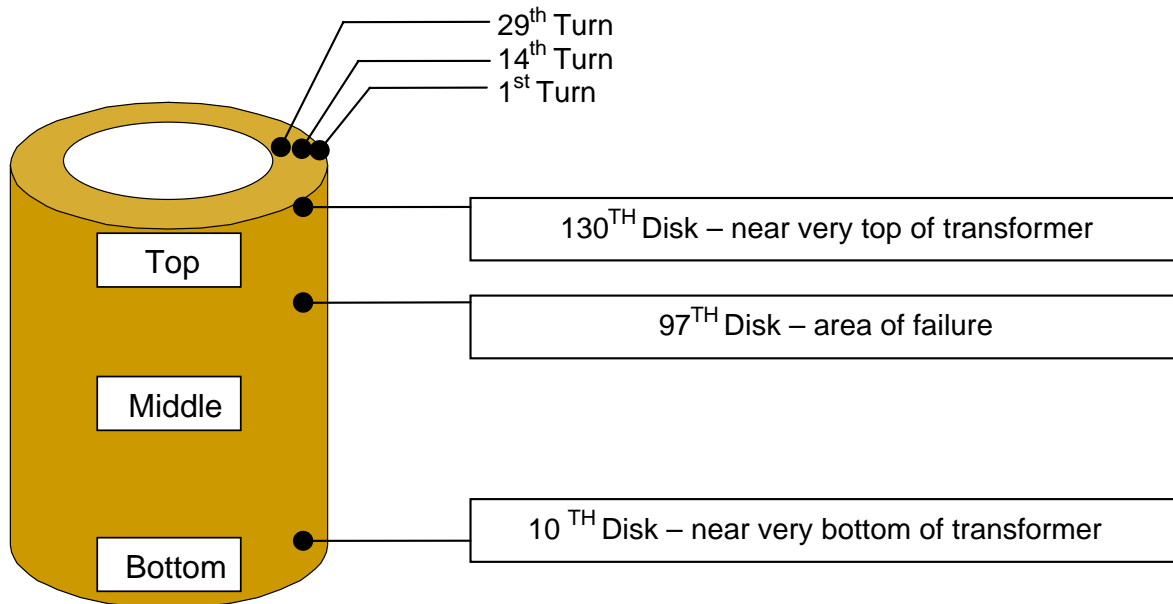
In addition, several additional tests were performed on the paper insulation. One of these tests consisted of testing the copper content of the paper insulation. Paper samples were taken from individual conductor turns at different regions and depths along the failed high voltage winding as shown in Figure 8.

**Diagram of Failed High Voltage Winding**  
**FIGURE 8**

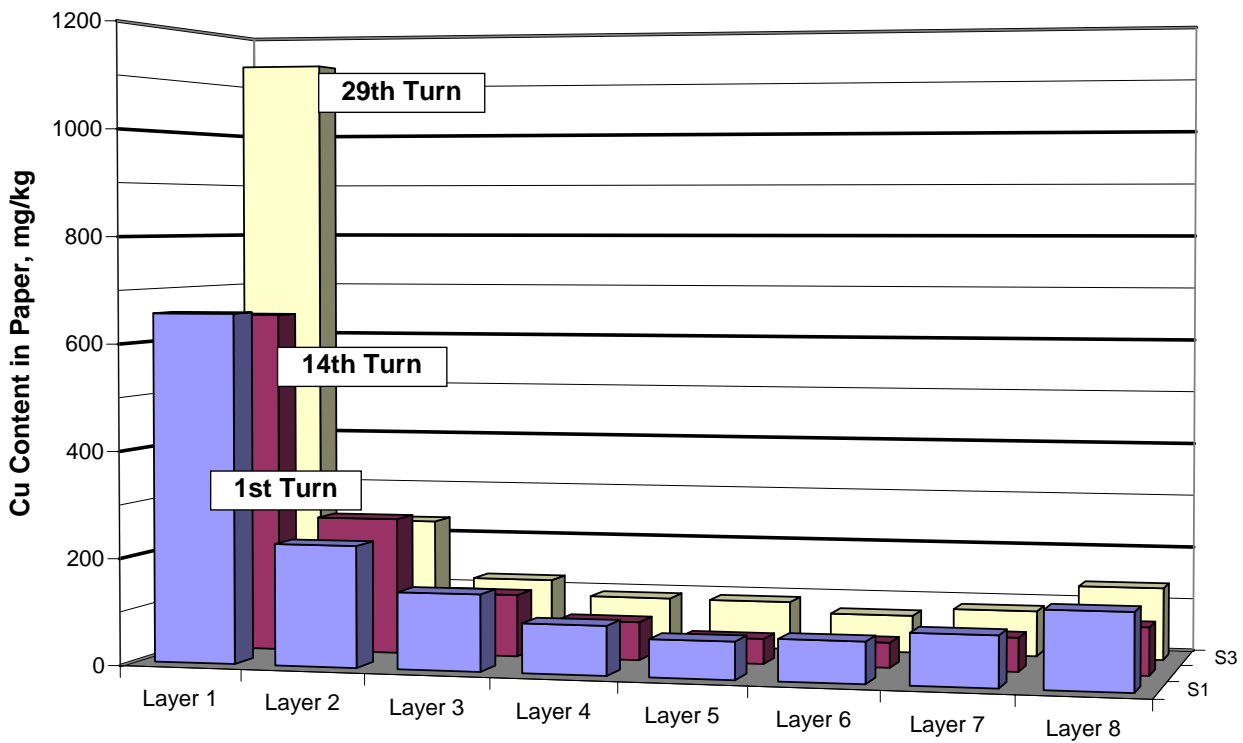
Table 6 and Figure 9 catalogs the copper (Cu) concentration and illustrates its distribution throughout the paper layers of three turns on the 130<sup>th</sup> disk. This disk is located near the very top of the winding.

Distribution of Copper in Paper in Winding Disk 130  
**FIGURE 9**

The copper analysis on the paper insulation was a clear indication that copper was being transported from the conductor to the layers of paper surrounding the conductor with the highest concentration being found next to the conductor. Of even more interest is the distribution of copper in the layers. The copper concentration followed a distorted U-shaped curve from inside to outside with the lowest concentration being in the middle layers of paper wrapped around the conductor. This illustrates that paper is adsorbing copper not only from the conductor on the inside layers but from the bulk oil on the outside layers so it is being impacted from both directions. It also shows that copper ions are being transported through numerous layers of paper. In previous experiments performed at Doble, new paper received from the paper manufacturer only contained about 1 to 3 mg/kg (ppm) of copper in the paper.

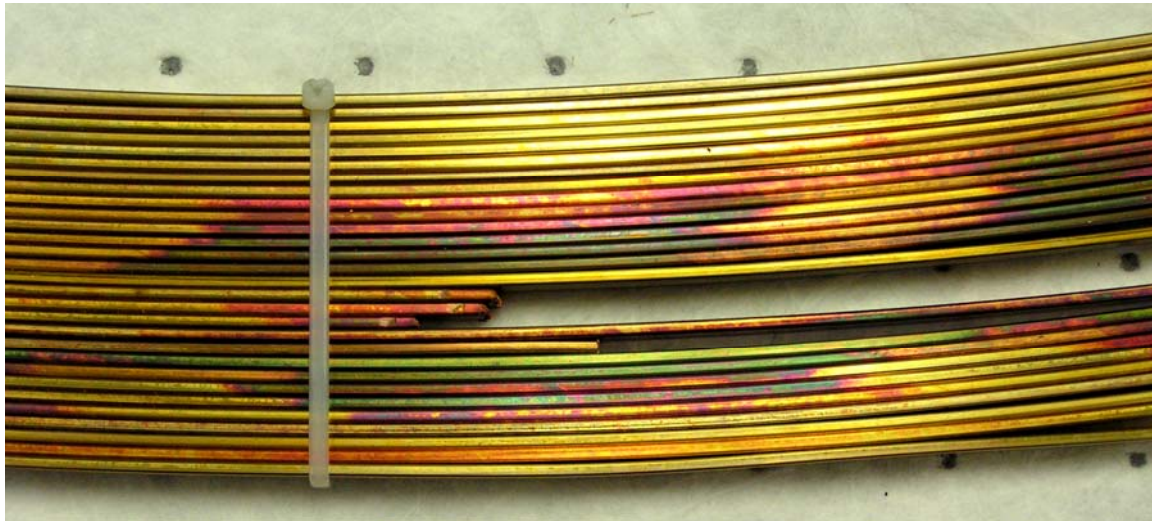
Removal of the paper insulation from the turn to perform the copper analysis on the paper also exposed the copper conductor. Significant discoloration of the copper was visible as shown in Figure 10. The copper turns in Figure 10 represent some of the 29 turns in Disk 130. This discoloration is different forms of copper-sulfur compounds.

**Picture of Copper Turns in Disk 130  
FIGURE 10**

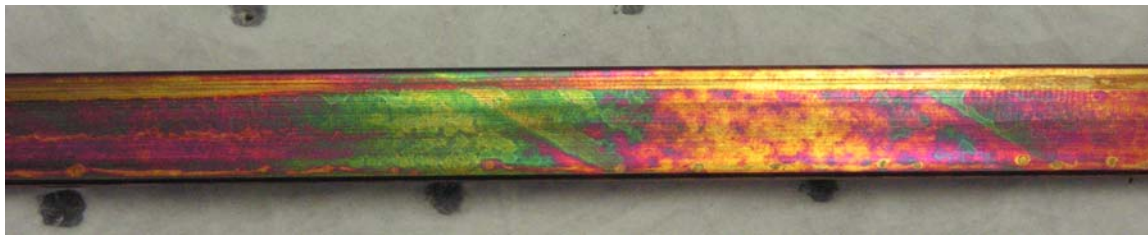
Removal of one piece of copper from this disk shows just how extensive some of the contamination really was. This is shown in Figure 11.

**Picture of Copper Turn 11 in Disk 130  
FIGURE 11**

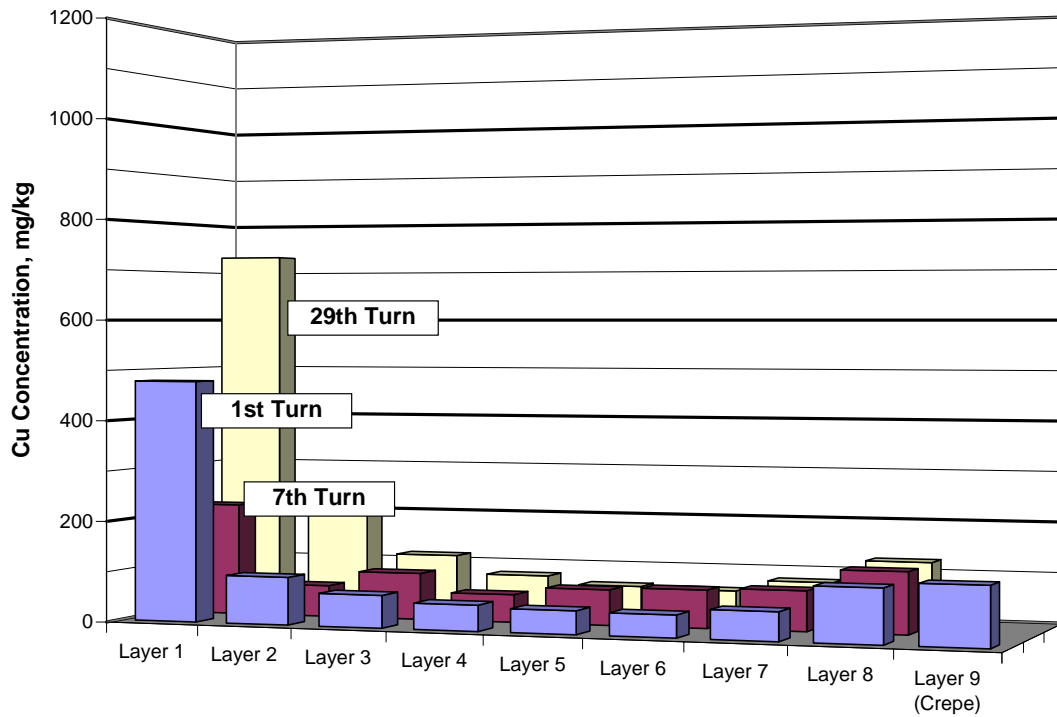
Table 7 and Figure 12 lists the copper (Cu) concentrations and shows its distribution throughout paper layers of three turns on the 97<sup>th</sup> disk. This disk was located in the direct vicinity of the failure. Figure 12 has been depicted on the same concentration scale as Figure 9 for comparison.

**Distribution of Copper in Paper in Winding Disk 97**  
**FIGURE 12**

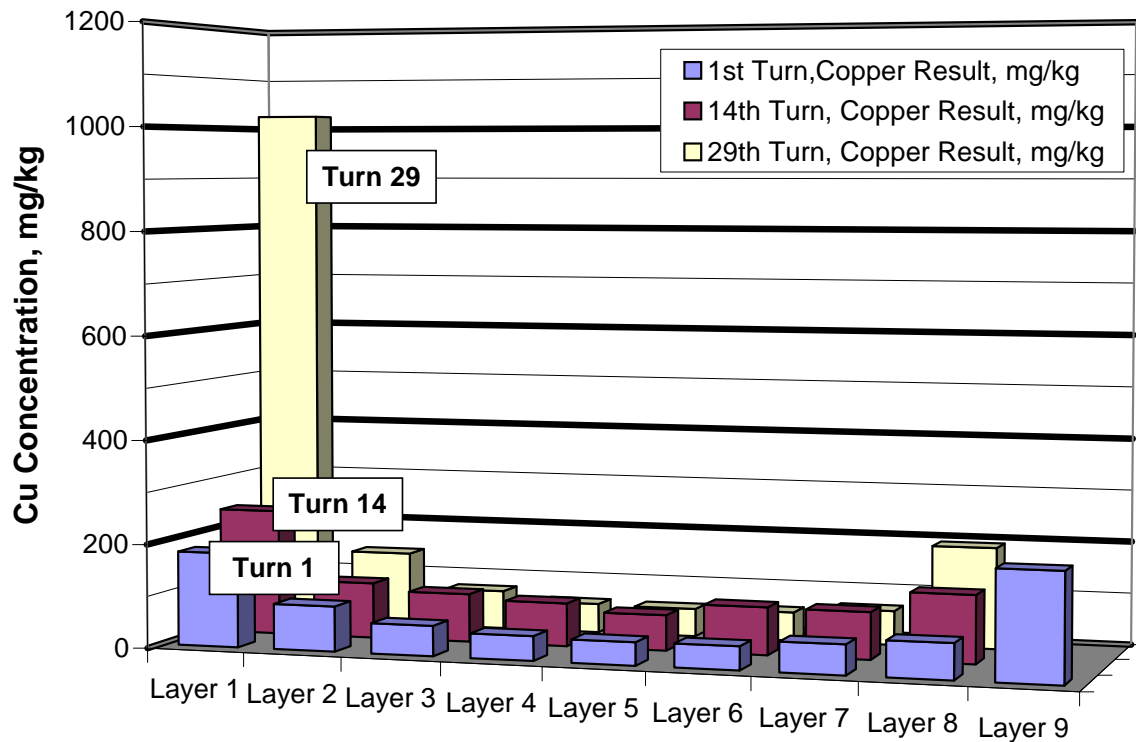
Table 8 and Figure 13 catalogs the copper (Cu) concentrations and illustrates the distribution throughout the paper layers of the three winding turns on the 10<sup>th</sup> disk. This disk was located close to the bottom of the transformer. Figure 13 depicts the same concentration scale as Figure 9 for comparison.

**Distribution of Copper in Paper in Winding Disk 10**  
**FIGURE 13**

What is also shown in these results is that the inner most turn (Turn 29), exhibits the highest concentration of copper of all the turns in a disk and it may be due to the oil flow that exists between the low voltage and high voltage windings. Even in one of the bottom most disks (Disk 10), though the overall copper concentration was much less than the other two disks tested, the 1<sup>st</sup> layer of the 29<sup>th</sup> turn still exhibited a very high copper concentration. Another interesting fact is that the copper concentration in the paper also increases as the disk position increases in the winding. Basically, the top of the winding exhibited the highest overall copper concentration even though this was not the immediate area in which the failure occurred. As this was a core form transformer, it is thought that the copper distribution in other core form units or designs would be similar if a problem of this type should exist. Figure 14 provides an overall diagrammatic view of the transported copper distribution determined in this analysis.

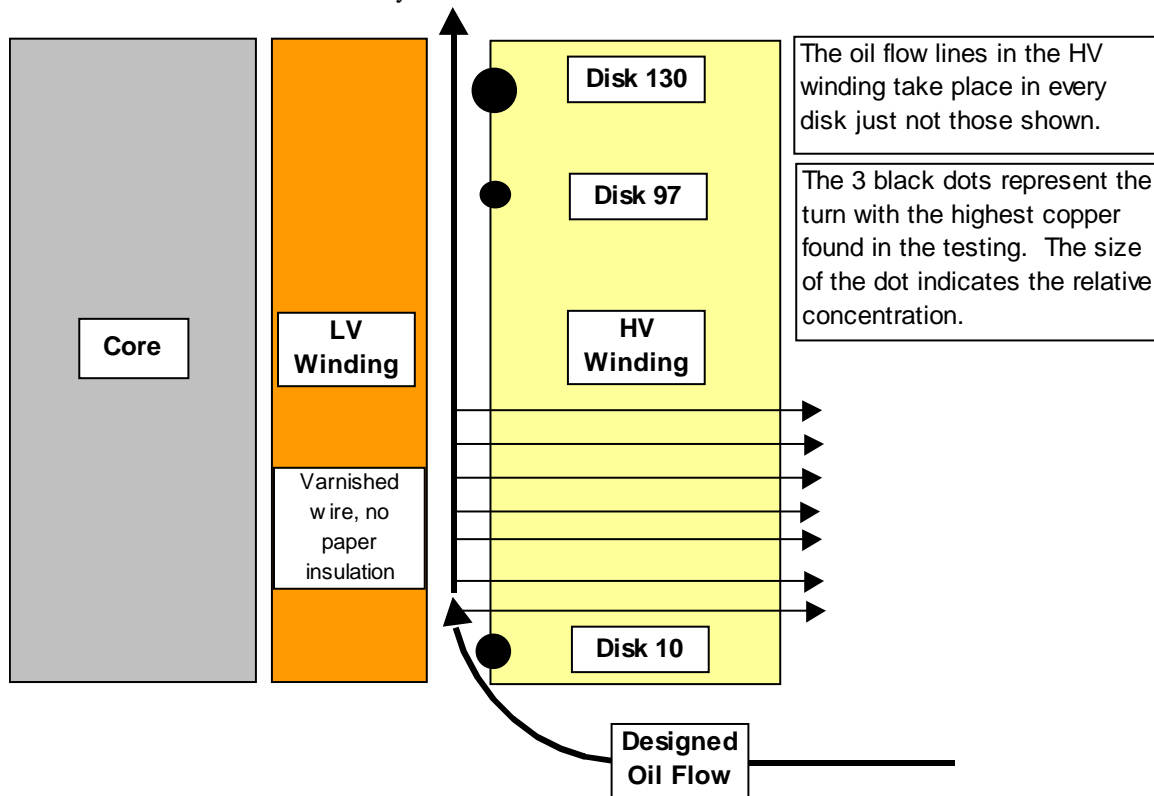
**Diagram of GSU Transformer Winding**  
**FIGURE 14**
