ISSUE 15
October 2021

TRANSFORMER TECHNOLOGY^{MAG}

Investigation and Teardown of OIP Bushings

by **Lance Lewand**
and **Leah Simmons**

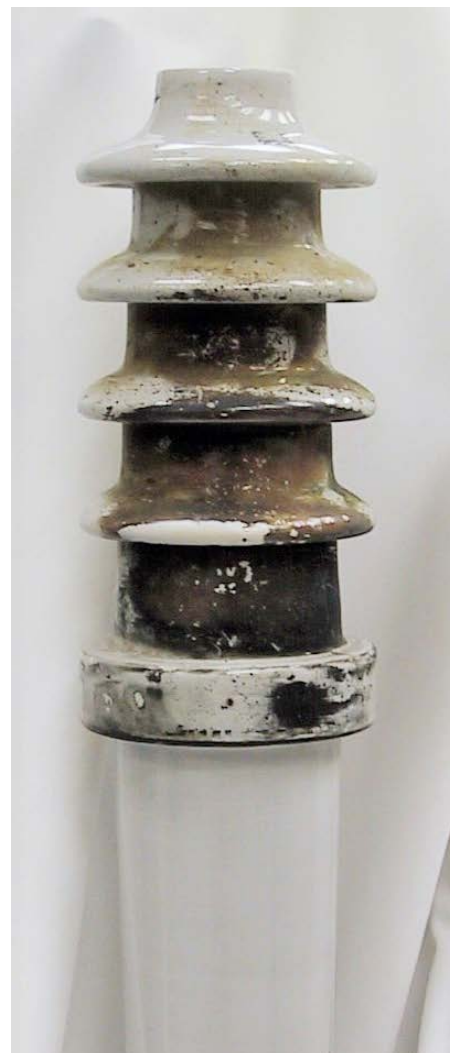
Deposits on the bushing sheds (see Figure 1), the oil level in the sight glass, the color of the oil, any deposits in the sight glass, and arc marks on the flange, the lower assembly below the flange, upper porcelain or the head of the bushing is additional information to gather.

Figure 1. Hot oil and fire soot deposits

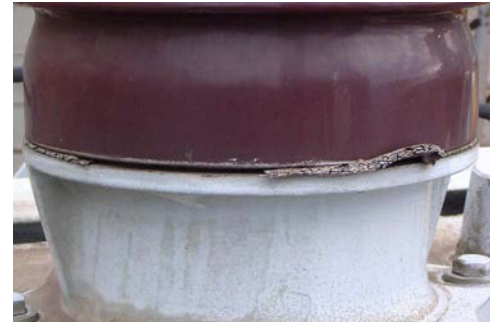
O-ring compromises have occurred as seen by the elastomeric material exuding from the gasket/O-ring groove or material crumbling (refer to Figure 2) away from areas that they were supposed to seal. In all, some bushings can have as many as 20 gaskets and O-rings, each of which must be fully studied and most of which will be found during disassembly.

Figure 2. Compromised bushing gasket at flange-upper porcelain interface

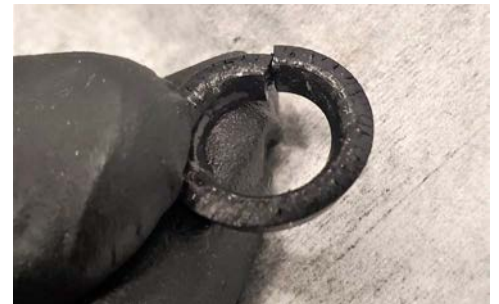
Dissolved gas-in-oil analysis (DGA) will provide information on arcing, partial discharge, overheating of the oil, overheating of the paper and possibly other issues. Oil quality tests will provide information on the condition of the oil and can determine if air and water ingress has occurred. This is important as water ingress is one of the primary drivers of bushing failures. The photo in Figure 3 shows a broken and deteriorated O-ring from the oil fill plug which allowed water and air ingress into the bushing.

Figure 3. Broken and deteriorated oil fill plug O-ring

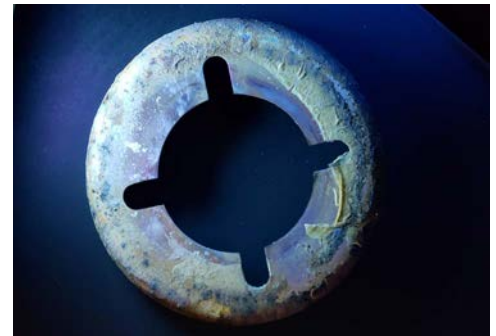
In the head will be a variety of O-rings and gaskets which will need to be inspected and categorized. The sight glass may also yield some evidence along with inspection of the spring basket assembly. Figure 5 provides a photograph of heavy x-wax formation on the corona ring of a bushing.

Figure 5. X-Wax on the corona shield of a bushing and other debris

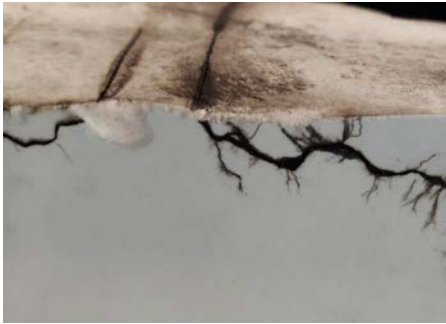
Once the head is removed, removal of the porcelain can ensue but there maybe one or more separate pieces of porcelain above the flange, so they need to be removed one by one without damaging the paper insulation of the core. Inspection of the internal surface of each piece of porcelain removed can also yield evidence. Figure 6 shows arcing found on the inside porcelain of one failed bushing.

Figure 6. Arc tracking on internal porcelain

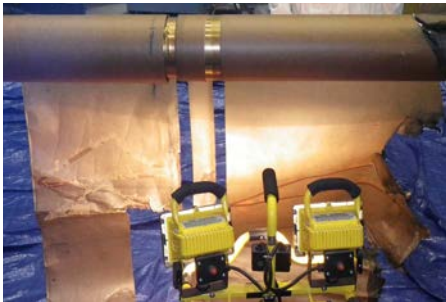
without damaging the core before the flange can be removed. Depending on the bushing manufacturer there are a variety of methods that were used to attach the tap to the core. In larger bushings, there may multiple taps all of which need to be disconnected prior to flange removal. Once all the pieces are removed, the inspection of the core can commence as shown in Figure 7.

Figure 7. Partial core of a bushing showing tap foils

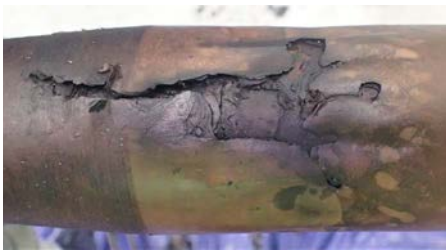
Figure 8. Arcing through core

Often paper samples are taken at different depths and positions within the core so that they can be analyzed for degree of polymerization (DP) and water content along with a variety of other physical, chemical and electrical analyses. Along the way, area of discharge may be found as shown in Figure 8 or partial discharge treeing in Figure 9.

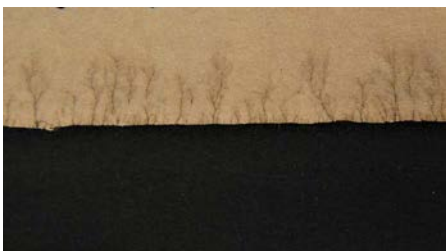
Figure 9. Partial discharge treeing from edge of ink layer

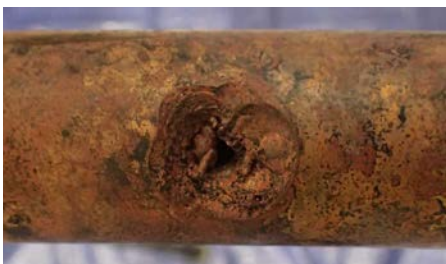
Figure 10. Arc hole through copper conductor

Once the unwrapping of the core is completed, the actual center conductor can be inspected. Most often copper is used in lower kV bushings whereas aluminum is used in larger voltage bushings to reduce weight. Occasionally, a combination of the two may be present. Some examples of damage done to the center conductor are found in Figures 10 through 12.

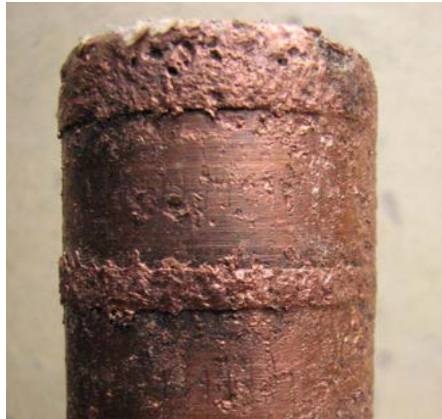
Figure 11. Pitting and melting of copper conductor

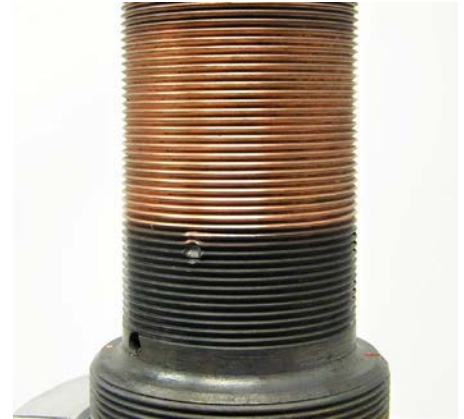
Figure 12. Copper sulfide formation on copper conductor
