WINDING RESISTANCE ISSUE DURING TRANSFORMER BUSHING REPLACEMENT

Andrew Stenabaugh
Ontario Power Generation

Ed teNyenhuis
Hitachi Energy

ABSTRACT

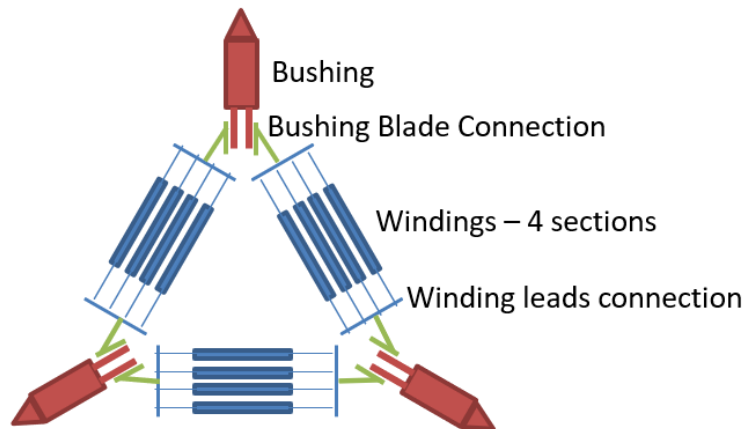
Sketch of the Internal Winding and Lead Connections for the Delta Connection
Figure 6

The bushing-to-bushing winding resistance measurement is shown below in Figure 6. The delta connection is made at the bushings. There are 4 winding leads (4 parallel winding sections) due to the high current of the LV. The 4 winding leads are connected to a copper plate and the copper plate connects to one blade of the bushing. The other bushing blade has a copper plate connecting 4 winding leads from another winding. A picture of the connections at the bushing is shown in Figure 7.

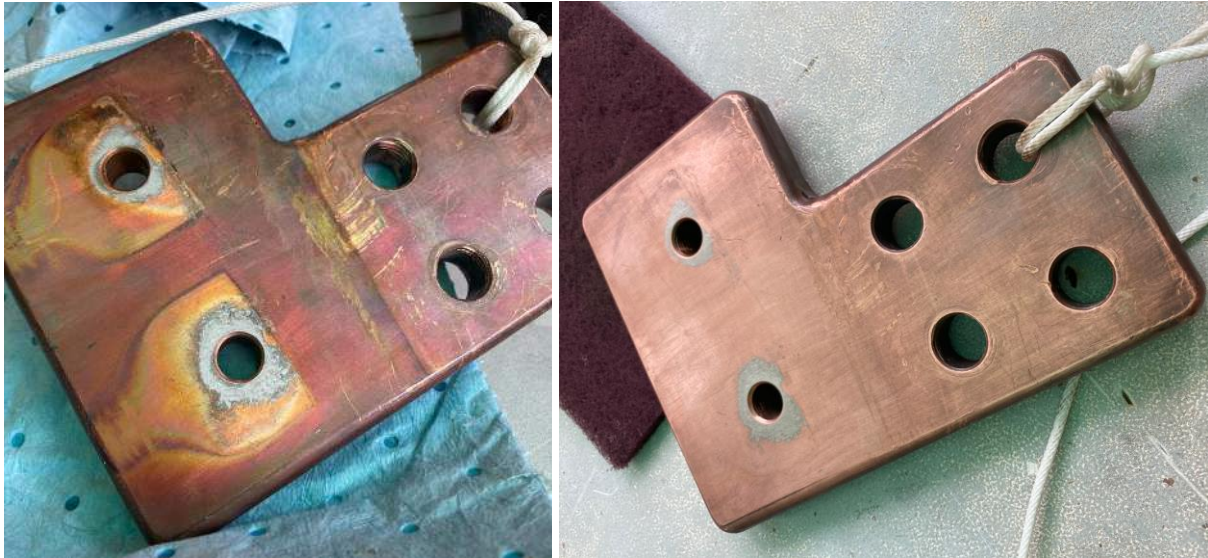
**Copper Connection Plate (Before and After Cleaning)
Figure 8**

6. Winding leads were disconnected from the 2 copper plates—The issue was seen on one of the copper plates where there was heavy surface corrosion or surface coating between the copper plate and the winding leads. The copper plate was removed from the transformer and thoroughly cleaned (see Figure 8).

The estimated 1.4 milli-ohms at the W2B connection is about 1/3 of the winding resistance, which is significant. This could lead to an estimated 17kW increase in load loss due to the high LV current and most likely a very high temperature increase at this location.

The problem with the copper connection plate most likely occurred when the heavy plate was moved slightly to rearrange its position to match the bolting to the new bushing. Although the new bushing was designed to be a direct replacement, the copper plate had to be disturbed to push it into position. This slight movement seems to have disturbed the 4 lead connectors on the copper plate. The corrosion on the copper plate between the connector and the copper plate caused the contact resistance to increase significantly. It is not clear why there was a surface issue on this one particular copper plate and not on the other copper plates.

The calculated 1.4 milli-ohm contact resistance, if left in place, would have likely overheated and caused gassing. It was thus prudent that the investigation and repair was performed.

7. Reconnected the winding leads to the cleaned copper plate—The winding phase was remeasured, and the value was close to the other phases.
8. Everything was fully reconnected—The winding resistances between LV bushings was measured and found to be close to the Pre-Test and FAT. See Table 2 for the final measured values compared to FAT and pre-test.

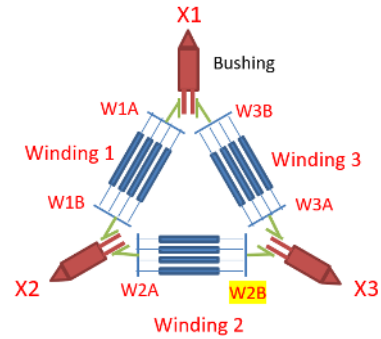
**Identification of Winding and Leads for Table 2
 Figure 9**

In order to understand the copper connection plate problem, the resistances of the various winding, connections and bushings were modeled in Table 3 and Figure 9. Each winding was called a “winding path” which includes the actual winding sections and the connection of the 4 winding leads onto the copper plate. For example, “Winding 1 Path” is the sum of W1A, W1B and the winding itself for a total of 3.805 milli ohms. The measured winding resistance between 2 bushings includes the parallel sum of 2 paths – a short path through 1 winding and a longer path through the other 2 windings in series. For example, the measurement of X1 – X2 is the parallel sum of Winding 1 and (Winding 2 + Winding 3). The resistance values of the bushings and the copper plate connections was assumed to be very low and the winding sections resistance was selected so the X1 – X2, X2 – X3 and X3 – X1 calculated values matched the FAT. This is all shown in the left column of Table 3.

The problem was found to be in the W2B connection location. The resistance of this W2B connection had to be increased significantly in order for the X1 – X2, X2 – X3 and X3 – X1 calculated values to match the measured Pre-Test values (it is not exact but very close).
