ARC FLASH INCIDENT DUE TO FAULTY SUBSTATION GROUND GRID

Lyndal Cost

Alabama Power a Southern Company

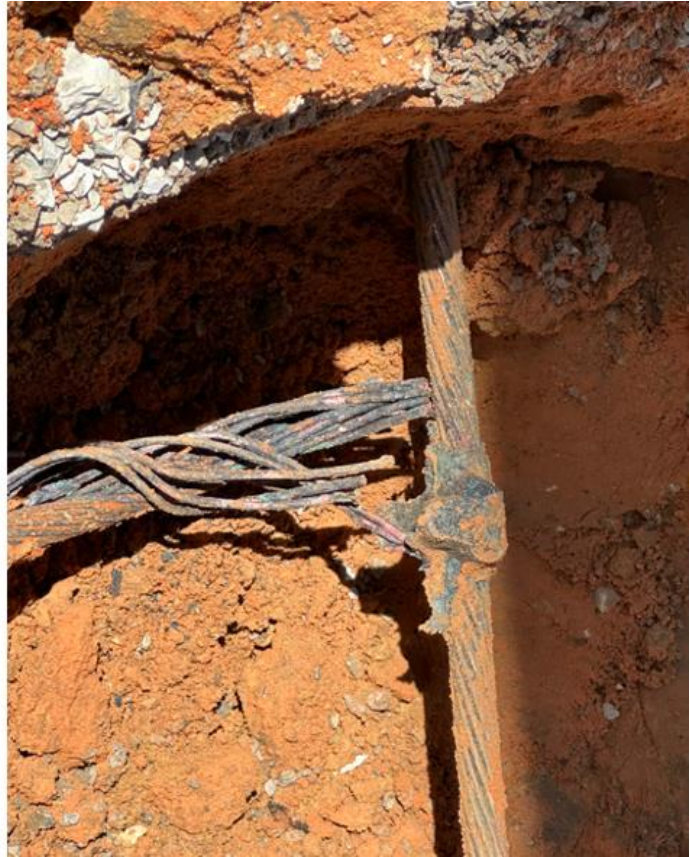
Figure 2

The subsequent investigation by the crew identified a defective cold abutment (CAD) weld connection below grade that compromised the grounding grid, resulting in a "floating neutral." The defective weld, which had possibly been compromised since the construction of the ground field, resulted in a break in the continuity of the ground field. An in-depth analysis of the deterioration, active causes, latent conditions, contributing factors, recommendations, and action items resulting from this event will be detailed in the paper.

It was determined that the reliability/function of the grounding grid was compromised. An underground CAD weld between the neutral's isolated vertical riser and the grounding grid separated, breaking continuity. From inspection, it was determined that the CAD weld was defective from the time the ground field was constructed. Without ground field continuity, the neutral return current, from the distribution lines on Bank #1, traveled through the low side TPGs connected to the isolated phases. When the X2 phase was unbolted and the loose end placed onto the transformer tank, it provided a path through the tank's case ground. This resulted in the arc. The failure of the CAD weld resulted in a "floating neutral." The diagram in Figure 1 helps to illustrate the fault condition.

The cad weld appeared to have high porosity and missing much of the expected weld material indicating that this defect likely occurred when the station was constructed.

Ensure that work methods and training are up to date regarding the proper installation of CAD welds for ground grids in substations. Reinforce the importance of self-checking and peer checking by Construction and Maintenance personnel before covering buried ground grid connections.

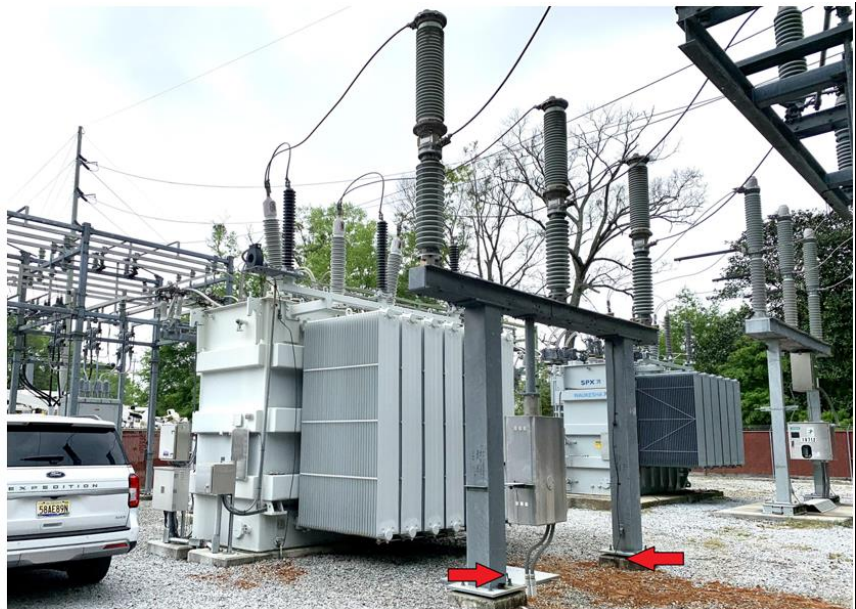
Figure 3

- The #2 bank high-side circuit switcher had no earth ground reference. Each structure leg had a ground riser, however they were bonded to each other and not the ground field. See Figure 3.

The Bank #2 High Side Series 2000 Circuit Switcher (#19992) structure had no earth ground reference on either of the two support legs. Each leg was bonded together with a common ground wire, but neither was connected to the Ground field.

If Bank 2 were removed from service and the HV leads grounded, one of these two risers would have been used to ground the transformer.

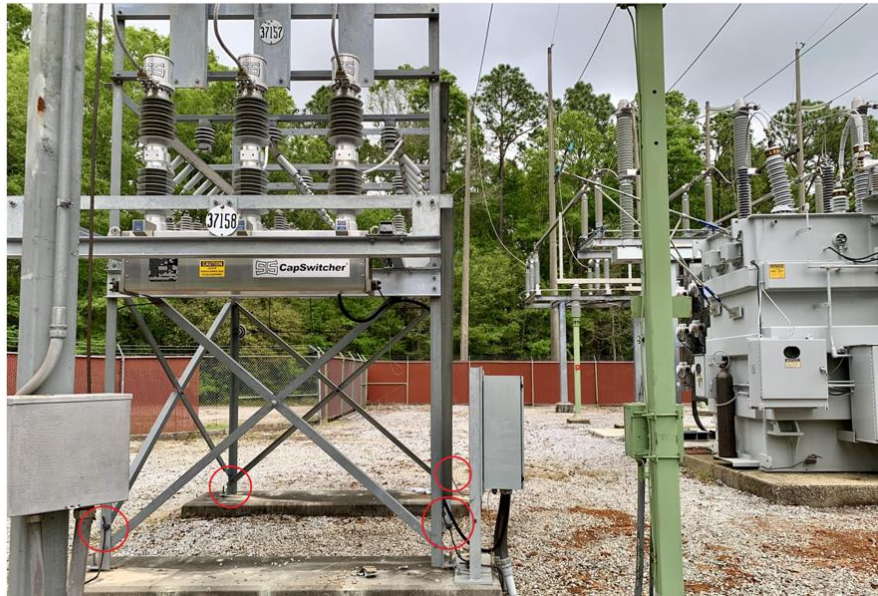
Figure 4

- The #1 distribution capacitor bank had high resistance on each of the four ground risers. Further investigation revealed that all four risers were bonded together with a single common connection to the ground grid, which was compromised, instead of four individual connections. See Figure 4.

The Bank #1 distribution Capacitor Bank had high resistance readings on each leg of the structure going to the Ground field. All four grounding wires were bonded together to a single common wire that had a bad connection to the Ground grid.
