CATASTROPHIC FAILURE OF AN ASEA TYPE IMBE-170 A4 CURRENT TRANSFORMER

**Hugo Simard, Rio Tinto
Jordan Beaudoin, Rio Tinto
Long Pong, Doble Engineering**

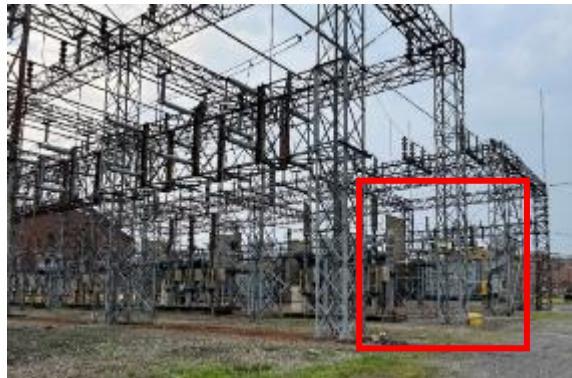
On July 6, 2023, a loud noise was heard in the high voltage substation in Figure 1a and a fire was observed on the phase C, in Figure 1c. Multiple pieces of porcelain were found over 250 feet around the CT and some pieces had damaged a nearby power transformer and the circuit breaker. Additionally, a piece of porcelain was found in a neighboring garage in Figure 1b.

a) Failed CT in 161kV substation

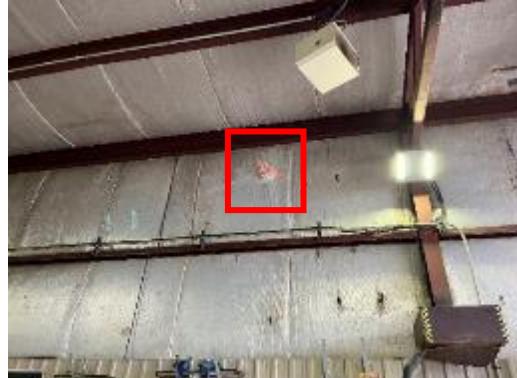
b) Flying porcelain in nearby garage wall

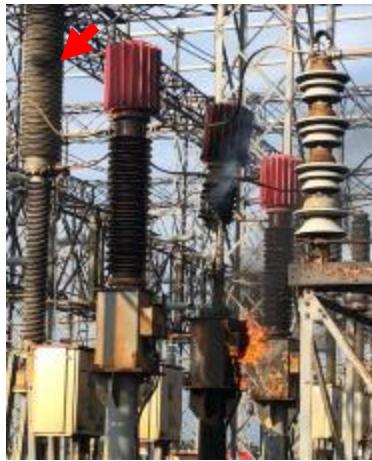
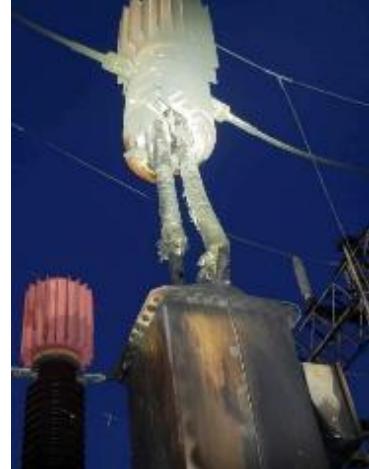
Overview of the Failed CT in Phase C Figure 1

c) Failed CT on fire and damage

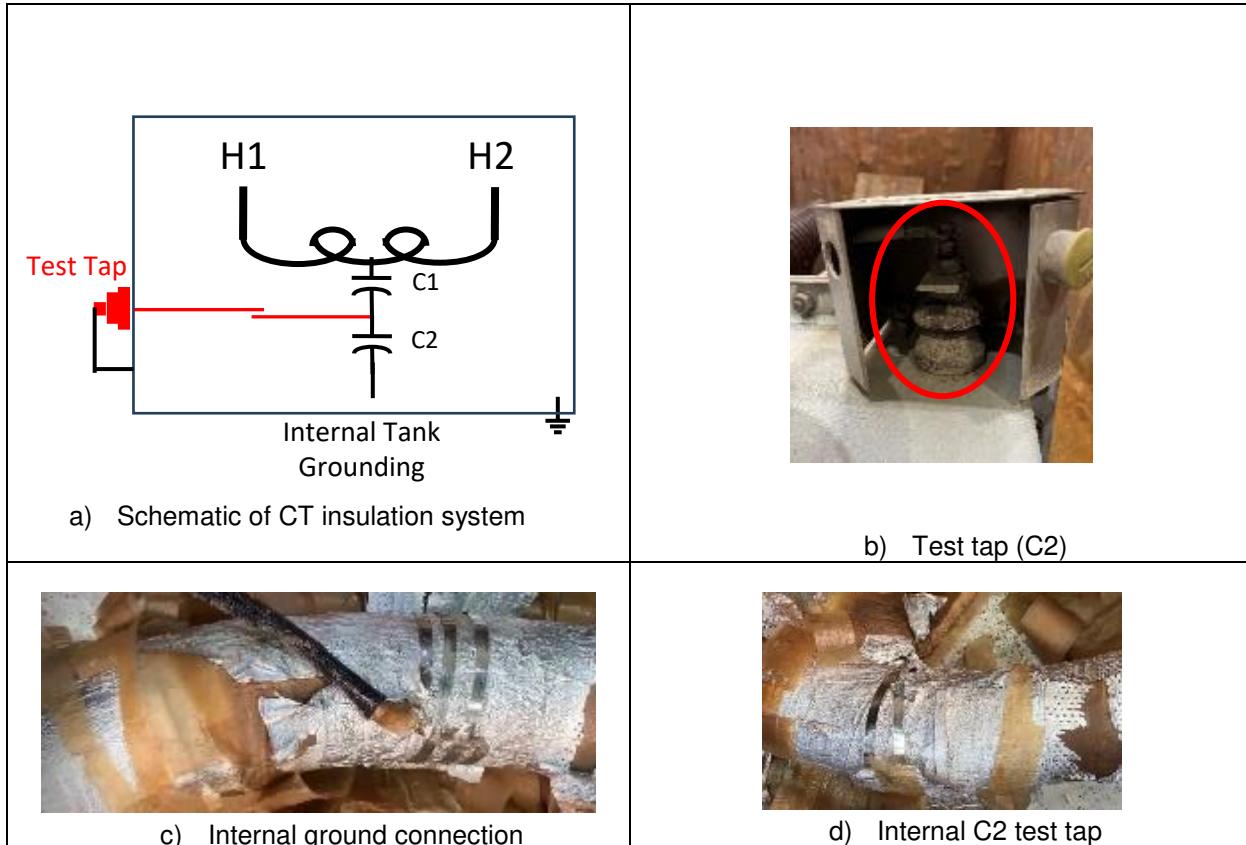
Overview of the CT Insulation System
Figure 2

Each CT is composed of a measurement tap (C2) that is connected to ground in normal operation (Figure 2b) and another measurement system that is the main insulation (C1) of the CT. The insulation system between the ground and the test tap consists of only a few layers of insulating paper (Figure 2c). This small insulation system measurement should be able to detect earlier internal degradation like oil contamination.

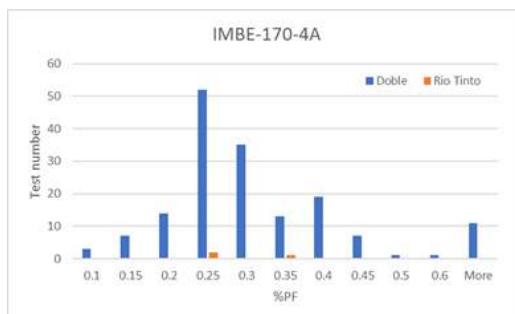
Doble Reference Overall Power Factor Since 2006-2023
Figure 3

PF Tests: The PF tests were performed on July 10, 2023 and provided the results in Table 5. The measured PFs were all within the acceptable limits and statistically well below the data from the previous test in Figure 3. The three CTs have noticeably different capacitances from each other; the deviation varies from 5% to 18%, suggesting some variation in the CT construction. However, the measured capacitance remained stable, with slight increases but still below 2% when compared to their baseline capacitance in 2006. All capacitance measurements are slightly different between the CTs, which can be explained by small differences in their construction.

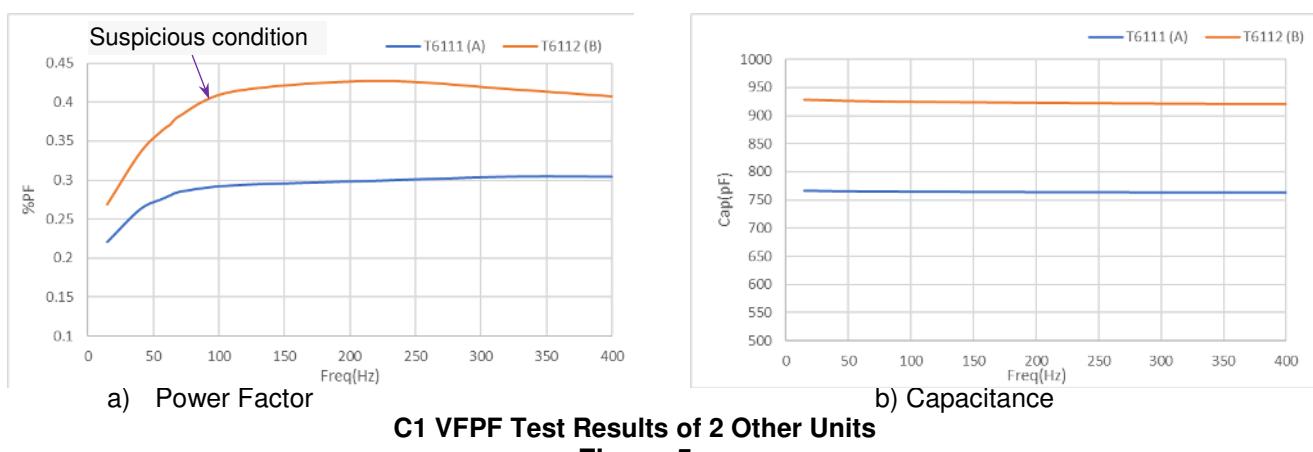
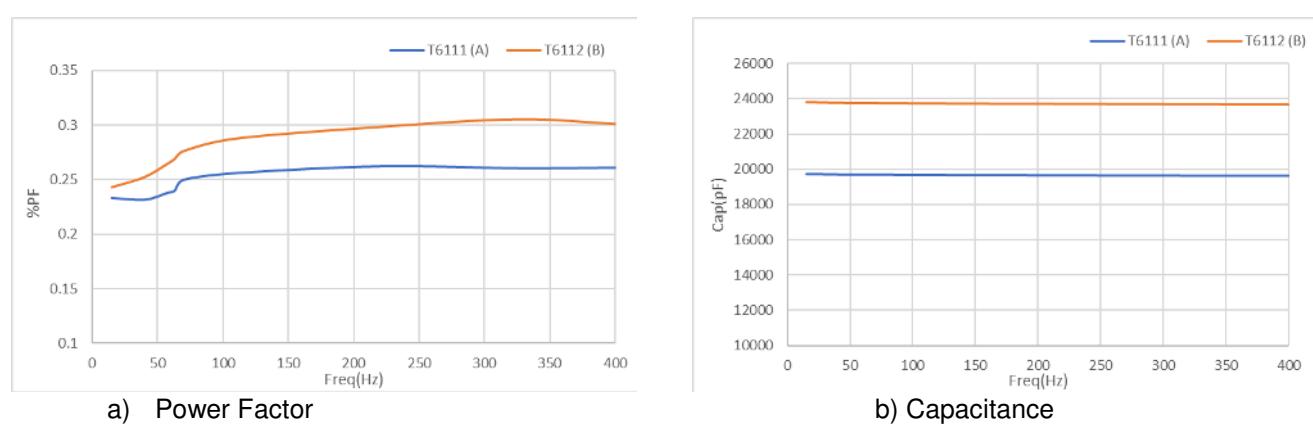
VFFP Tests: Figure 4 describes the VFFP C1 test configuration on the sister units: test voltage at 2 kV, frequencies sweeping from 15 to 400Hz. The results are plotted in Figure 5 and 6 and correlated with the overall test data in Table 5. At power frequency (60Hz), the VFFP detected the same pattern of capacitance and PF as measured by the overall tests, so the observations mentioned in the previous section of overall test apply to VFFP as well. The capacitance remained stable across the frequency spectrum. The PF versus frequency was lowest at 15Hz, then rose to form a shape of an inverse “fish-hook,” typically caused by low conductive losses in the insulation. But when comparing the two traces in Figure 5a for C1 or in Figure 6a for C2, it is remarkable that the higher the power factor, the greater the shape of the inverted fishhook. This behavior was identified as Pattern 4 in [1], making the PH B condition suspicious.

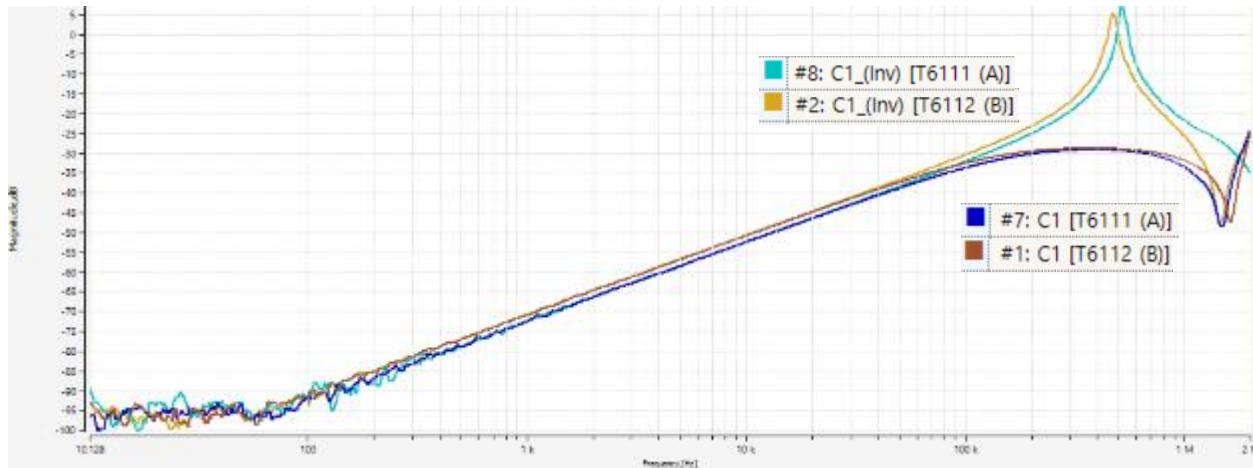
SFRA Tests on C1 - T6111 (A) Versus T6112 (B)
Figure 8

The C1 traces in Figure 8 exhibit comparable frequency characteristics between the PH A and B CTs, meaning similar shapes and different resonance frequency due to the dissimilarity of their capacitances. However, the C1 (Inv) trace behaves differently from the C1 trace regarding the resonance type, the former has series type resonance (peak), and the latter has parallel type resonance (valley). This was probably caused by the CT magnetization reactance being excited in C1 test and not excited in C1 (Inv) test.

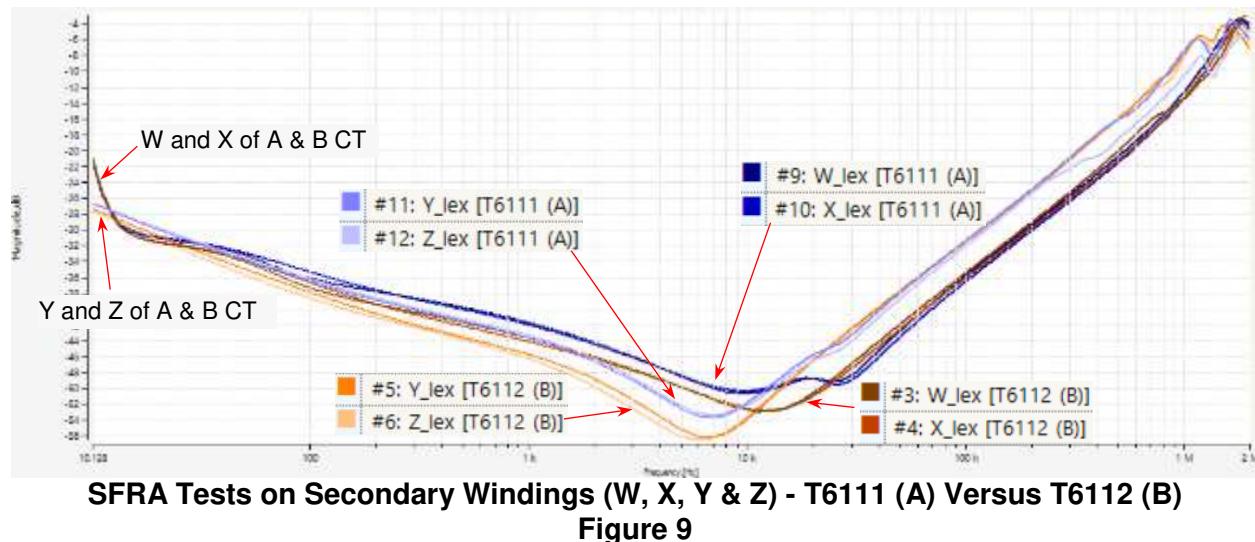
The traces of the open-circuit tests (lex) in Figure 9 classified the four secondary windings into two groups: W&X and Y&Z, suggesting that the four windings were regrouped into two winding structures and this difference was confirmed by the CT nameplate, which shows two different classes, 0.3B2.0 for W&X windings and 2.5L400 for Y&Z windings.

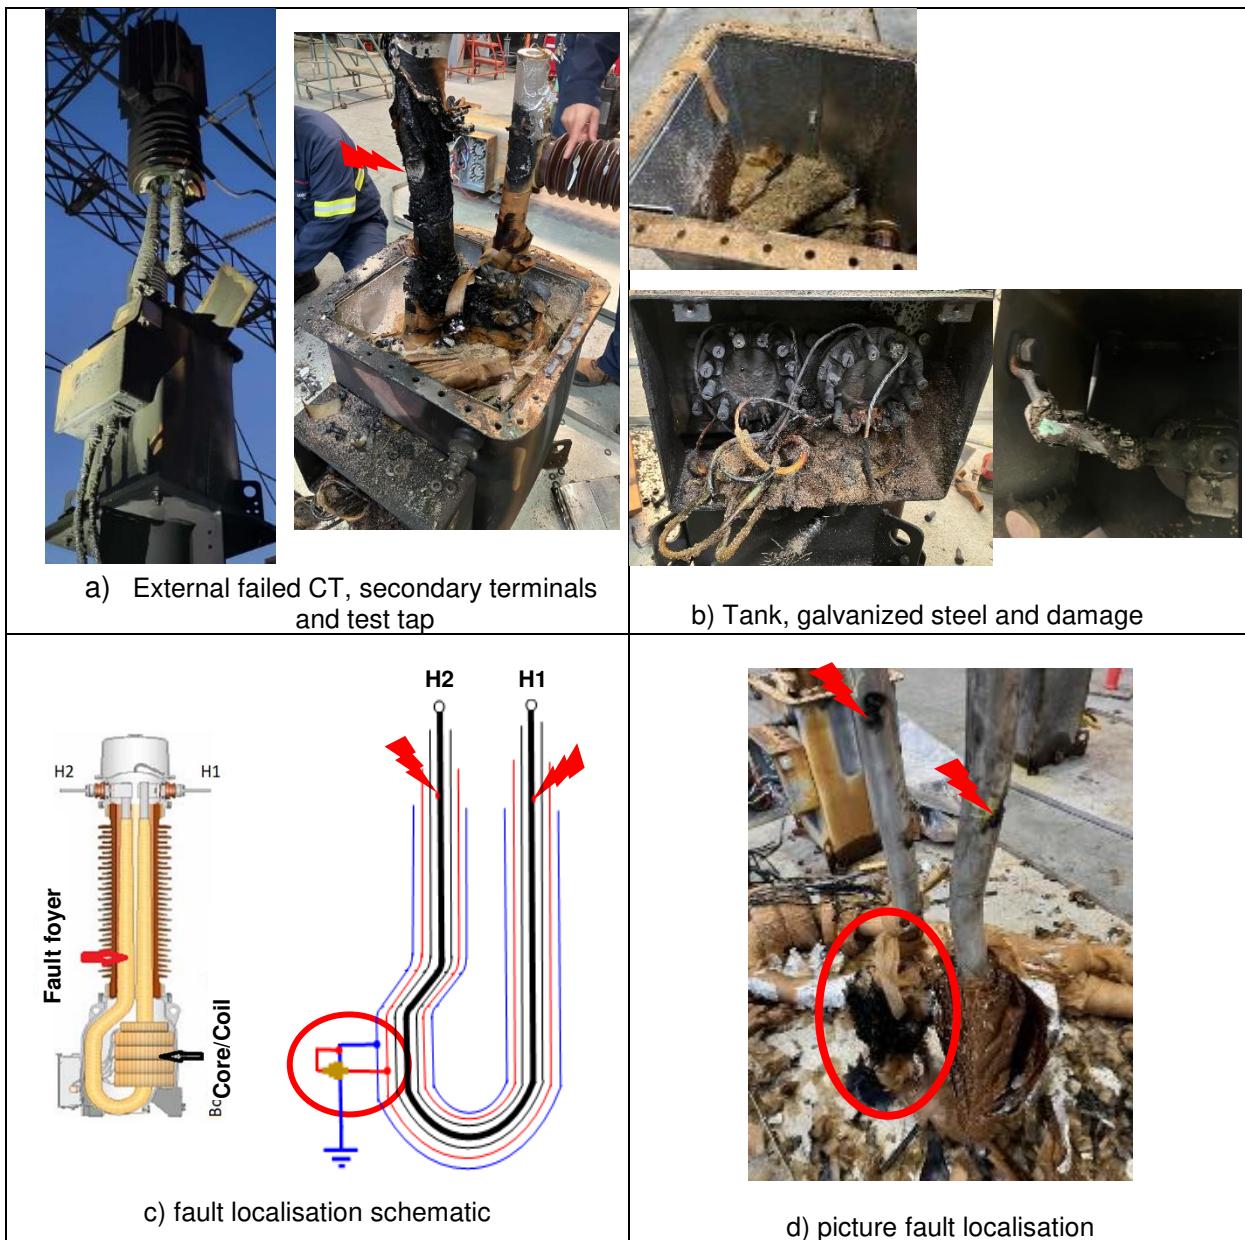
Failed CT in Phase C
Figure 9

All three current transformers in the failed CT Group were brought to the shop and torn down to collect evidence for determining the root causes of the failure and to understand the failure mode for preventing the failure from happening with other units. The failed PH C CT had no housing insulator due to the explosion exposing the primary HV conductor linking between the head and the base tank, as shown in Figure 10a. The external inspection revealed that the head section was in good condition and the damage was concentrated from near mid-section down to the test tap. There was an arcing spot on each primary conductor pointed by the red lightning bolt in Figure 10a and 10d. This meant that the arc punched through all conductive layers of the C1 insulation from the primary conductor, tracked to the conductive layer of the test tap and discharged downward to the grounded test tap at the bottom of the base tank. As a result, the leads on the test tap and the secondary terminals were partially melted and were blown out of the tank, as shown in Figure 10b. Furthermore, the disposition of the arcing spots suggested an occurrence of arc-over between the two stems of primary conductor before finding the grounded layer of the test tap to be discharged.

Following the failure and investigation, a replacement program of IMBE-170 current transformers was established, and the priority was based on the insulation measurements, oil analyses and criticality of the load and location.

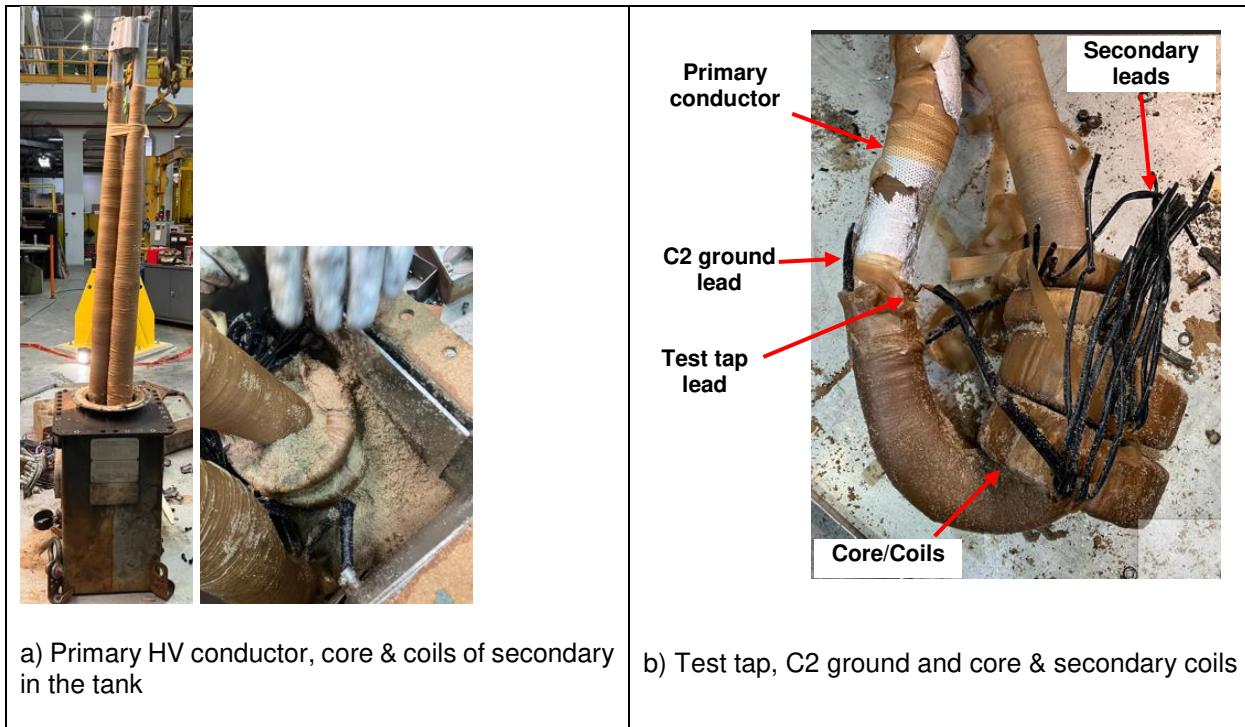
Condition of CT in A and B Phases
Figure 10

The CTs in the other two phases were in good condition and dismantled to study the insulation system in hopes of detecting any weakness or signs of deterioration. After removing the head and the housing insulator, the insulation system in Figure 11a was in excellent condition, including the core/coils, leads of the C2 ground, test tap and secondary, as shown in Figure 11b. Due to time constraints, the insulating wraps were cut to the conductor at once instead of removing each individual layer, and then they were visually inspected without finding any abnormality.
