## **SALIENT POLE GENERATOR FAILURES**

**W. Howard Moudy**  
**National Electric Coil (NEC)**

This paper focuses on failures of a family of salient pole generators from multiple manufacturers ranging from about 15 MVA to about 65 MVA, with nominal operational speeds of 1200 and 1800 RPM. The damage from these failures was considerable, requiring stator core restacking or replacement, stator rewind, and other rotor repairs and/or upgrades. The presentation reviews the basic construction elements of salient pole generators and identifies failure mechanisms and engineered solutions. Long-term maintenance and operational considerations are also discussed.

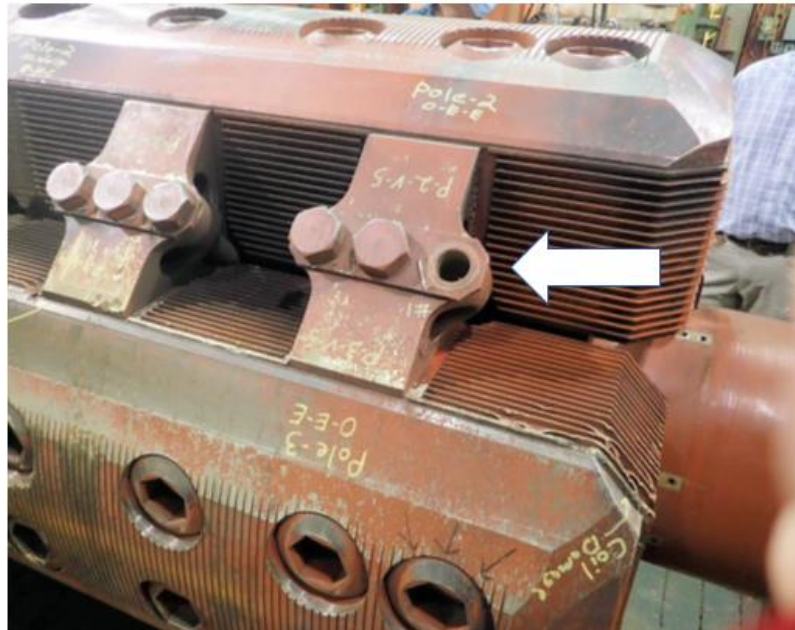
**4-Pole Salient Pole Rotor with Removable Pole Top Caps**  
**Figure 4**

The V-block bolts and pole head bolts can be seen on a 4-pole unit in Figure 4 above. The white arrow points to a broken (missing head) V-block bolt. Note that similar V-block bolt failures have occurred on multiple units across different manufacturers, models, and ranges of generator ratings having this configuration. Similarities in failure and damages incurred will be easily recognized as we explore two failure case discussions: one a 6-pole machine, the other a 4-pole machine.

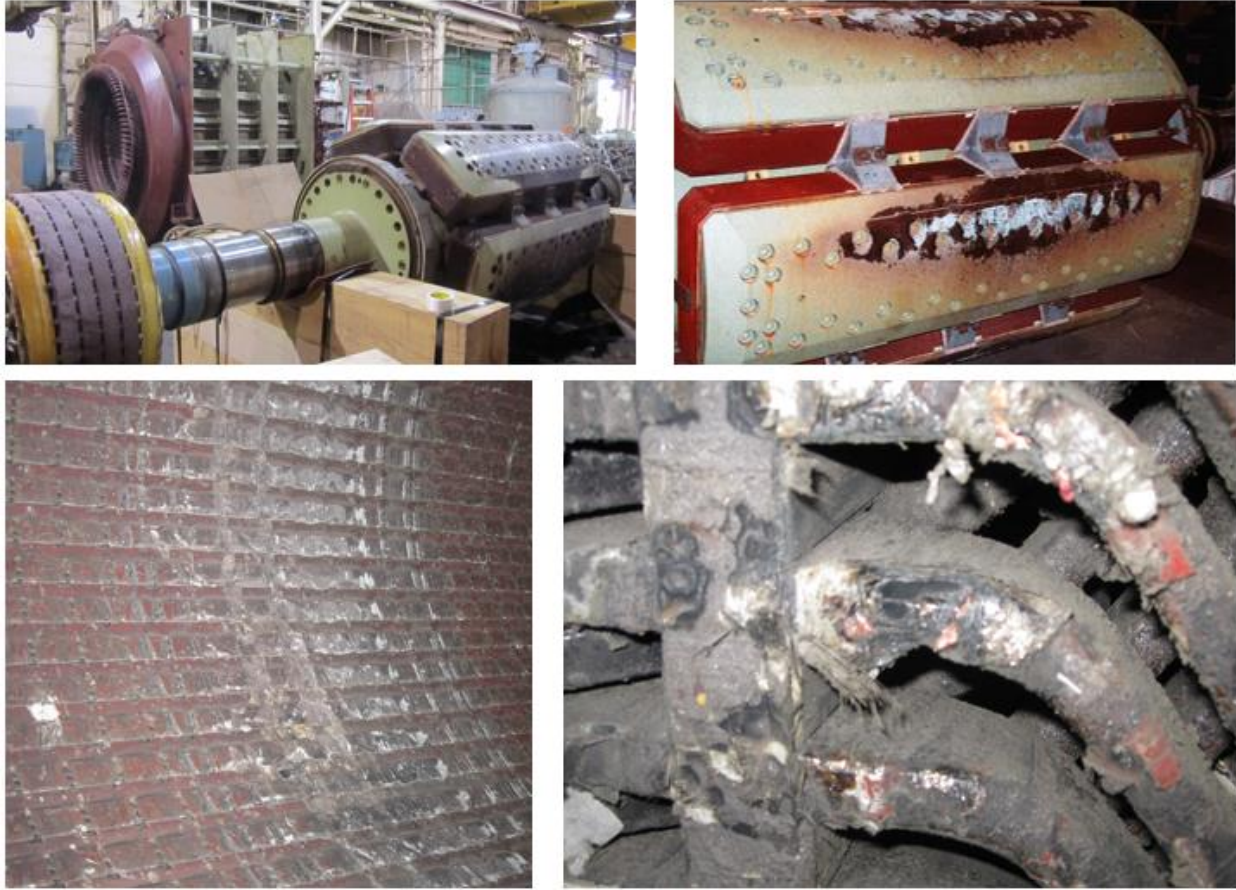
**Rotor, Exciter and Stator**  
**Figure 5**

The generator in this case discussion is rated 38,750 KVA; 13,800 VAC; 1200 RPM. Figure 5 (upper left) shows a photo of the rotor, exciter and stator as received for incoming inspection. One of the V-block bolt heads fractured, became liberated from the V-block assembly. The rotor sustained numerous gouges and dings, see Figure 5 upper right. The exciter was undamaged from the event. The stator damage was catastrophic as seen in Figure 5 lower left and right.

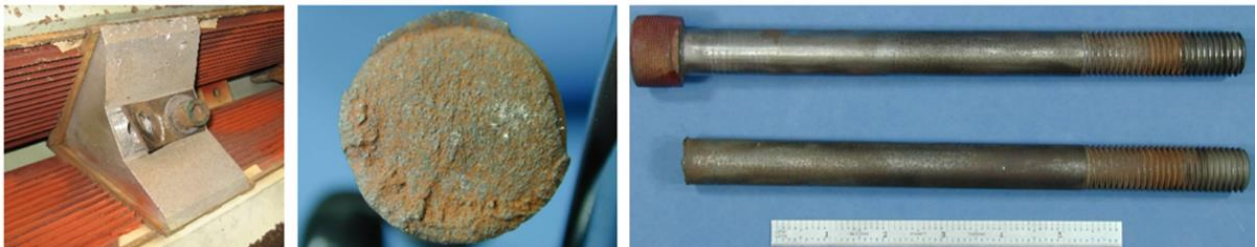
**V-Block Assembly**  
**Figure 6**

Figure 6 shows the V-block assembly missing a bolt head (left), and the bolt stem end at the fracture (center). The failed bolt can be seen under the other non-failed bolt of the assembly, Figure 6 (right). As reference, the undamaged bolt length is slightly over 10 inches. Two V-block bolts, washers, and the plate weigh approximately 3 ½ lbs. A visual observation was made regarding the minimal radius at the head to stem juncture of the V-block bolts.

Analysis of the V-block bolts identified they were likely manufactured to ASTM F568M-07, Class 12.9 alloy steel specification. This material is commonly referred to as AISI 4140 alloy steel. The high hardness of the material makes it susceptible to environmentally influenced cracking such as hydrogen embrittlement

and stress corrosion cracking. Corrosion can clearly be seen in the right photo of Figure 6. Although, hydrogen embrittlement was the primary failure suspect given:

- High hardness low alloy steels, such as this bolt material are susceptible to hydrogen embrittlement
- Inter granular cracking was in one plane
- Cracking location was at an area of stress concentration – juncture of the bolt head and stem
- The approximate 6-year life is indicative of the delay, which results from constant load, such as this applications bolt preload.

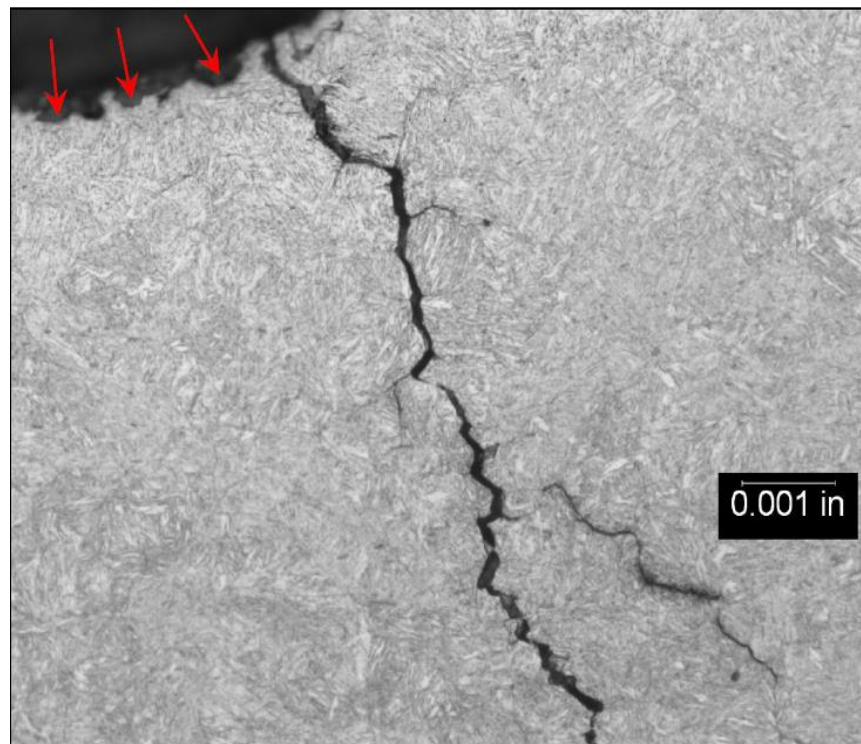
**Intergranular Cracking and Pitting  
Non-Failed V-Block Bolt at the Head to Shank Radius  
Figure 7**

A metallographic cross-section through the non-failed V-block bolt head to shank radius was performed. The cross section was polished, Nital etched, and magnified. Intergranular cracking can be seen in Figure 7. Pitting can also be seen on the bolt surface at the red arrows in the upper left.

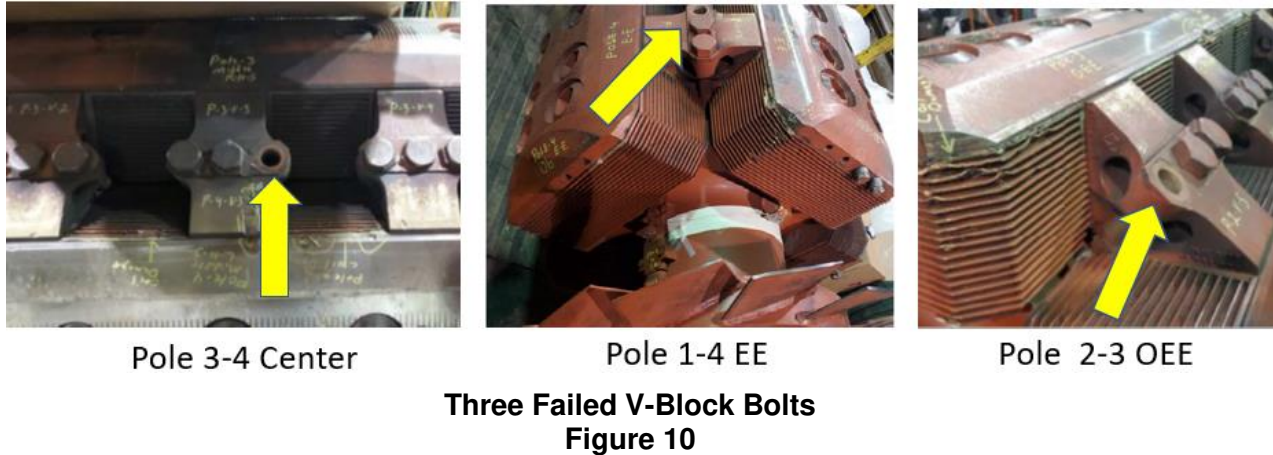
The generator in this case discussion is rated 52MVA; 13,800 VAC; 1800 RPM and was manufactured in 2008. At the OEM recommendation, the owner replaced the V-block bolts using OEM replacement bolts during a 2015 outage. Seven years after the replacement bolts were installed, this failure of 3 V-block bolts occurred in 2022. Figure 10 shows the location of the three failed V-block bolts.

Observations and analysis of the V-block bolts, after the 2022 failure, were comparable to the prior case discussion, but the bolts and assembly are considerably larger to make up for the higher unit rating and increased mechanical stresses. Each V-block assembly, which in this case includes the V-block, 3 bolts, and heavy washer/spacer plate, weighs 98 lbs. The V-block itself is a large majority of the weight. Breakaway torque of the replacement V-block bolts was inconsistent. Sixteen of the sixty total V-block bolts per unit (total including three failed) had a breakaway torque ranging from about 500 lbf-ft to 1100 lbf-ft. The remainder of the unit V-block bolts breakaway torque ranged from only about 25 lbf-ft to 150 lbf-ft.

- The geographic location of the unit, and 3 sister units, is susceptible to tropical storms and hurricanes, presenting significant potential exposure to saltwater mist, a strong source of corrosive chlorides. This and other factors make stress corrosion cracking (SCC) a primary failure contributor.
- It is suspected that the failed V-block bolts had been over torqued, making them more susceptible to SCC failure.
- Hydrogen embrittlement remains a strong potential contributor despite the owner claim of no hydrogen presence in their processes. However, the owner was told the V-block replacement bolts had a coating treatment applied to help inhibit corrosion. While not confirmed, there is reason to believe that as the coating deteriorated over time, hydrogen was let off.

Following analysis and investigative efforts, the scope of work for the repair included new V-block and pole head bolts. The V-block bolts employed an improved alloy more resistant to hydrogen embrittlement and stress corrosion cracking. The V-block bolt geometry was optimized, increasing the radius at the bolt head to the stem. Given the as-found pole head bolt was already the highest strength class of steel fastener commonly available for the given size, a nonstandard specialty manufactured pole head bolt was used to at least gain a minimal amount of design margin. The rotor pole windings were refurbished and then proceeded much the same as the 6-pole case discussion with the impact gouges and dings dressed and blended prior to reassembly. Rotor reassembly was performed following strict procedures and QA/QC checks to ensure proper placement as well as necessary assembly process sequencing and critical to quality factors including bolt torque application and final torque values applied. The catastrophic stator damage was addressed with essentially the same scope as the prior 6-pole case discussion stator scope.

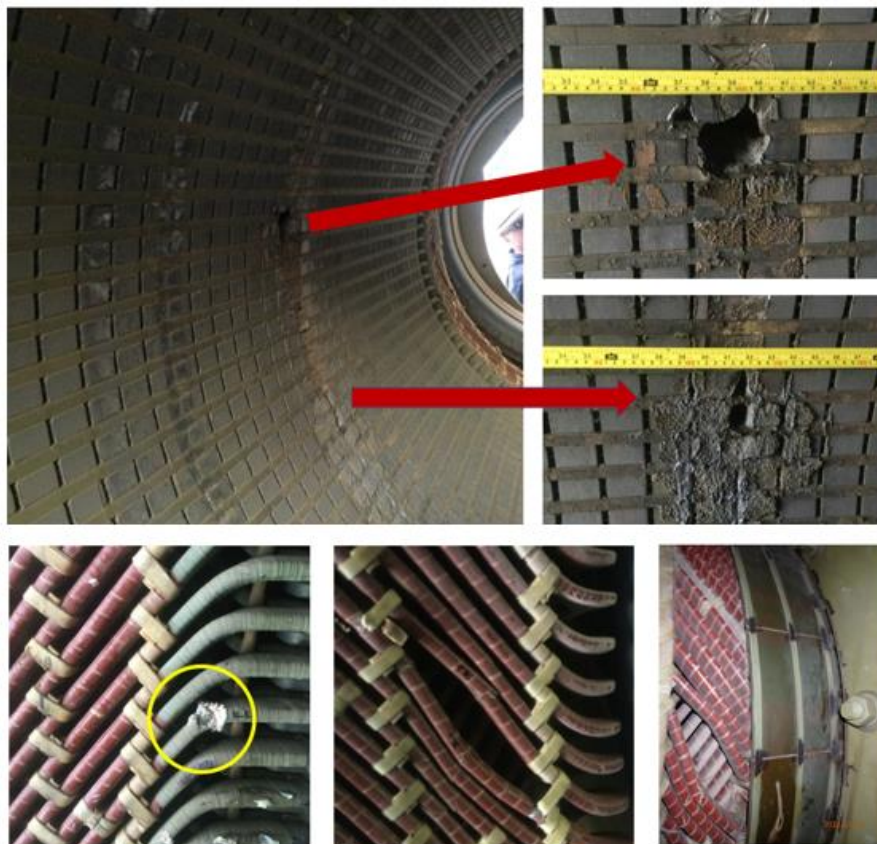
The rotor sustained numerous gouges and impact dings. The exciter was undamaged from the event. The stator damage was catastrophic, see Figure 11 below.

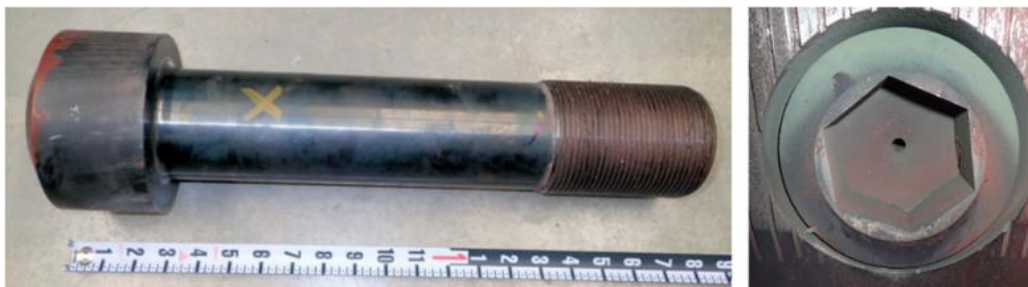
**Four Pole – Pole Head Bolt  
Figure 12**

While there is no doubt the V-block bolts caused the failure, reports and evaluation discoveries regarding the pole head bolts became a large concern. Photos of the bolt can be seen in Figure 12 below.

The OEM supposedly expressed to the owner that a similar generator had experienced a pole head bolt failure about 10 years earlier. The bolt reportedly failed during commissioning following a 1½ year period at standstill. The bolt separated at the head to shank area of the bolt, liberating the bolt head. Intergranular cracking was reportedly present at the fracture origin. OEM consultants supposedly attributed the failure to temper embrittlement (TE). The OEM reportedly expressed that there was no evidence of stress corrosion cracking (SCC), or hydrogen embrittlement found in the failed bolt. TE, SCC and hydrogen embrittlement can all be manifested by intergranular corrosion.

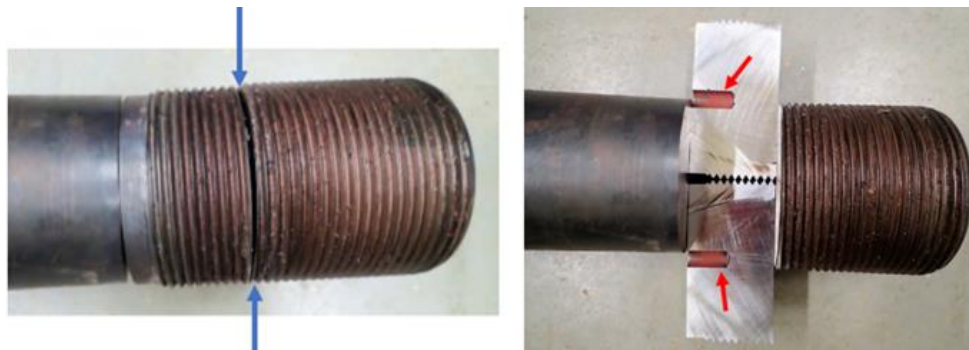
**Segmented Pole Head Bolt**  
**Figure 13**

One of the three representative samples was found to have a crack about 1/3 the way down the threaded portion of the bolt. The bolt was cut above the threads and again through the cracked area in the threads as can be seen in the left photo of Figure 13 below. The blue arrows show the crack location. The cut segment was then cut through the bolt centerline, splitting the 10 mm bolt elongation measurement hole. The segment halves were flipped over for evaluation and comparison, as can be seen in the right photo of Figure 13. The red arrows point to the bolt elongation measurement hole.

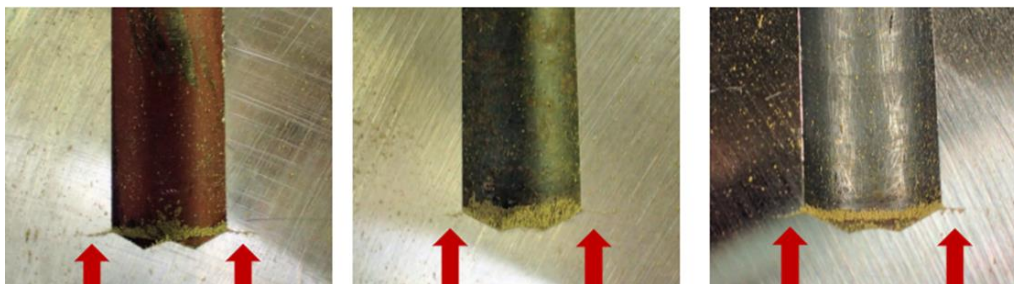
**Crack Propagation from Elongation Hole Bottom Radius**  
**Figure 14**

Magnetic particle testing of the segments through the pole head bolt elongation measurement hole found cracks in all segments emanating from the radius at the bottom of the hole, see Figure 14. Crack lengths varied from 0.10 to 0.16 inches. No cracks were revealed in areas other than the bottom radius of the elongation measurement hole. Only one bolt was found to have a coating inside the bolt elongation measurement hole. This can be observed in the left photo in Figure 14, which shows a reddish color cast to the hole wall. Coating coverage was not complete on the hole ID where the coating was missing. But no corrosion was observed under the coating indicating the coating was at least somewhat effective. The other two uncoated bolts did have observable corrosion.
