## SWITCH BEARING ISSUES AND SOLUTIONS

Thomas R. Wittner

Brazos Electric Power Cooperative, Inc.

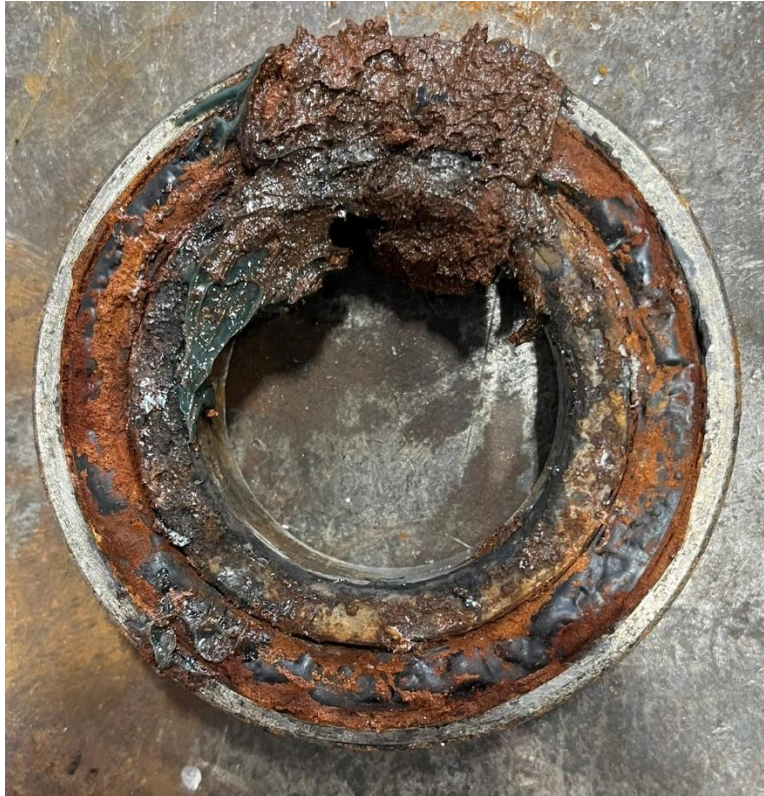
**Bearing Removed from Housing**  
**Figure 3**

In every instance, a significant amount of rust was found in both the upper and lower ball bearings. It was also reported at Itasca that water was pushed out of the bearing assembly when grease was pumped into the housing in an attempt to free the bearings. Moisture intrusion was clearly causing some of the steel in the bearings to rust, but our specifications for 138 kV and above gang operated switches require stainless steel bearings. While stainless steel can rust, the amount of rust found in the bearings was far more than expected for switches not installed in a corrosive environment.

Due to the amount of rust on what we believed was stainless steel, Brazos had a third party perform material testing on the bearings to determine the types of steel used for their construction. The inner and outer races were found to be SAE 52100 steel, and the balls were found to be 400 series stainless steel. While 52100 is a common steel for bearings, it is not a stainless steel and is quite susceptible to corrosion. [1]

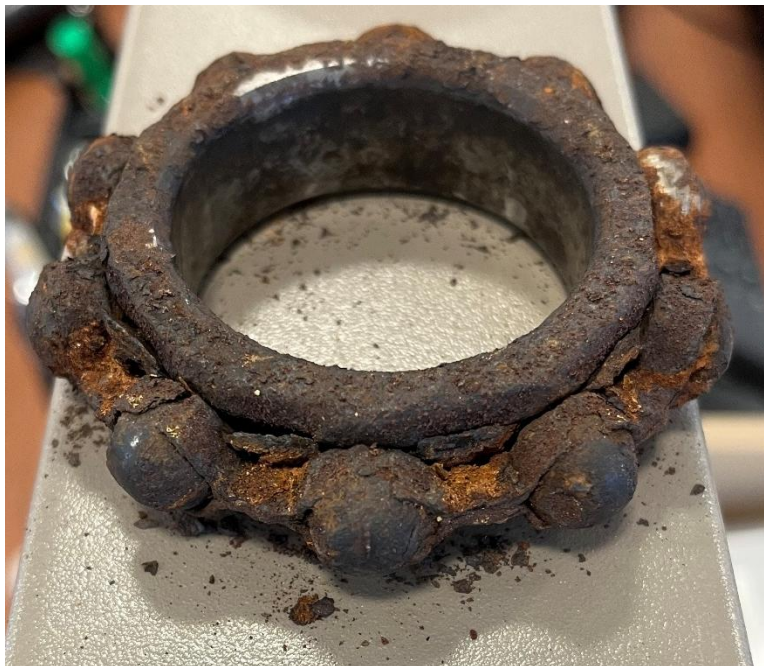
**Bearing After Removing Outer Race**  
**Figure 4**

Our investigation found that water was collecting on top of the top bearings whenever the switches were exposed to rain. Eventually the water migrated under the seal and into the bearing. The water eventually migrated past the lower seal of the top bearing to the lower bearing. Since 2019, we have had multiple EV-2 bearing failures each year. All of the EV-2 bearing failures have been on switches that are horizontally mounted. None of the EV-2 switches on our system that are vertically mounted have experienced bearing failure. This is likely due to the fact that rainwater does not pool on the bearing seals since the seals are perpendicular to the ground when the switches are mounted vertically.

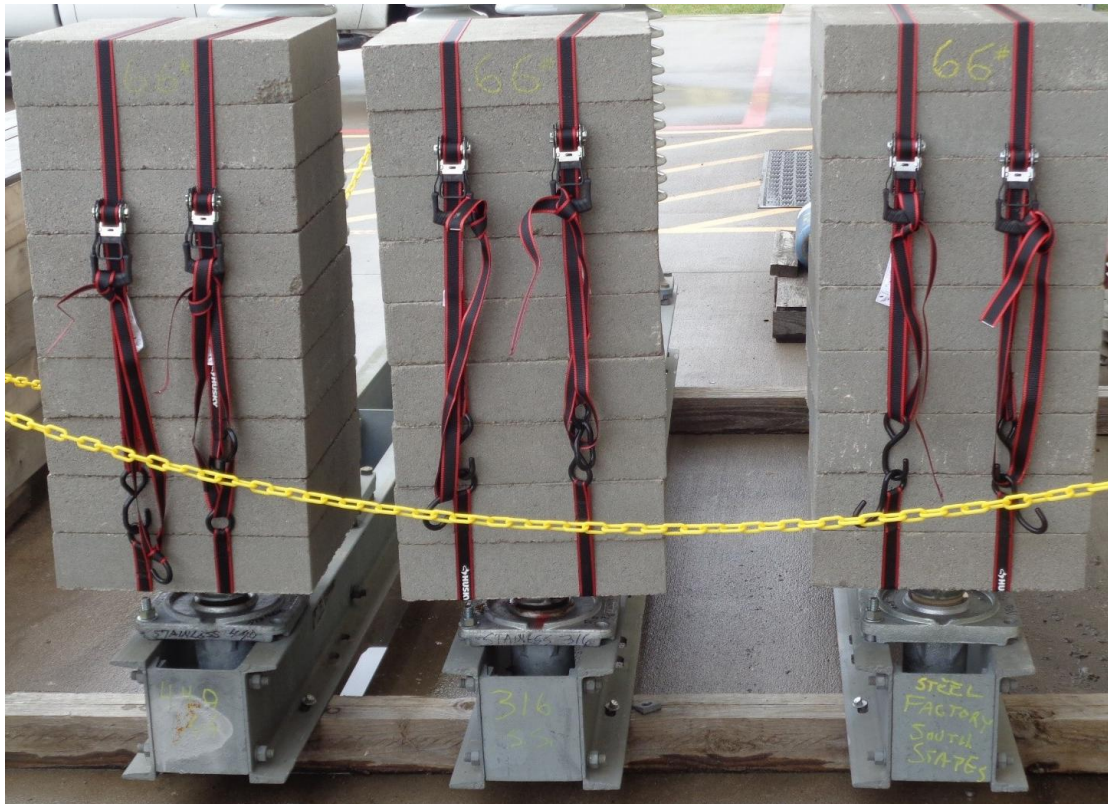
**Simple Overloading Setup  
Figure 5**

Some of the management at Brazos was concerned with utilizing a non-OEM bearing in the rebuilt bearings, so they directed us to set up a simple test. We decided to rebuild one phase's bearing assembly with 316 bearings, rebuild another phase's bearing assembly with 440 bearings, and leave one phase's bearing assembly with the OEM 52100 bearings. We would then overload the bearing assemblies with four times the weight of a TR 288 insulator. We took a switch from inventory, removed the rotating insulators, rebuilt the bearing assemblies as described, and stacked 600 lbs of concrete blocks on top of each of the bearing assemblies. Figure 5 shows the test setup. The test switch was set up for 1 year, and each bearing assembly was rotated weekly for 2 months to verify that the bearings were still functional, and then the bearings did not move for the final 10 months.

At the end of the year, all three bearing assemblies rotated freely with minimal input force.

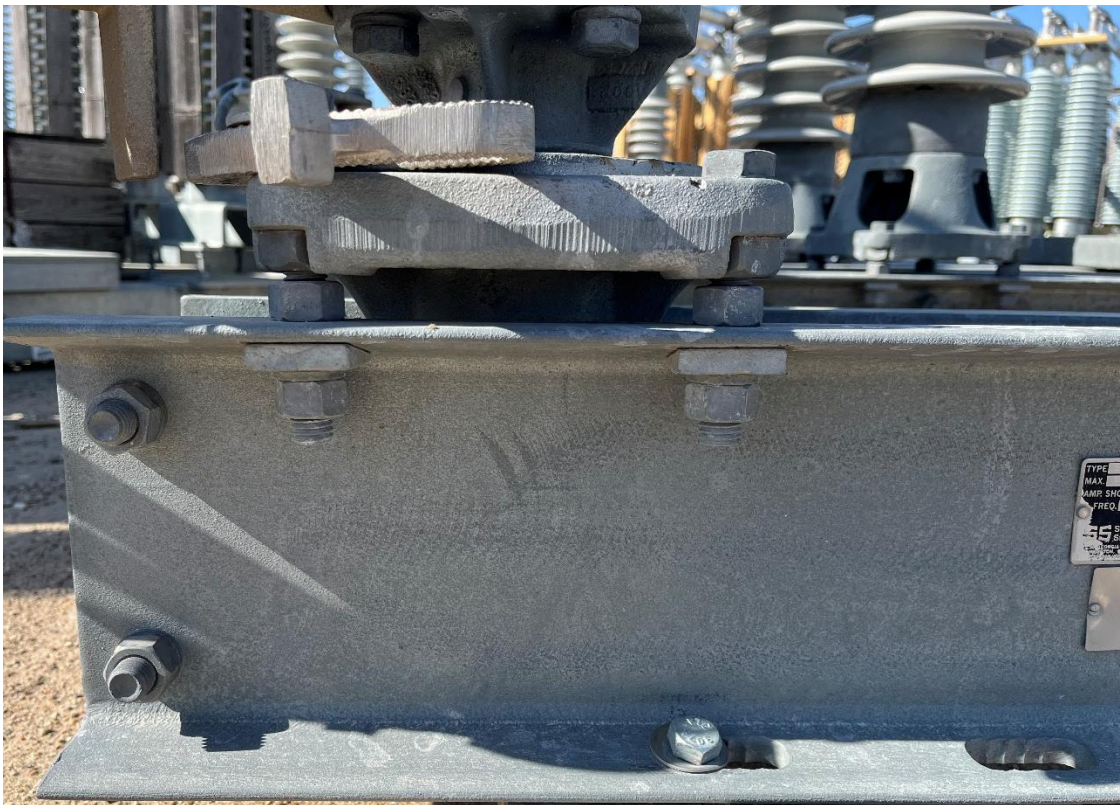
**Bearing Assembly Mounted on Switch Base**  
**Figure 6**

Figure 6 shows a close view of the bearing assembly and how it is mounted to the switch base. By working carefully and intentionally, it is possible to replace the bearing assembly without compromising the switch's adjustment or alignment.

- Remove the lower bolts from the rotating insulator
- Remove the linkage arm from between the insulator and the bearing assembly
- Mark the threads on the jacking bolts and nuts with match-marks where the bearing assembly sits
- Remove the jacking bolts and note each one's location on the switch
- Lower the bearing assembly down to the switch base
- Slide the bearing assembly toward the stationary insulators
- Lift the bearing assembly out of the switch base
- Reverse the above steps to install the new or rebuilt bearing assembly, making sure to set the jacking nuts and bolts in their original locations and line up the match marks
