ALSTOM/AREVA HGT DASHPOT REBUILD PROCESS

Michael D. Wolf, PE

Tri-State Generation and Transmission Association

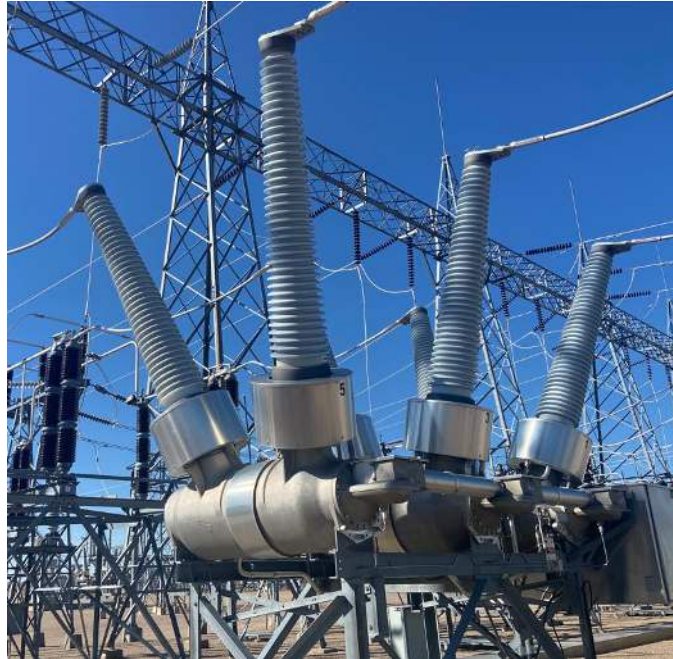
At some point prior to the failure, the Pole 1 drive rod had broken in service during a closing operation. When the trip command was issued that lead to the failure, the contacts of Pole 1 did not open but the crank was in the open position. The stuck pole led to significant system impacts at Tri-State, which will not be discussed.

Upon inspection and evaluation of the relay records, the point of failure inside Pole 1 was obvious to the responding technicians. Main circuit resistance showed the closed position while the Pole 1 crank, interphase operating linkage, and other two poles were in the open position. The breaker in question is shown below in Figure 1.

Failed HGF 1014 Breaker
Figure 1

The breaker was determined to be a total failure. Due to its age there was no consideration made to pursue repairs or refurbishment. The breaker was scrapped.

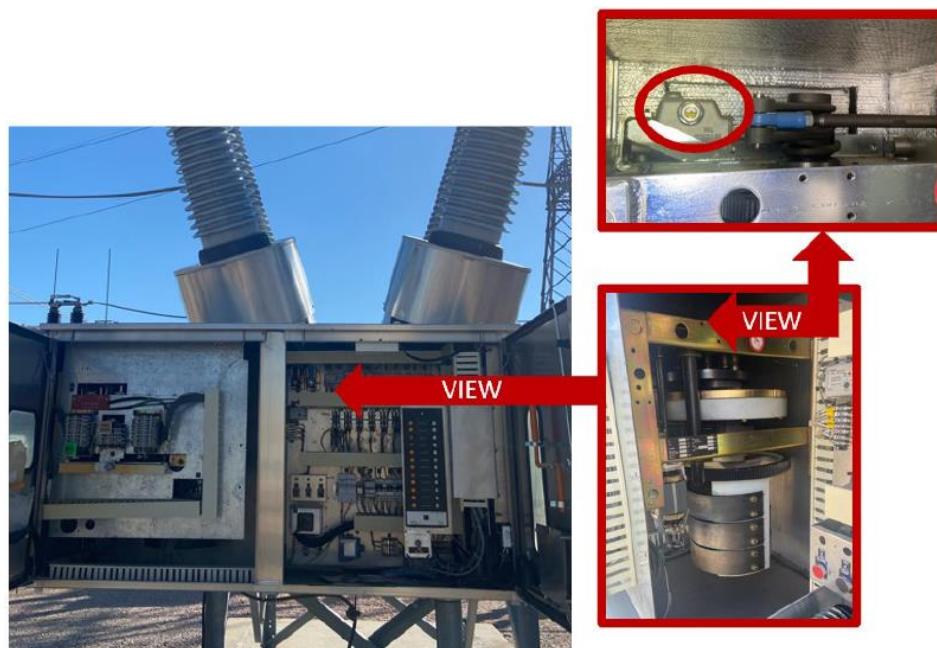
The dashpot oil level was inspected and found to be not visible in the sight glass. The dashpot oil level is found by viewing the top-left edge of the inside of the control cabinet from the right side. Details are shown below in Figure 2.

Finding Dashpot Oil Level
Figure 2

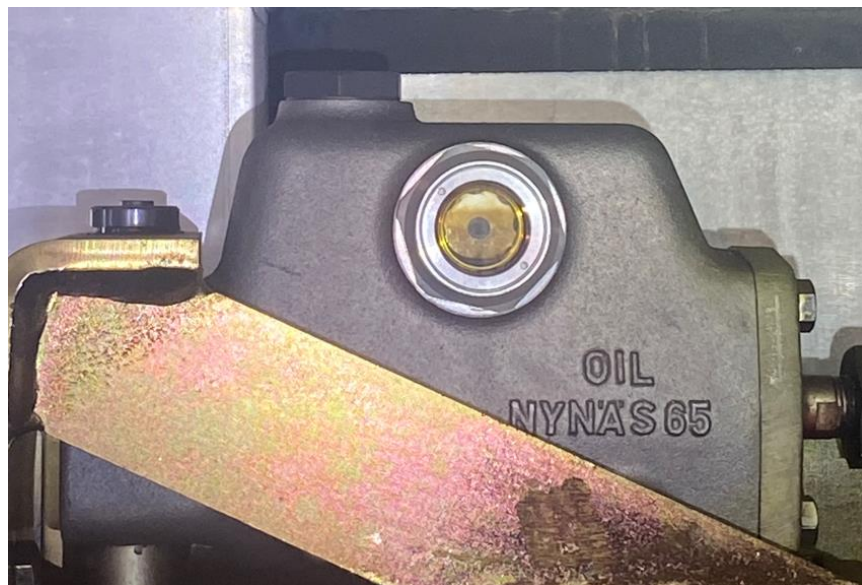
The dashpot of the impacted breaker is shown below in Figures 4 and 5. Note that there is no oil in the sight glass, however it is discolored. It is suspected that this is from oxidation – with the compromised shaft seal, oil was leaking out and oxygen and moisture were leaking in. There was extensive dried up oil residue below an obviously deteriorated and non-functioning shaft seal.

**Dashpot with No Oil Level Visible in Sight Glass
Figure 4**

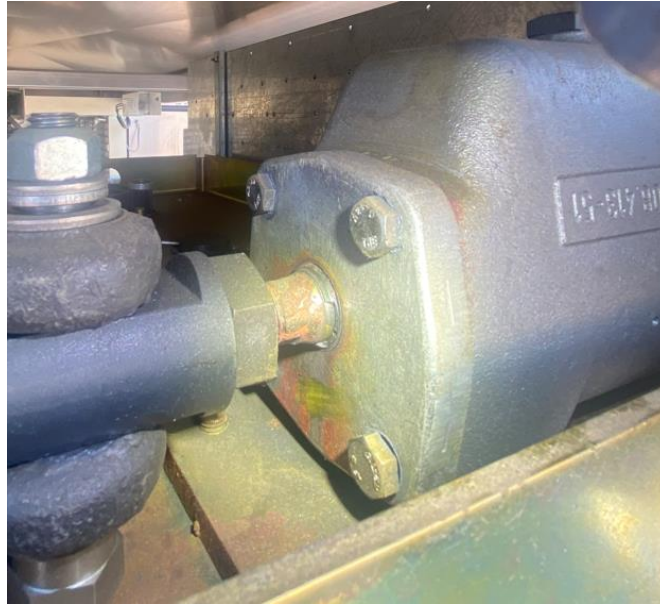
Compromised Shaft Seal
Figure 5

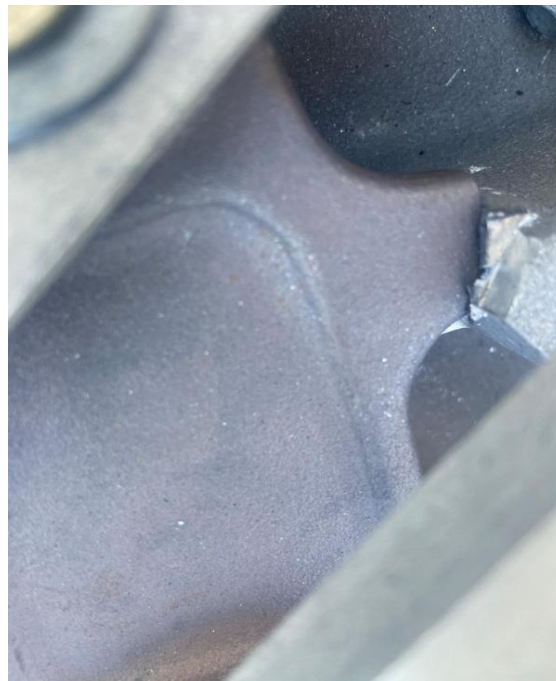
During physical inspection of the bell crank on Pole 1, the crank stop was found to be buried into the casting stop up to 0.25 inches when in the open position. This indicates that there was damage to the insulating drive rod inside the tank. A photo of the damaged stop is shown in Figure 6.

Crank Over travelled into Open Stop
Figure 6

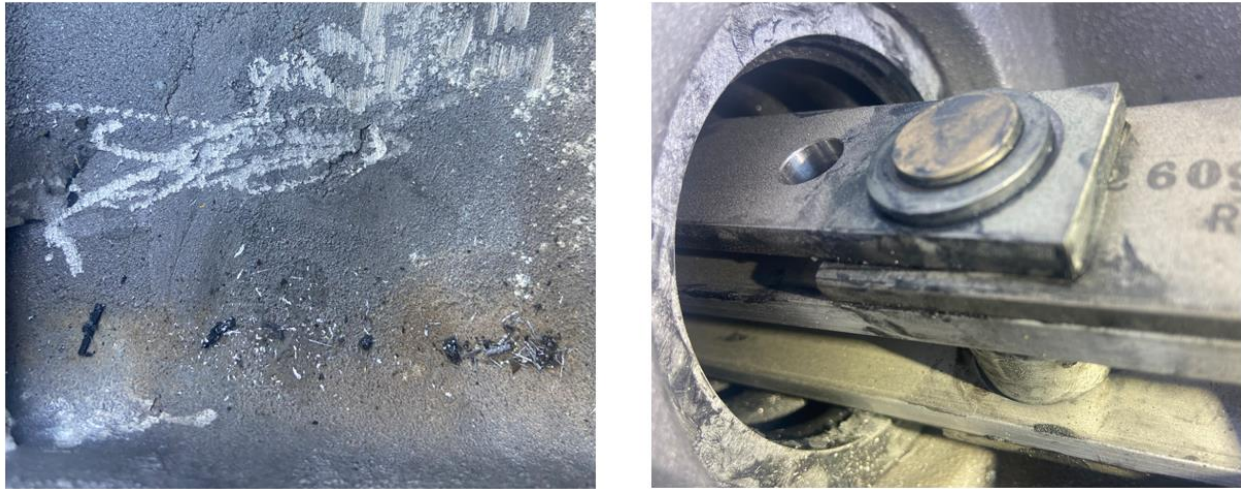
The interphase operating linkage was also found to be bent between Pole 1 and Pole 2. The linkage had been scraping the housing and causing significant metal shavings inside the crank box on Pole 1. Photos

of this are shown below in Figure 7. The bent linkage is another indication of damage related to the empty dashpot.

Damage to the Interphase Operating Linkage Seen from Pole 1 Crank Box
Figure 7

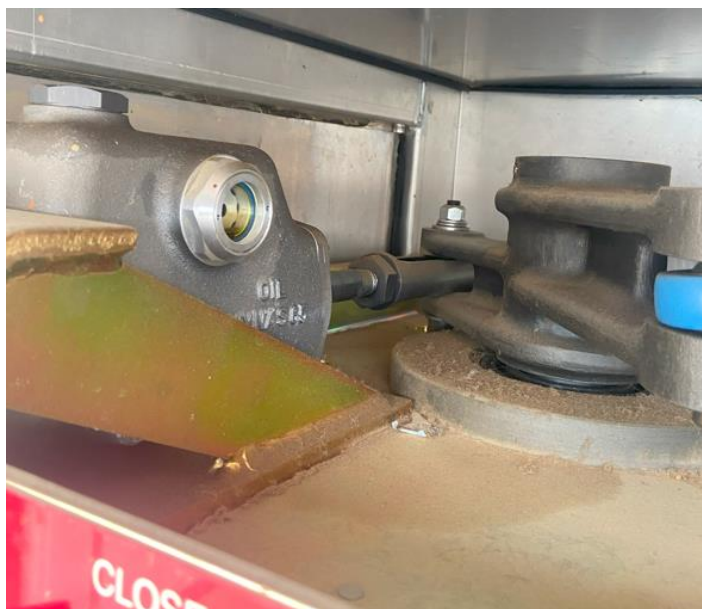
Example of Low Oil and Signs of Leakage
Figure 9

If no concerns were found during the detailed visual inspection, oil was added to the dashpot to bring it to an acceptable level. This was done with the dashpot in place via a DGA syringe and Tygon tubing. The oil level was inspected biweekly and the rebuild was to occur as soon as practical. An example of low oil level and signs of oil leakage is shown below in Figure 9.

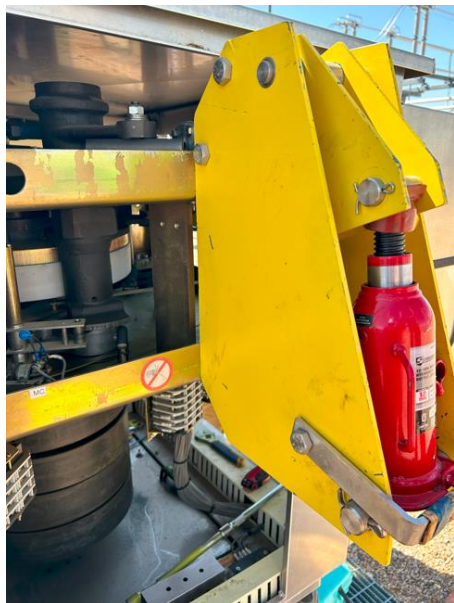
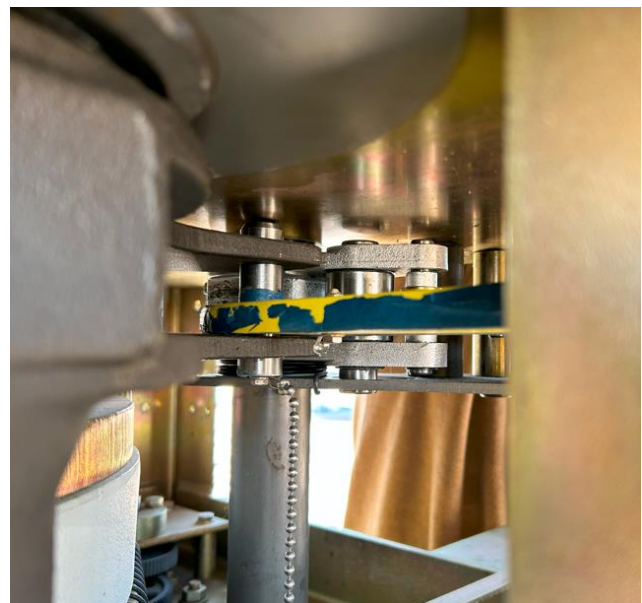
Much time was spent on ensuring full understanding of the slow-close device prior to use, getting an appropriate bottle jack, and making custom adapters to ensure the jack stays aligned during the slow-close operation. The alignment of the slow-close device and its linkage connection is shown below in Figure 11.

Slow-Close Device Mounting
Figure 11

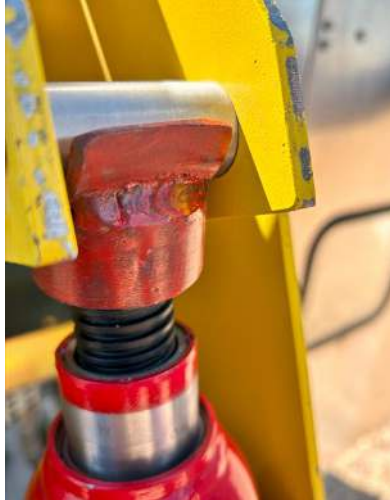
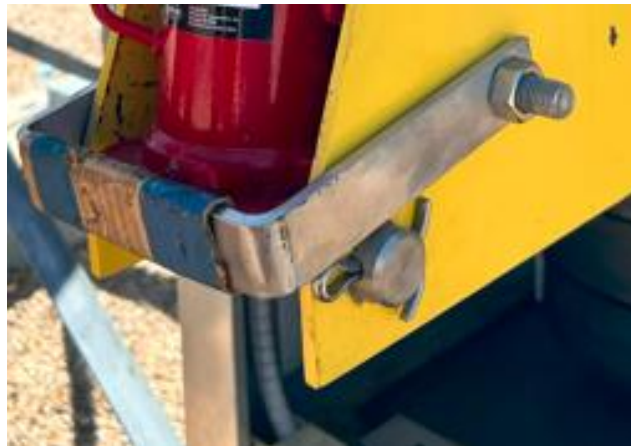
The jack could potentially slip off the device, making the process dangerous without adequate controls put in place. An example including the jack head saddle and the base strap of the device are shown in Figure 12.

Slow-Close Device Safety Provisions
Figure 12

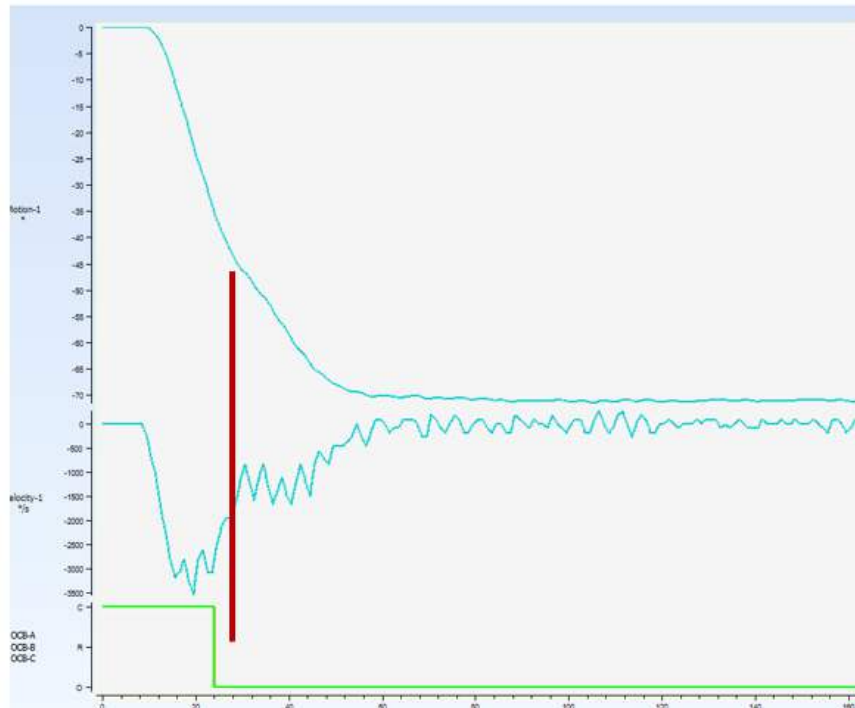
Each breaker was fully tested after the dashpot rebuild to confirm workmanship and validate the dashpot action. A complete diagnostic maintenance was performed per Tri-State standards, given the amount of required work. While performing timing and travel testing, special attention should be paid to the action of the dashpot on the open stroke. An example of acceptable dashpot action is shown below in Figure 13. The opening motion of the breaker begins to be retarded by the action of the dashpot catching the linkage.

Correct Dashpot Action in Travel Traces after Rebuild
Figure 13
