MANAGING OIP TRANSFORMER BUSHINGS ON ESKOM & NTCSA'S TRANSFORMERS: STANDARDIZATION AND REPLACEMENT CHALLENGES

Khayakazi Dioka
Eskom NTCSA

Sandile Ngubane
Doble Engineering

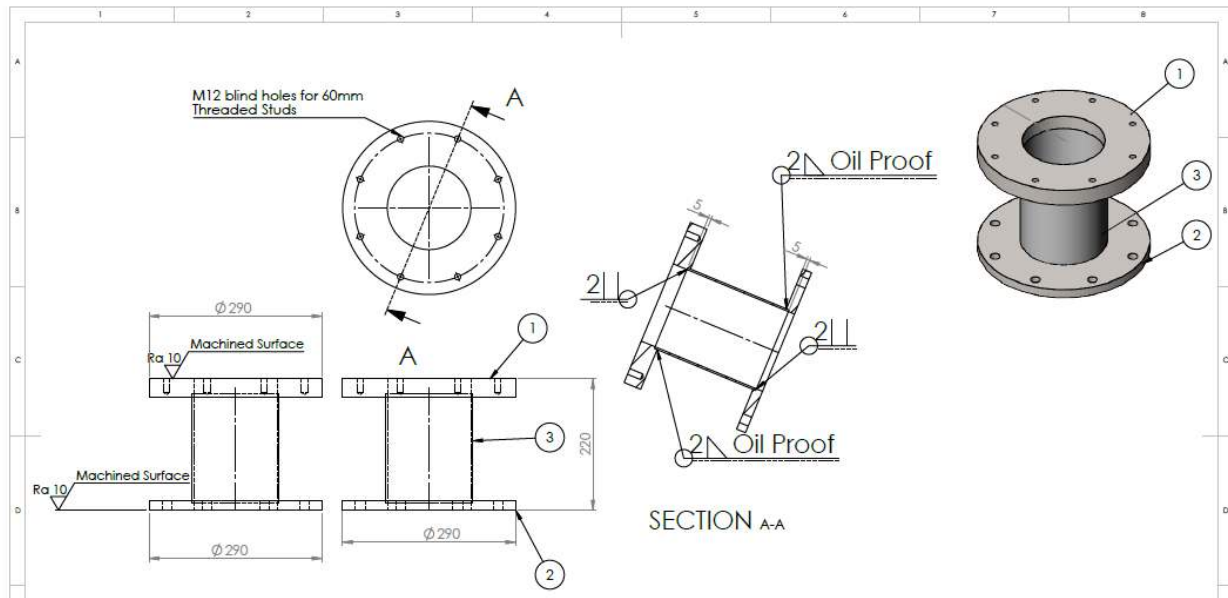
An Example of an Adaptor Design
Figure 1

The differing sizes of bushings installed in Eskom/NTCSA transformers, even for those with comparable voltage ratings, reflect a historical issue within the network. As a result, despite uniform network voltage levels, there is no consistent standard for bushing sizes across the fleet. An example of this variation is shown in Table 3 below in a 132kV 1250A bushing from the same manufacturer. Some of these variations could be identified from drawings, while for others, where drawings are unavailable, the measurements are taken when the bushing is removed from the transformer. This has resulted in longer outage durations. Some bushing drawings were unclear, showing multiple possible conductor connections without specifying which one applied to a particular transformer. This ambiguity often leaves field engineers uncertain about the correct configuration for a specific unit. This further complicates the modification process as conductor modifications can only be confirmed once the bushing has been pulled out of a transformer.

- manufacturing of adaptor flanges to be rewelded on existing flanges,
- manufacturing new solid rods (conductors), or machining replacement conductor to required lengths,
- cutting of exit leads to be connected into shortened conductor,
- manufacturing an adaptor turret where the replacement bushing is longer than an existing bushing.

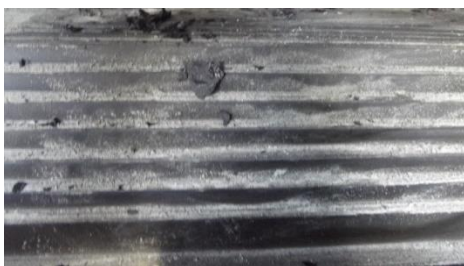
Bushing replacement was carried out to prevent a catastrophic transformer failure. However, at NTCSA, an incident occurred when a healthy 27-year-old 250MVA 400/132/22kV transformer was taken out of service to replace OIP bushings with deteriorated insulation. During the scope of work execution, modifications were made to the bushing turrets and flanges, which involved some welding activities. Unfortunately, a welding spark made its way into the active part of the transformer, resulting in a fire. The internal damage and contamination of the active part rendered the transformer unserviceable. This was an unfortunate incident that could have been avoided by adhering to proper procedures.

**Burned Top Yoke Covered in
Fire Soot**
Figure 2a

The goal of managing OIP bushings was to prevent catastrophic transformer failures, typically resulting in fires. However, an unfortunate incident occurred during a replacement in which a transformer caught fire. This incident serves as an example of human error, which is an inevitable aspect of fieldwork. It underscores the importance of strictly following proper procedures during bushing replacements to avoid such catastrophic failures.

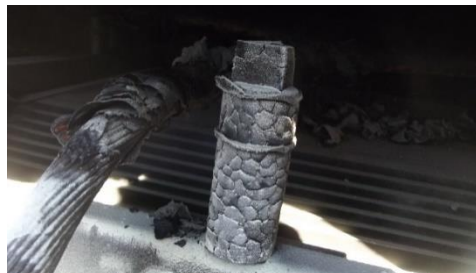
**Burned LV Lead, and Core
Clamping Structure**
Figure 2b

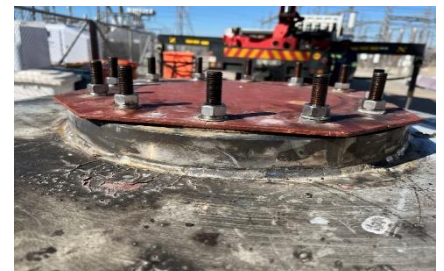
**The Turret Where Welding
Was Taking Place**
Figure 2c
