# 90th International Conference of Doble Clients

## Winding Resistance Issue During Transformer Bushings Replacement

Andrew Stenabaugh – Ontario Power Generation

Ed teNyenhuis – Hitachi Energy

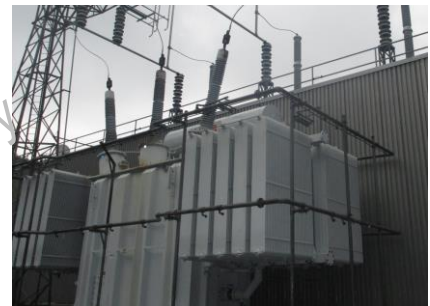
- Winding resistance measured before and after the LV bushing replacement – 22% increase in 1 phase and 6% increase in the other 2 phases
- T2 unit had no change in resistance

all milli ohms @85C	X1 - X2	X2 - X3	X3 - X1	% Difference between Phases
1	FAT	2.580	2.580	2.590	0.39%
2	Pre Test	2.554	2.571	2.549	0.87%
3	First Measurement	2.695	3.138	2.681	16.08%
4	% Change	6%	22%	5%

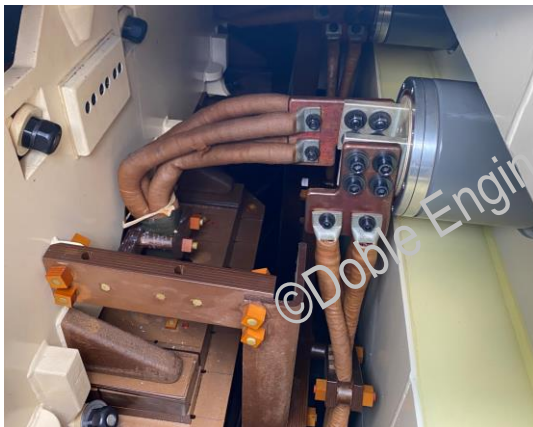
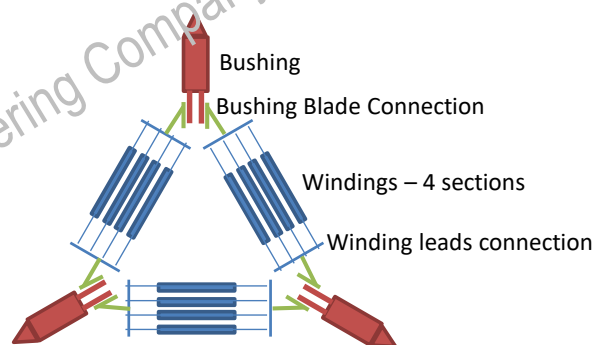
- LV delta connection made at bushings
- 4 large leads for each winding phase group

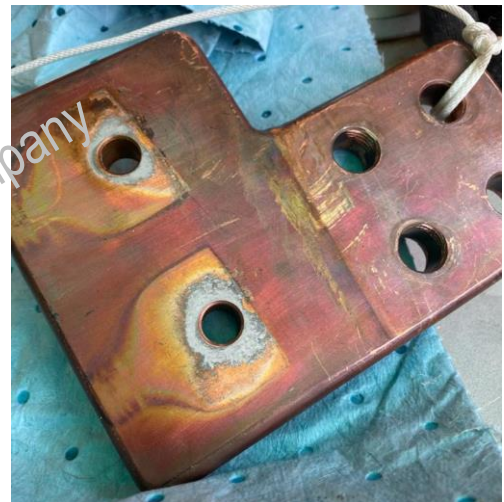
- Found heavy surface contamination or build-up on copper plate
- Removed the copper connector plate and cleaned thoroughly
- Reconnected and winding resistance was good

- Problem with copper plate most likely occurred when it was moved slightly to align with the bushing blade
- Slight movement seems to have disturbed the 4 lead connectors on the copper plate
- Corrosion on the copper plate between the connector and the copper plate caused the contact resistance to increase significantly
- Not clear why there was a high contact resistance

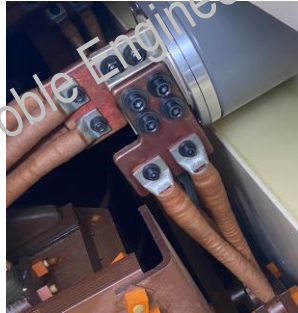
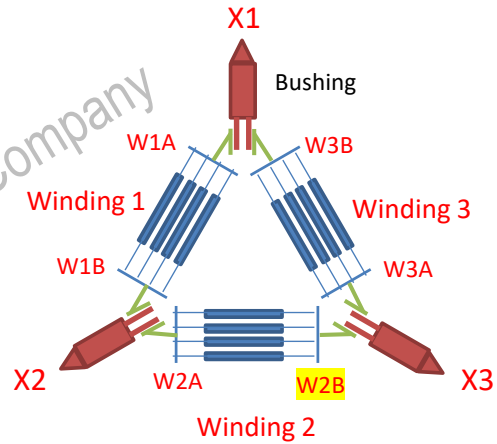
# Location of Copper Plate Issue – see W2B

- W1A = Winding 1 Top Leads Connection Plate
- W1B = Winding 1 Bottom Leads Connection Plate
- W2A = Winding 2 Top Leads Connection Plate
- W2B = Winding 2 Bottom Leads Connection Plate
- W3A = Winding 3 Top Leads Connection Plate
- W3B = Winding 3 Bottom Leads Connection Plate

- Delta winding resistance connection (bushing to bushing) has 2 paths (short path through 1 winding and longer path through the other 2 windings in series)
- Estimated 1.4 milli-ohms of added resistance at the copper plate (each winding is 3.7 milli-ohms)
- Very large added resistance could be 17kW ( $I^2R$ )
- Likely this would have overheated and gassed in service
