Arc Flash Incident Due to Faulty Substation Ground

Lyndal Cost, Alabama Power Co

92nd International Conference
of Doble Clients

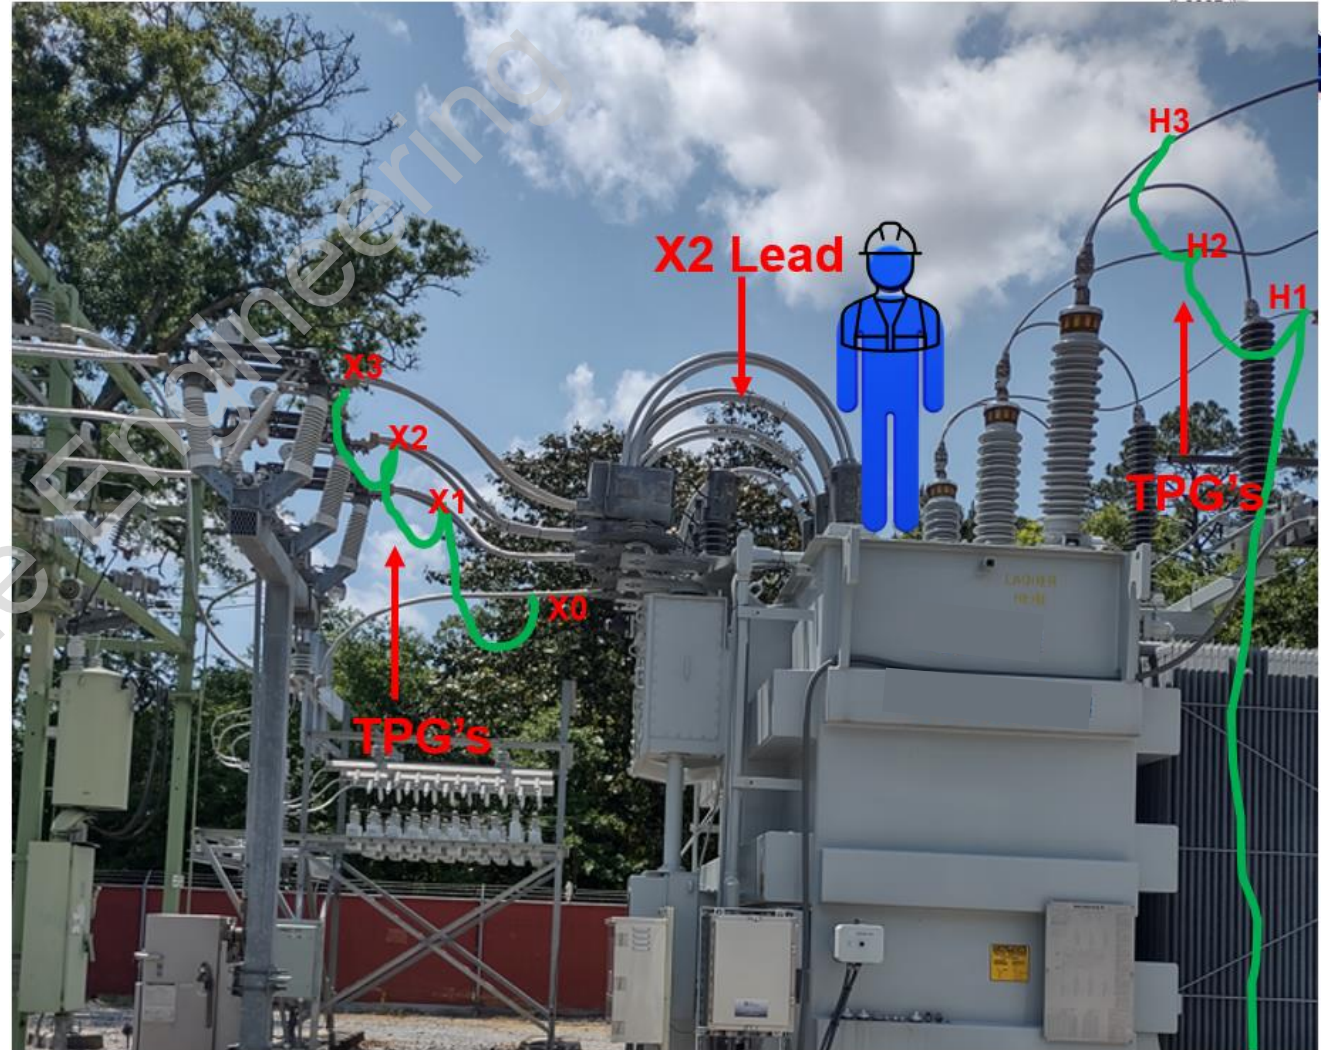
Bank 1 was taken out of service to investigate a bushing monitor alarm which came in on the X2 bushing. The bus tie switch was closed, allowing the Bank 1 feeders to be fed from Bank 2.

Clearance was issued and temporary grounds (TPG) applied as shown in green

The work plan was to perform power factor test on the transformer to validate the bushing monitor alarm.

One journeyman electrician climbed onto the cover. The X2 lead was the first to be removed. When the lead was disconnected and laid down on the tank cover, an arc occurred.

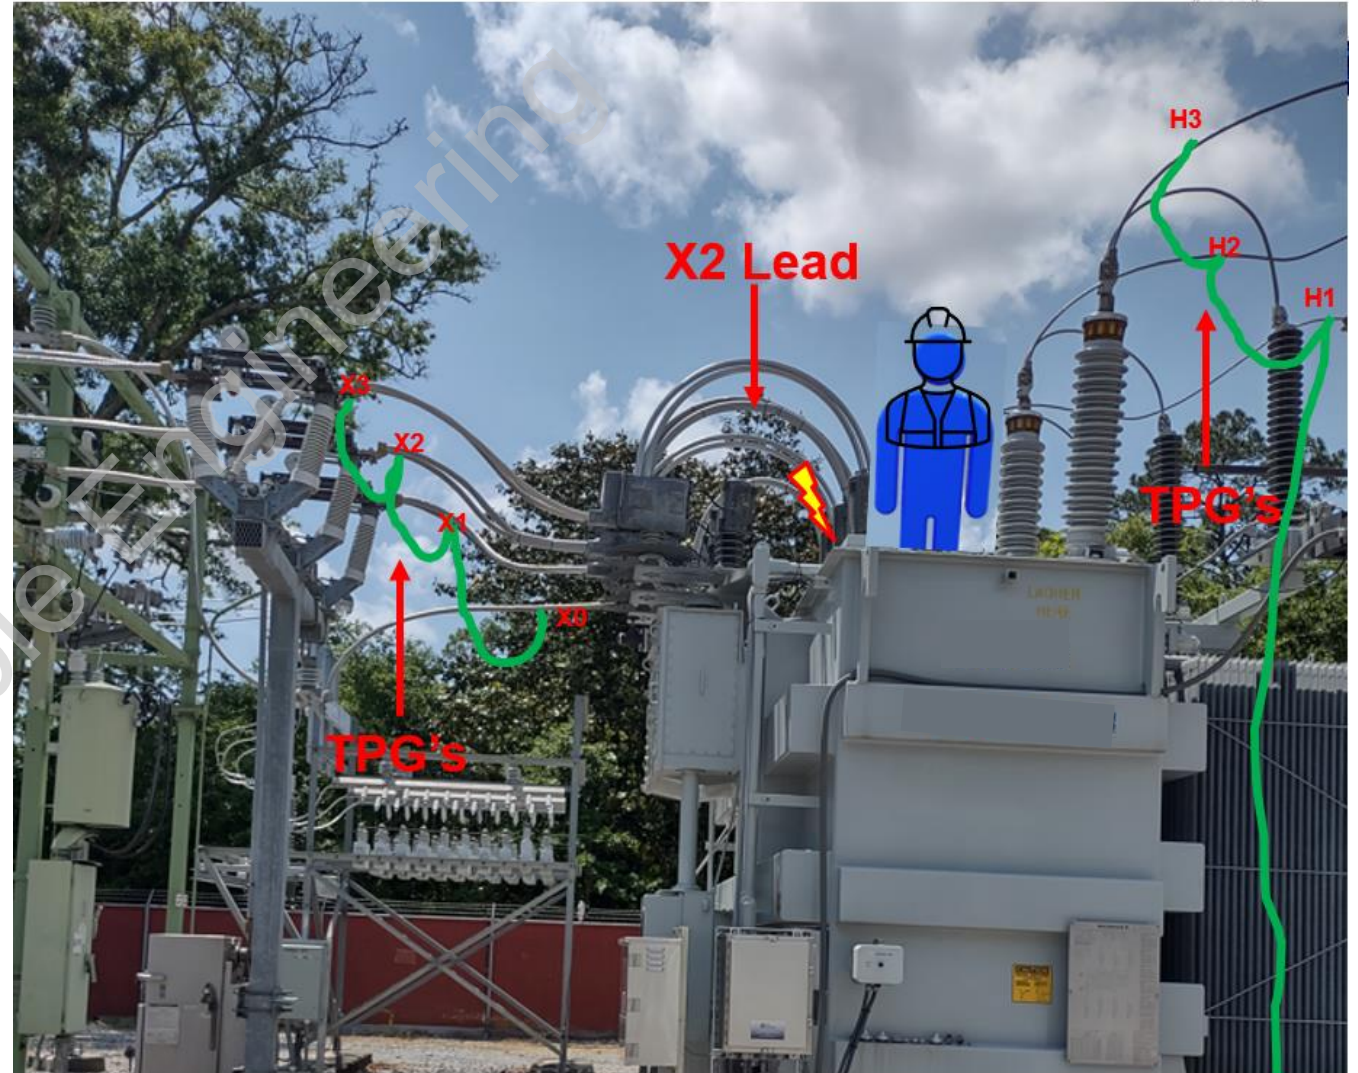
When the 4-hole weldment terminal on the end of the X2 lead touched the tank, personnel on site stated that made a sound like the arc from a welder.

They described seeing sparks as the pad was contacting the tank cover.

Work was stopped immediately.

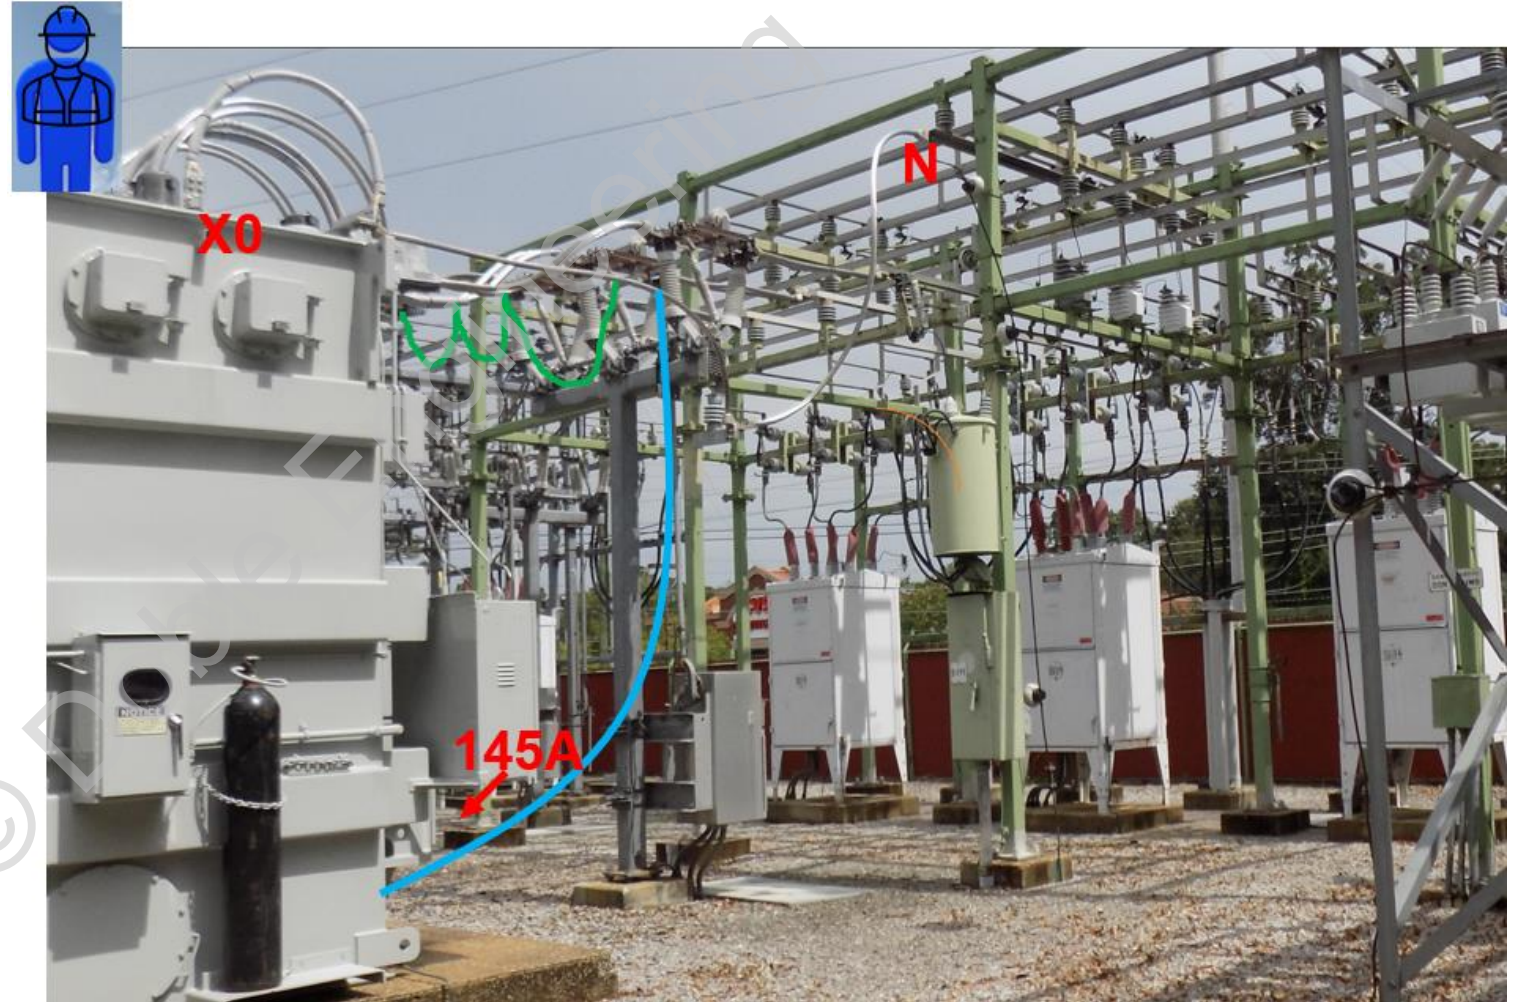
An additional TPG was installed on the neutral and bonded to the transformer tank ground.

A clip-on ammeter was used to read current in the TPG.

145 amps were measured in the TPG. This is the magnitude of current which would have passed thru the lead when it arced to the tank cover.

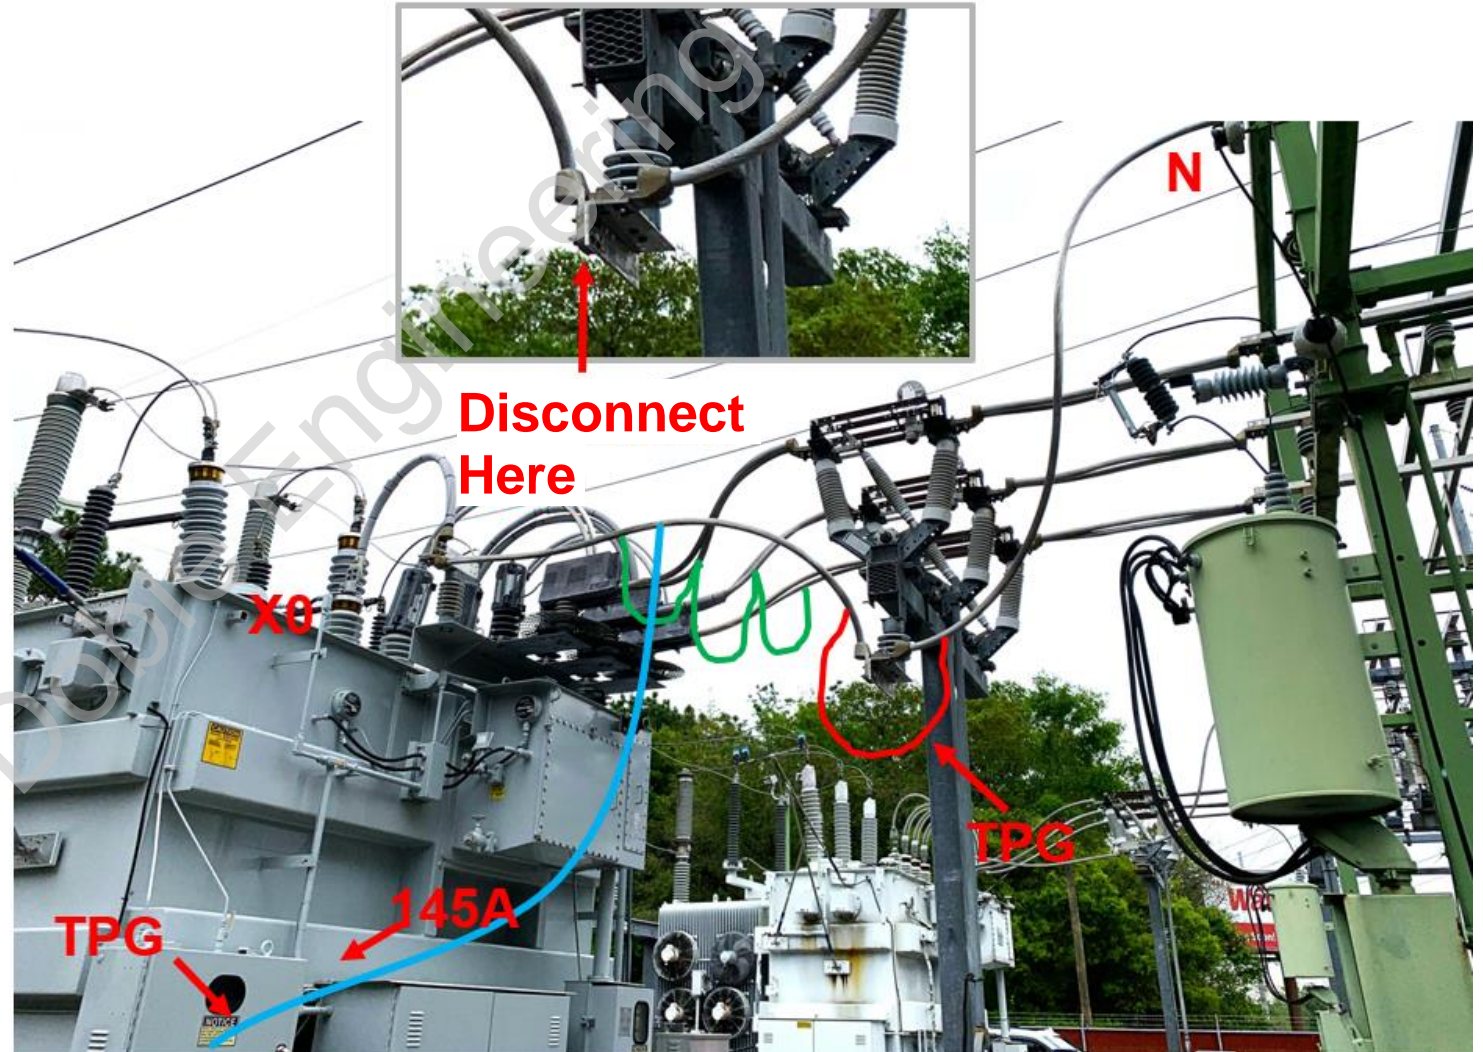
The crew decided they needed to completely isolate the transformer neutral lead from the system to continue work.

They decided to open circuit the neutral lead at the bolted detail located on the low side switch structure.

A TPG was installed across the bolted joint to shunt the neutral current so that the bolted connection could be safely removed without splitting the current.

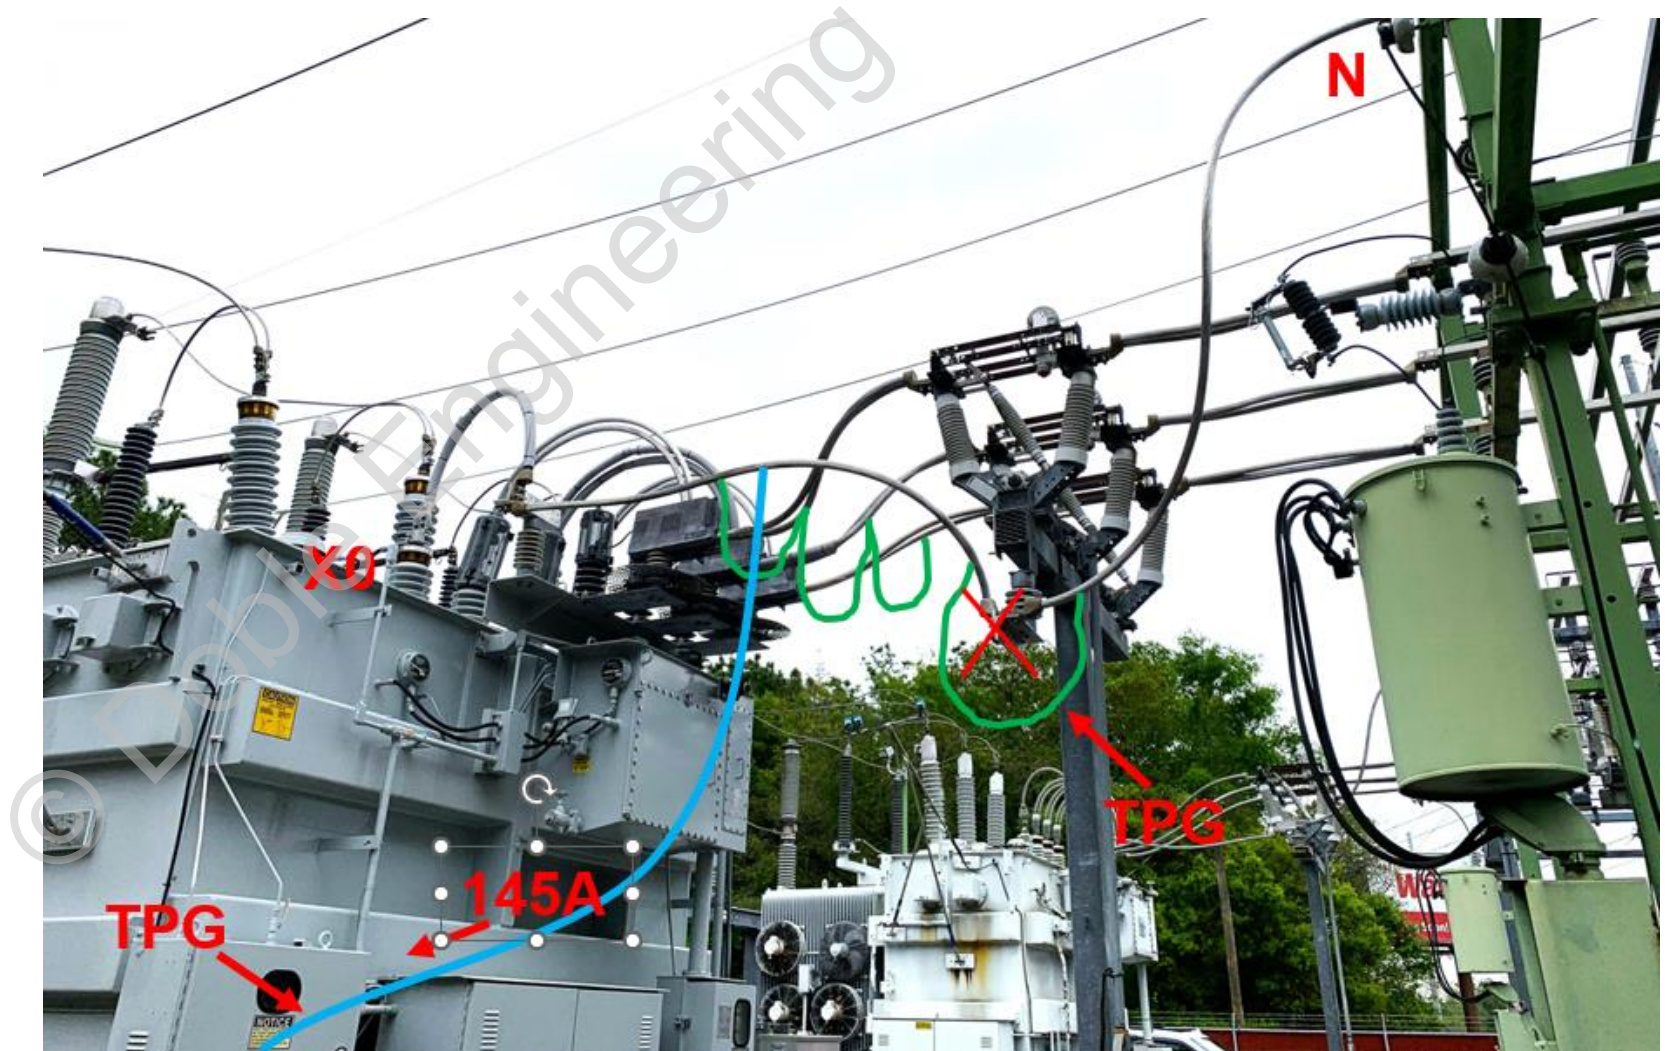
The bolted connection was removed.

Then the TPG was removed with a hot stick; effectively splitting the neutral current coming into the station from the feeders and completely isolating the transformer.

Worker continuity to ground was maintained throughout the process.

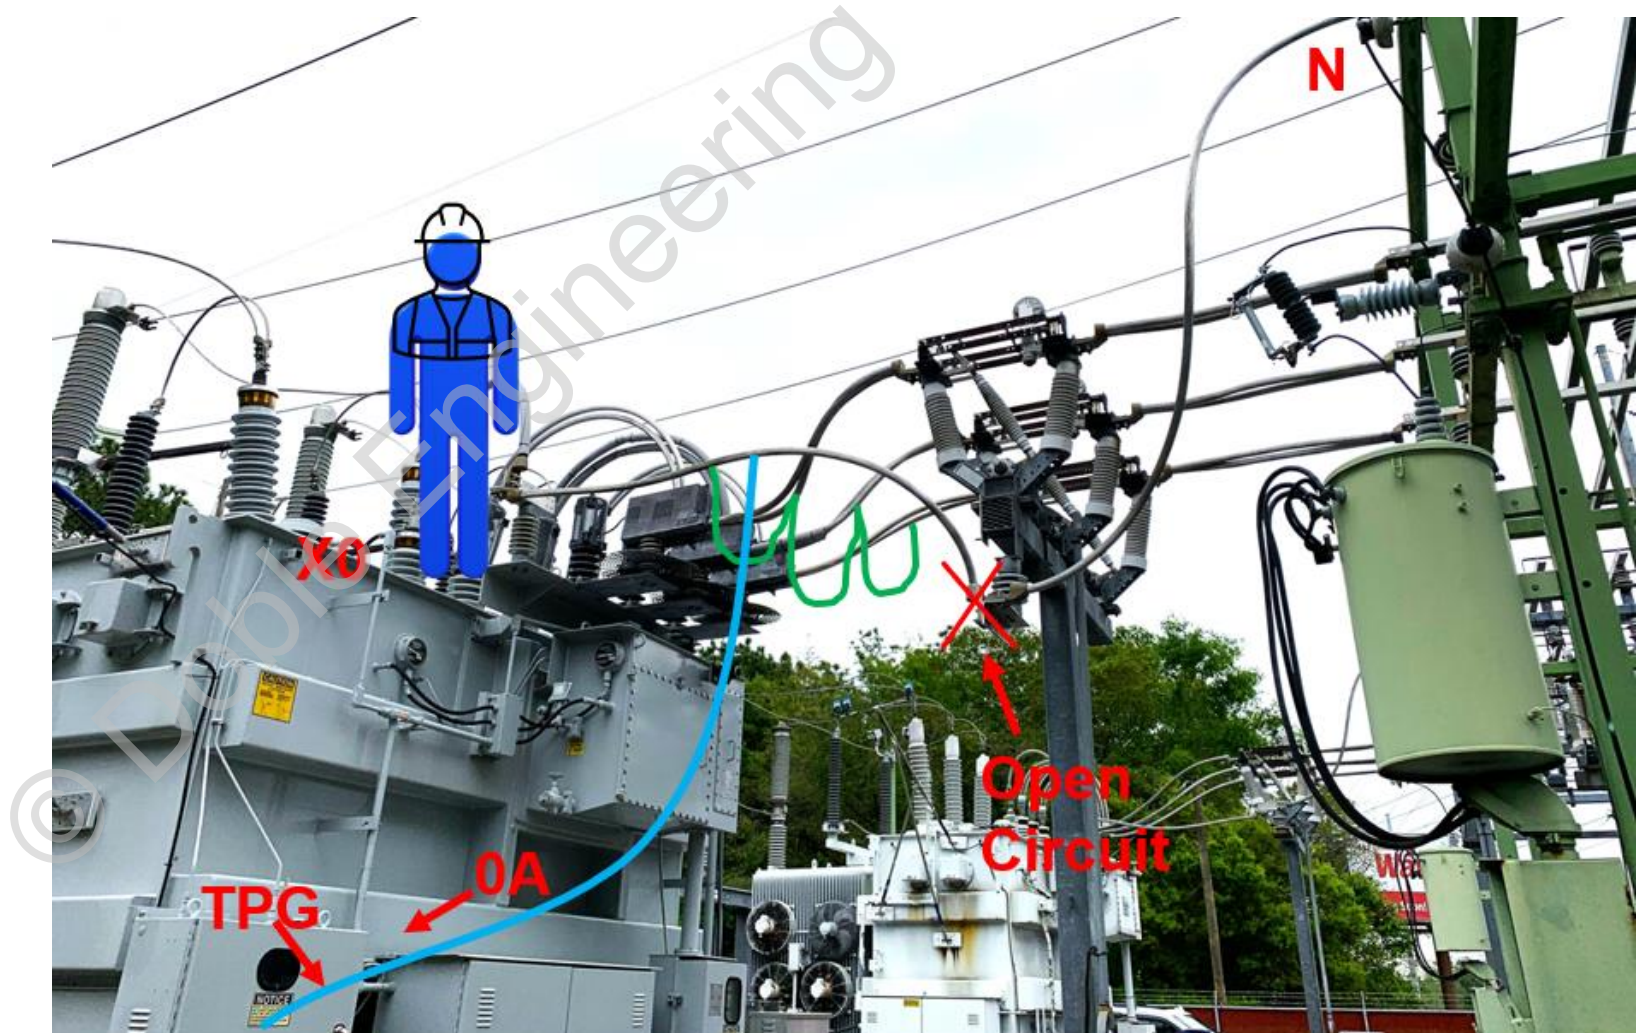
Power factor and capacitance testing of the transformer resumed without incident.

Ultimately, the transformer bushing in question tested good. A defective bushing sensor was determined to be the root cause of the bushing alarm and was replaced.

Once the power factor testing was completed, the transformer leads were reconnected to the bushings and the journeyman electrician exited the transformer cover.

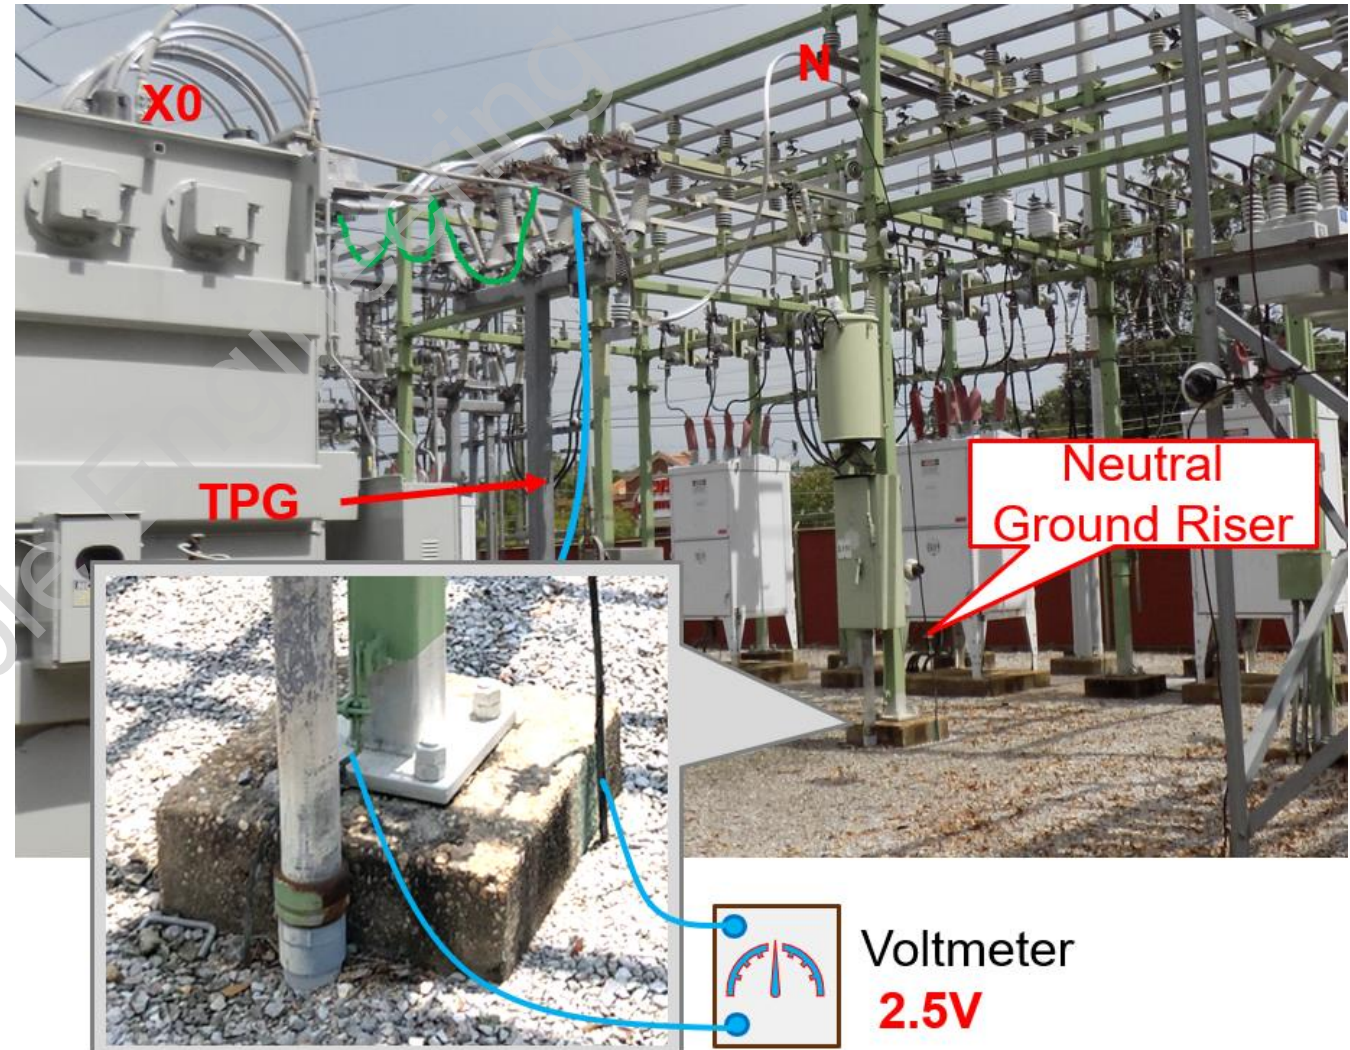
A **2.5V** difference was measured between the 250MCM neutral ground riser and the 2/0AWG structure ground on the same structure leg. Zero volts would have been expected.

This measurement coupled with the Ductor reading indicated a clear problem with the connection of the neutral ground riser to the buried ground field.

The connection was not completely open circuited but definitely compromised.

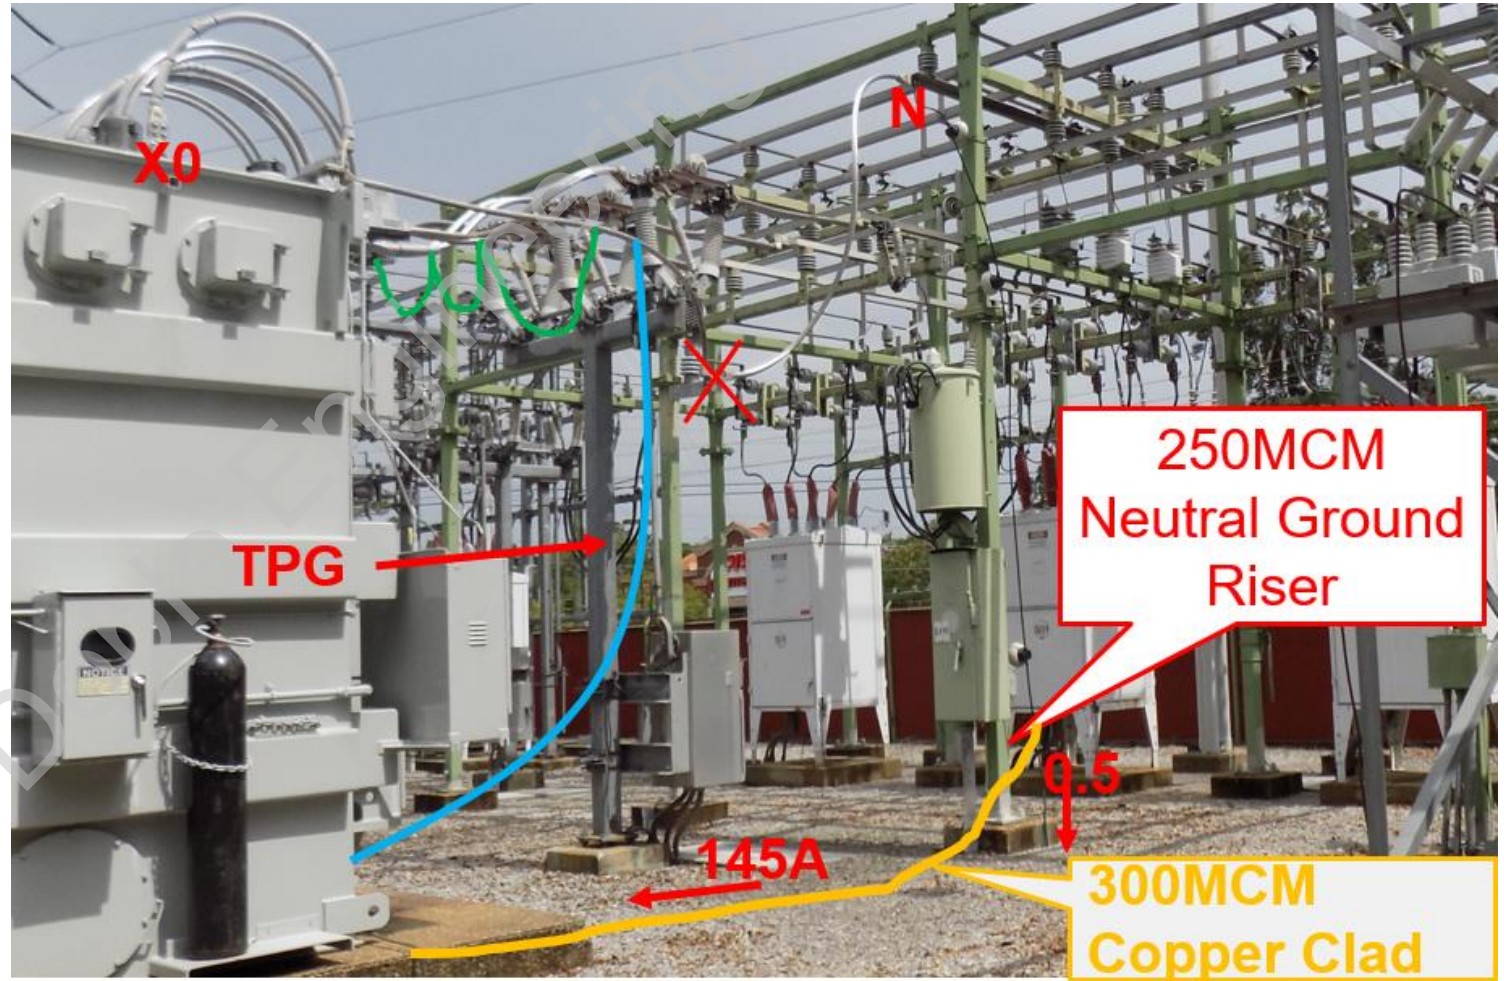
145 amps were measured flowing in the 300MCM temporary lead and 0.5 amps flowing in the neutral riser into the ground field.

This proved the theory that there was an issue with the connection from the neutral riser to the buried ground field.

The crew then installed a 300MCM copper clad ground conductor (yellow) above grade using mechanical clamps from the ground riser to the transformer tank ground. This was intended to be a temporary repair until the problem below grade could be identified.

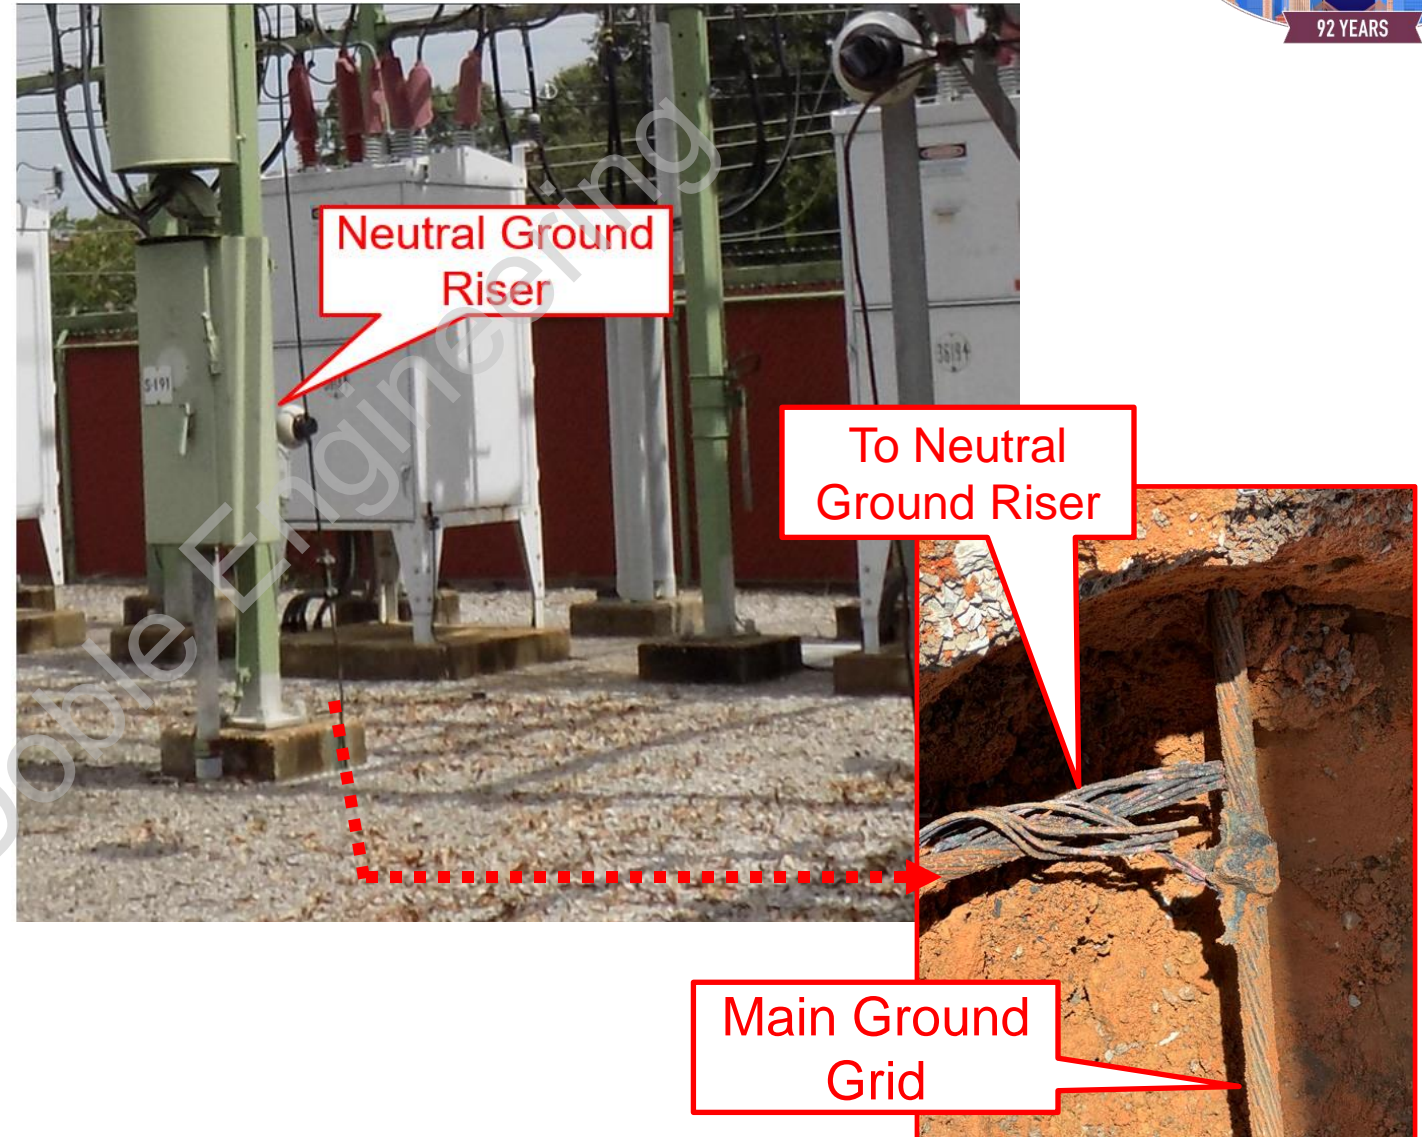
Next, the neutral ground riser was unearthed and traced to the T-connection at the main ground field.

The exothermic cold abutment (CAD) weld at the T-connection was extremely compromised with only a few strands of conductor still making connection

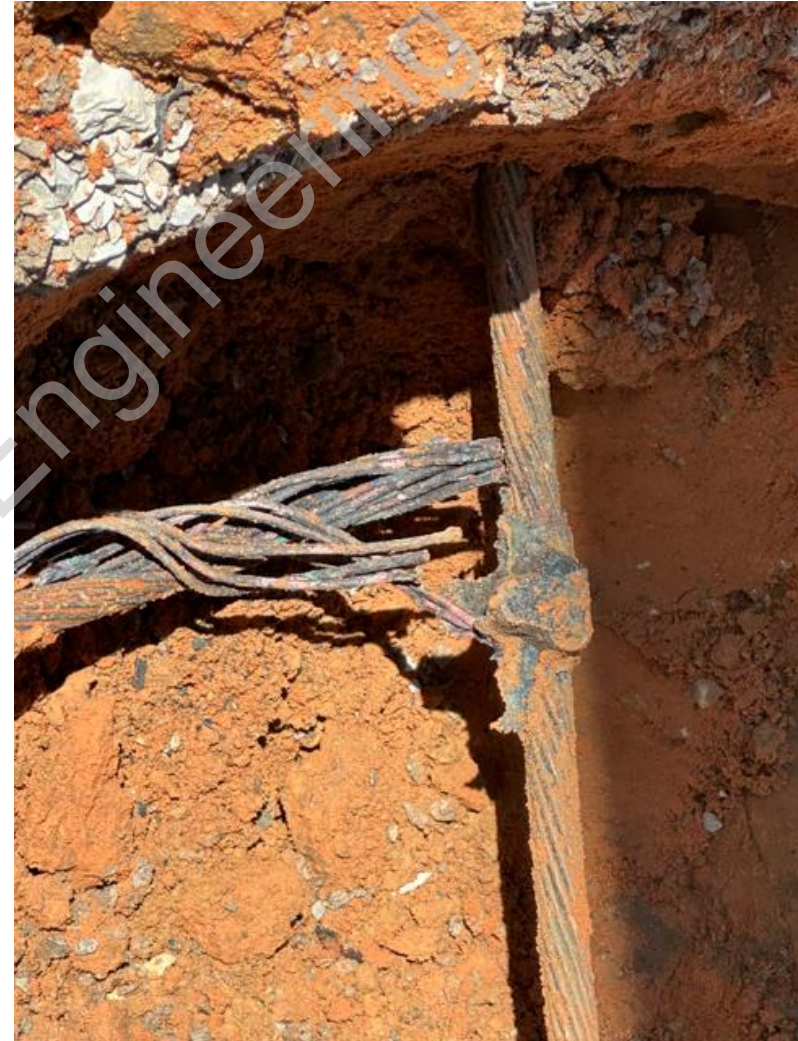
The CAD weld appeared to have high porosity and missing much of the expected weld material indicating that this defect likely occurred when the station was constructed.

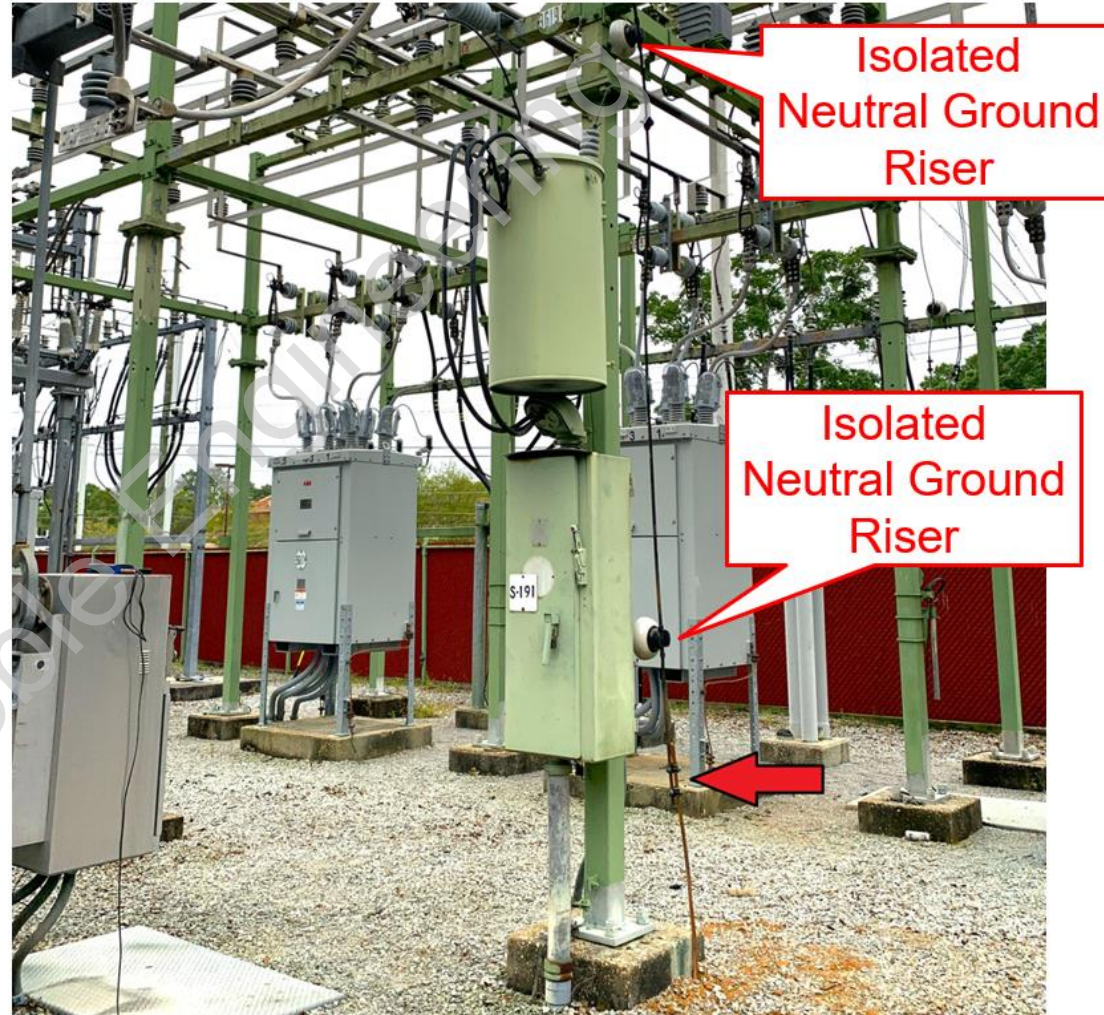
The neutral buss on the Bank #1 transformer only has one earth grounding connection point.

The neutral buss and earth ground are isolated from the steel structure by porcelain standoff insulators.

The break below grade created a single point of failure in the neutral grounding system at the station.

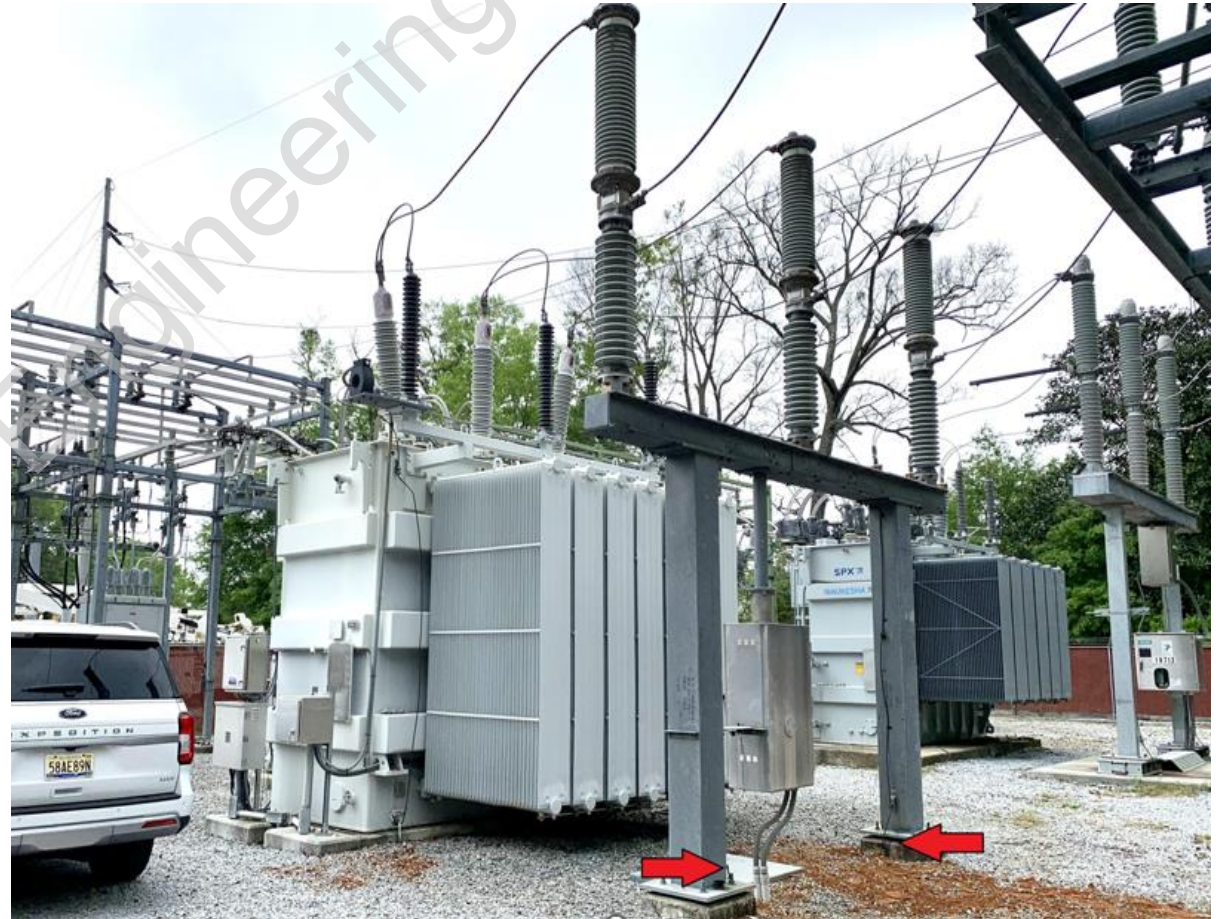
The Bank #2 high-side Series 2000 Circuit Switcher structure had no earth ground reference on either of the two support legs. Each leg was bonded together with a common ground wire, but neither was connected to the ground field.

If Bank 2 were removed from service and the HV leads grounded, one of these two risers would have been used to ground the transformer.

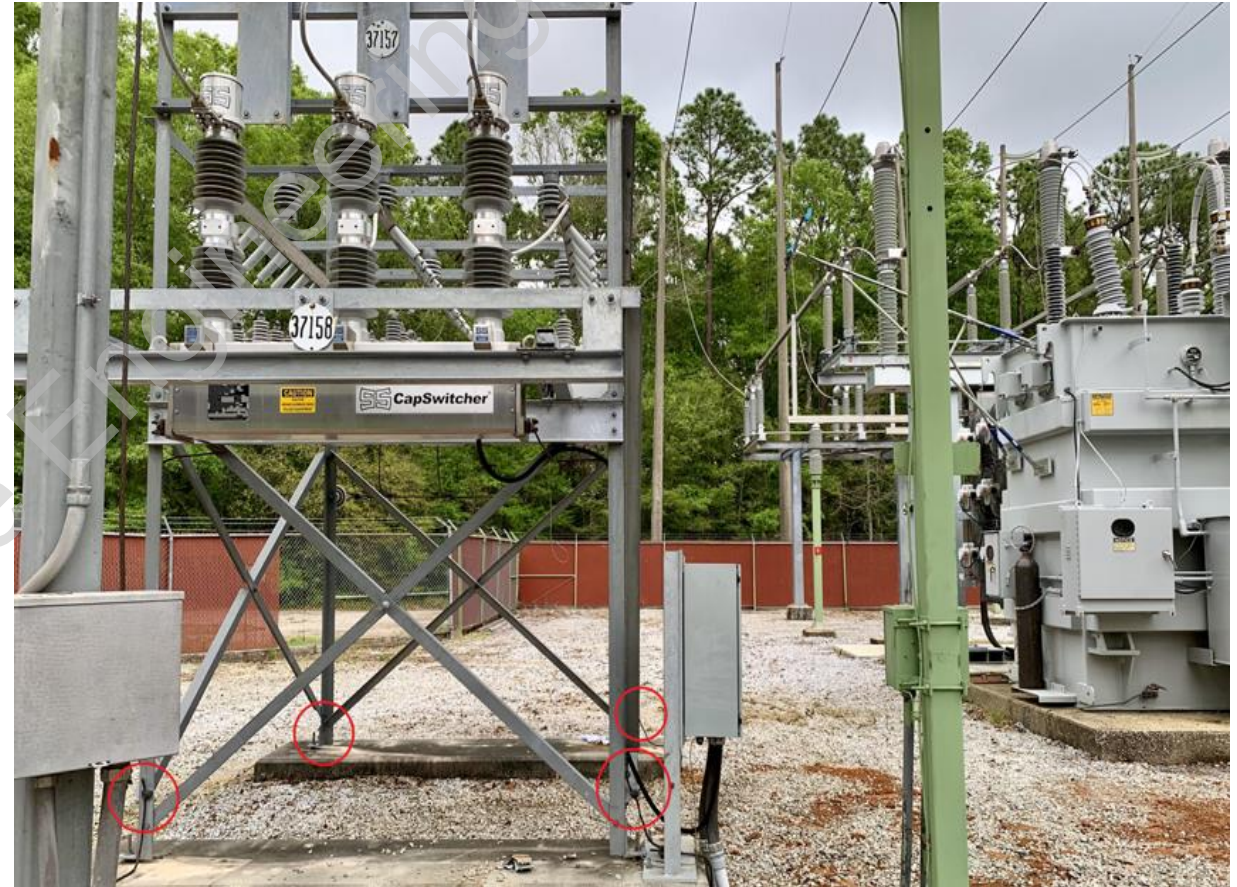
The Bank #1 distribution Capacitor Bank had high resistance readings on each leg of the structure going to the Ground field. All four grounding wires were bonded together to a single common wire that had a bad connection to the Ground grid.
