Switching It Up: A New Innovative 3-Way GOAB Switching Structure

Nick Choi, P.E. – Transmission Reliability Engineering
Hunter Boggs, P.E. – Transmission Line & Asset
Engineering

92nd International Conference
of Doble Clients

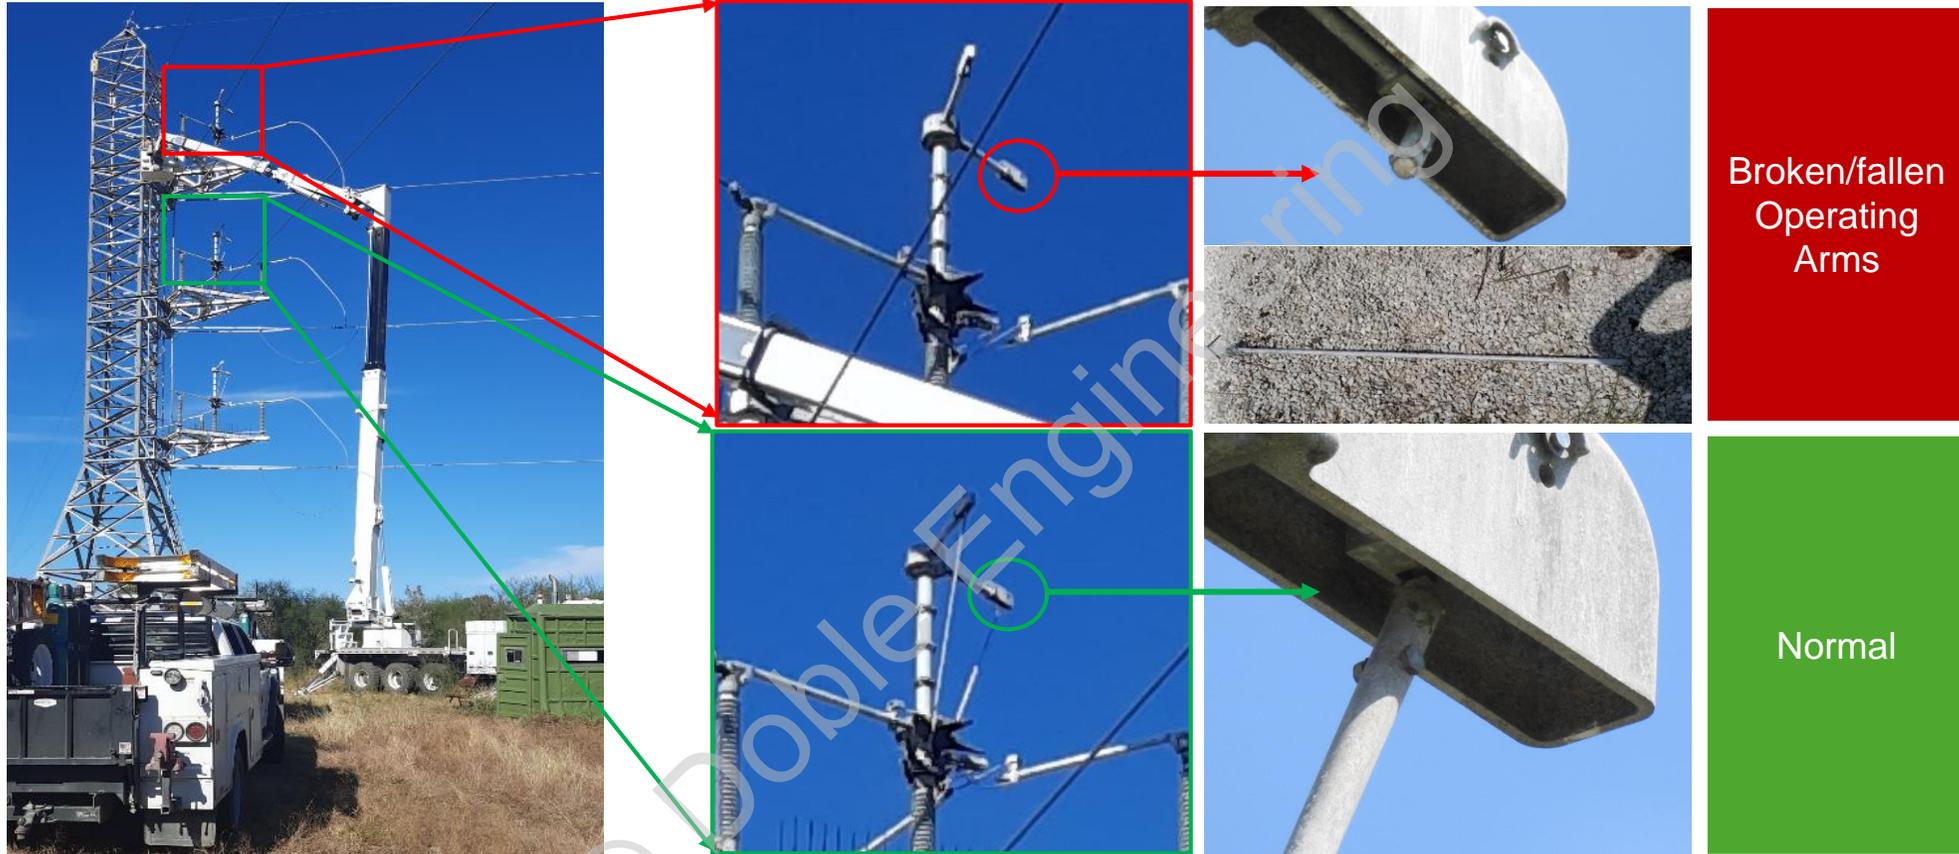
Fallen Object Safety Near Misses

- LCRA experienced two (2) fallen objects from previous GOAB switch design in 2020.
- Assets were 5 years old at the time of failure.
- Switches had been exercised annually (recommended by manufacturer).
- Both switches and interrupters were manufactured from same company.

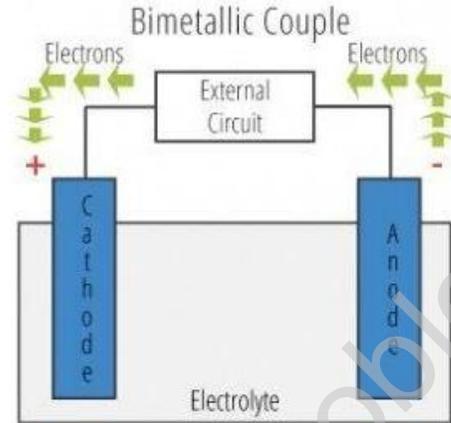
LCRA investigation team concluded the interrupter operating arm failure was caused by the design allowing galvanic corrosion to take place at the operating arm pivot joint.

Root Cause : Design - absence of separator between bronze and aluminum material at the pivot assembly.

Contributing Cause : Design - the pivot joint assembly is exposed to rainwater.

Galvanic Corrosion Prevention can be achieved with a design improvement.

- Selecting metals with similar potentials
- Eliminate physical contacts between two dissimilar metals.
- Prevent exposure to electrolyte/rainwater.

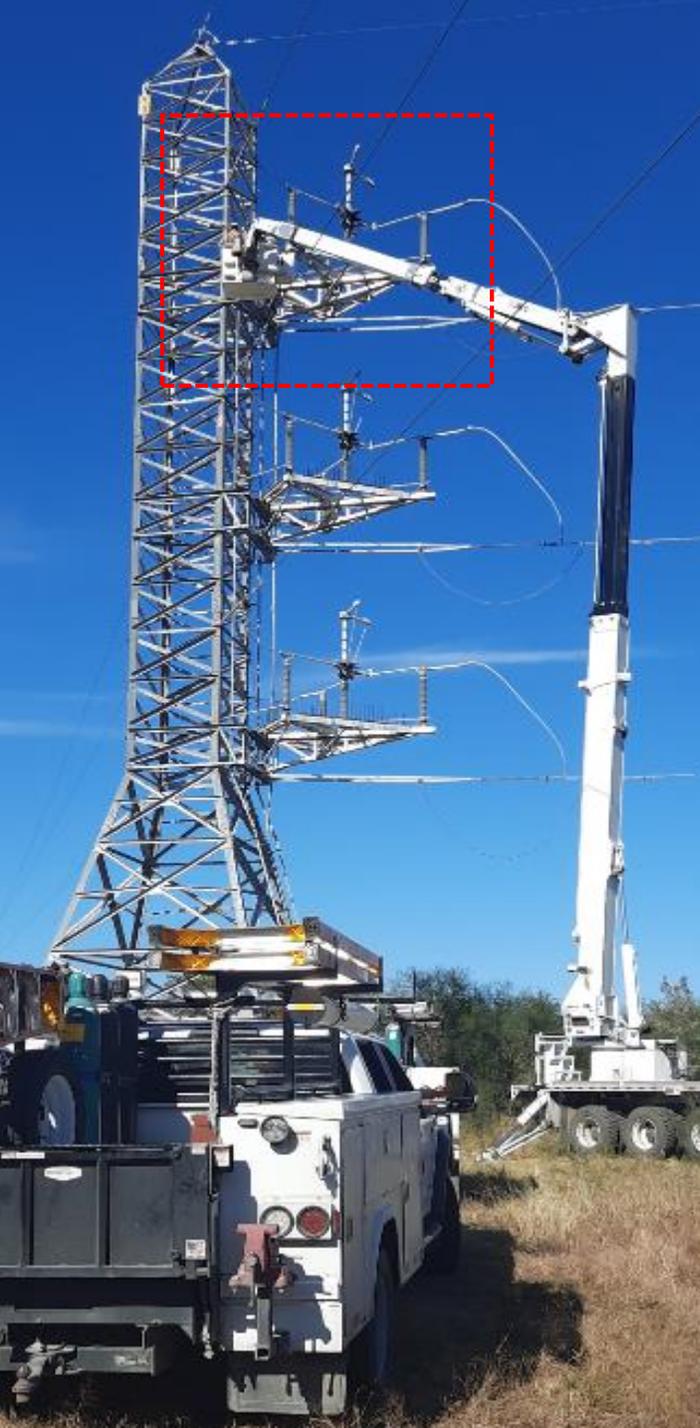
- LCRA and the switch manufacturer did not agree on the cause of the aluminum corrosion. No product design change has been made.
- LCRA replaced the top interrupter assembly with new. However, LCRA became concerned with long-term equipment reliability and employee safety as the fallen object problem could continue.
- LCRA halted on all routine switching activities associated with nine(9) 3WAY GOAB transmission switching structures due to safety concerns.
- LCRA decided to re-design the traditional 3-WAY GOAB Transmission Switches as the original design did not meet LCRA’s requirements.

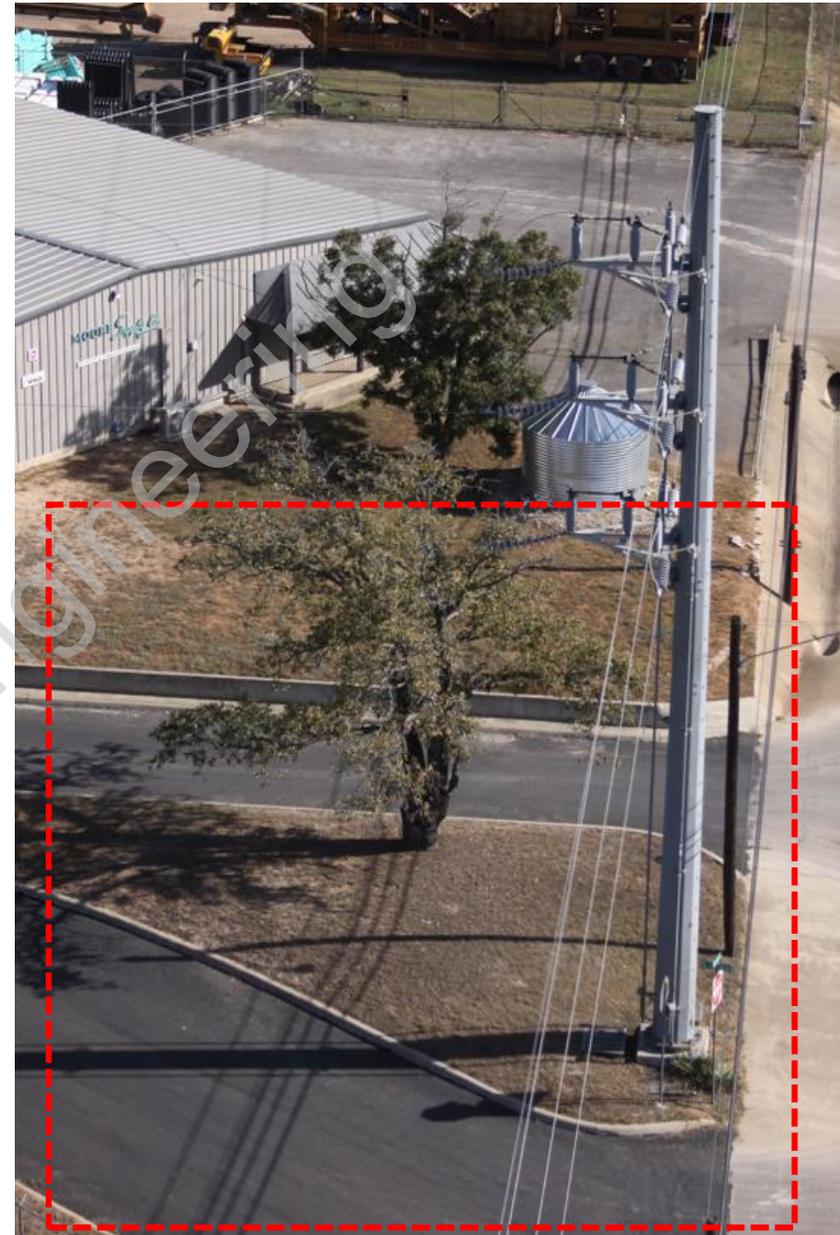
< Existing LCRA owned 3-WAY Switching Structure >

3-WAY Box Structure was unfeasible to replace the existing 3-WAY Switching Structure due to its size and real estate concerns.
