Catastrophic Failure of ASEA Type IMBE-170 A4 Current Transformer

Hugo Simard, Rio Tinto
Jordan Beaudoin, Rio Tinto
Long Pong, Doble

**92nd International Conference
of Doble Clients**

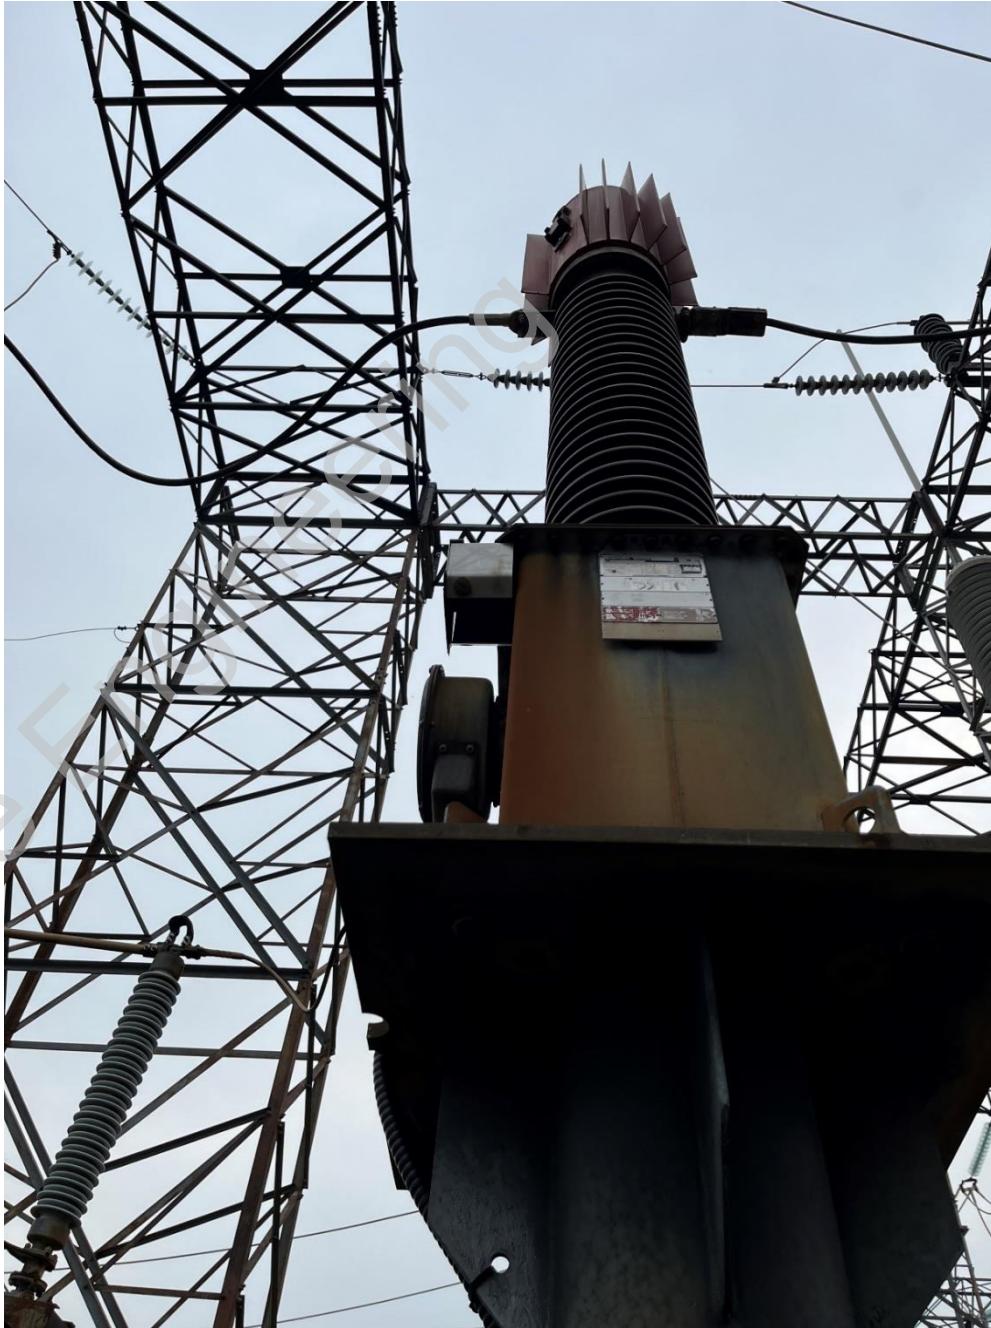
3 x single phase CT in 161kV
substation feeding industrial load
with harmonic filter

ASEA

Made in 1988 by Sweden

Type: IMBE 170 A4

Rated voltage : 170 kV

Standard : CAN3-C13-M83

4 secondary windings

Shed porcelain insulator

3 X SIMILARS UNITS

PHASE	SERIAL NUMBER
A	7739539
B	7739540
C (Failed)	7739541

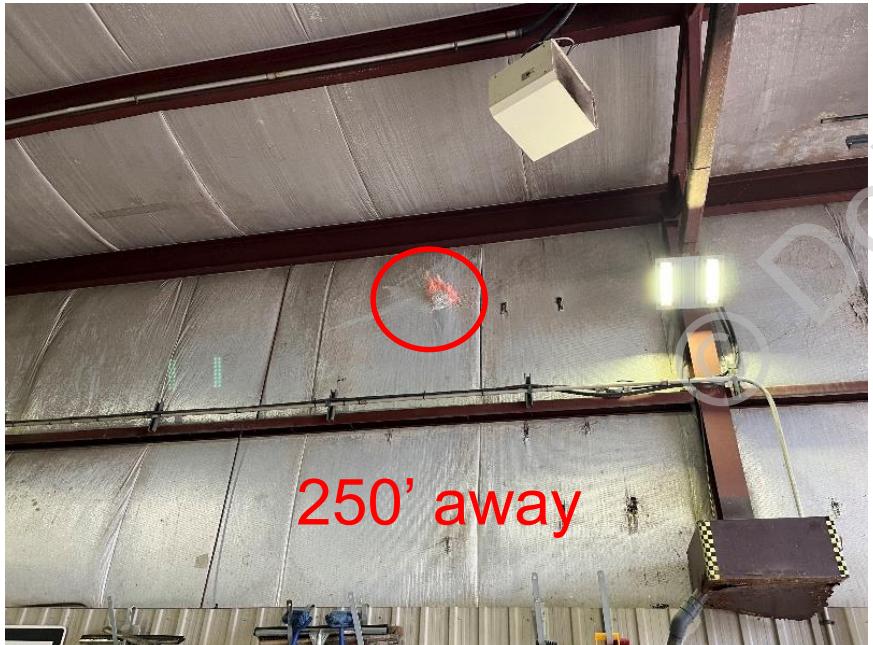
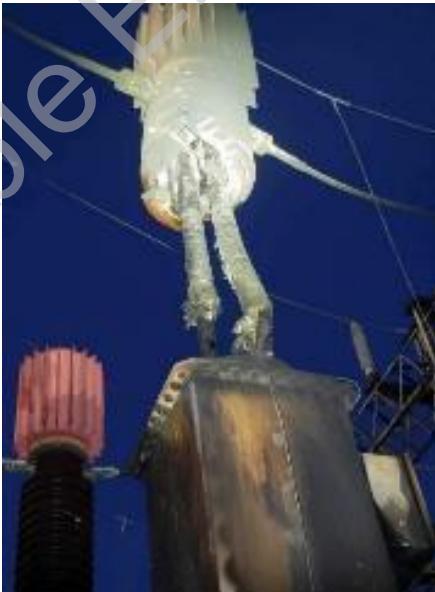
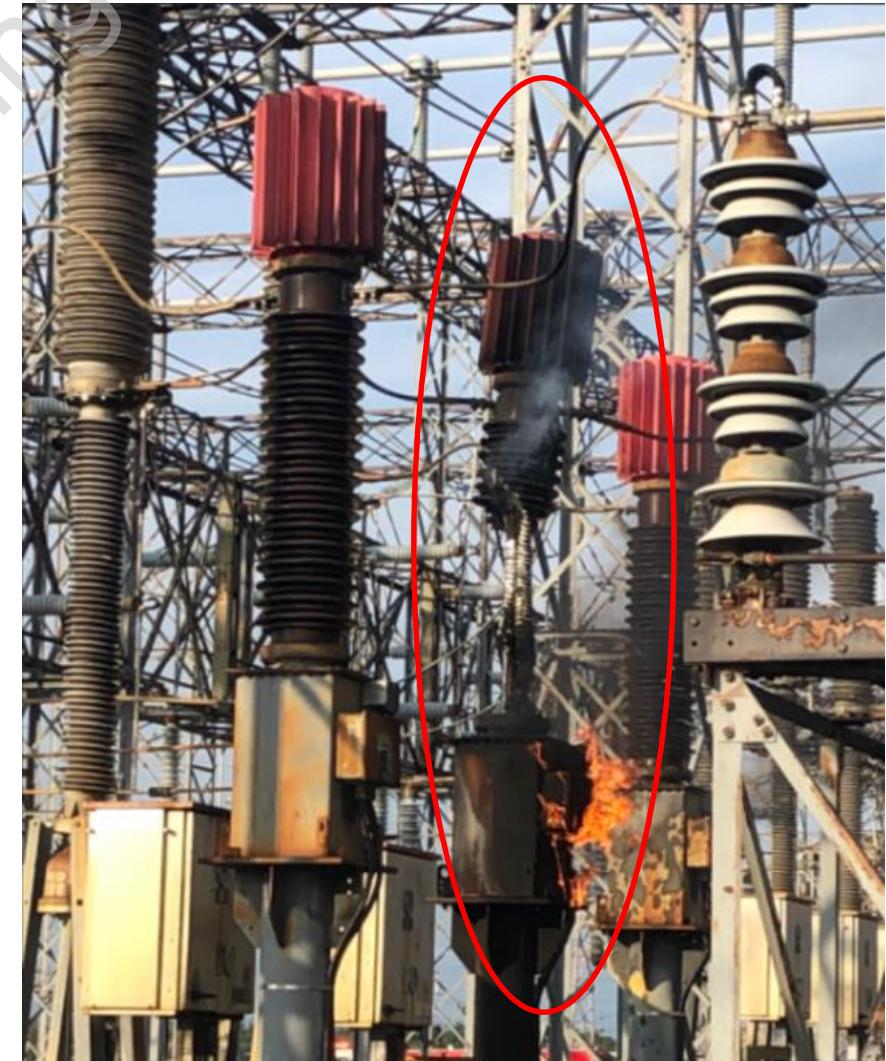
Failure Information

- 'C' phase unit failed June 2023
- Bottom half of housing is gone
- Collateral damage up to 250' away & adjacent CT's
- Burnt secondary leads and test tap ground connection
- Harmonics filter removed from service weeks before failure

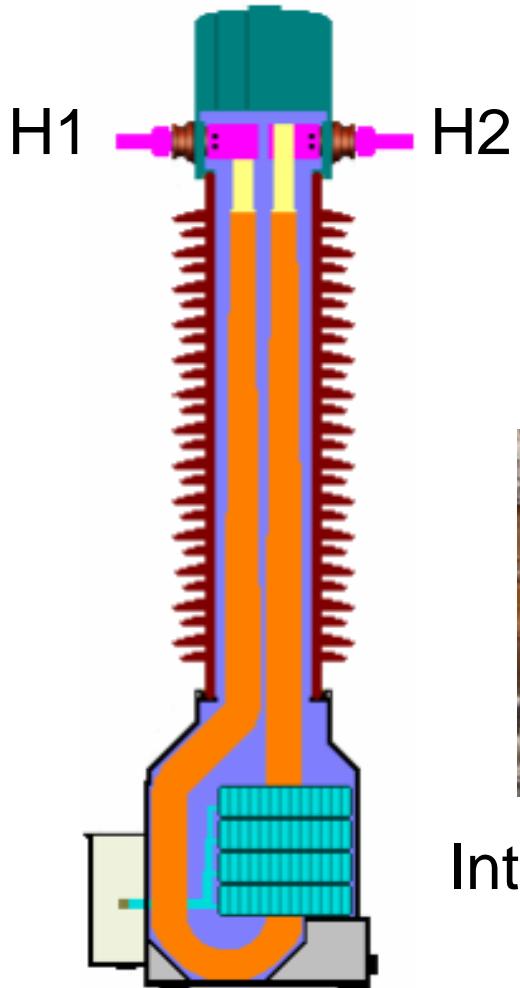
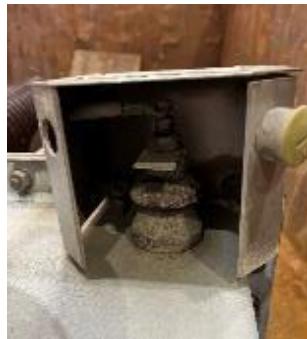
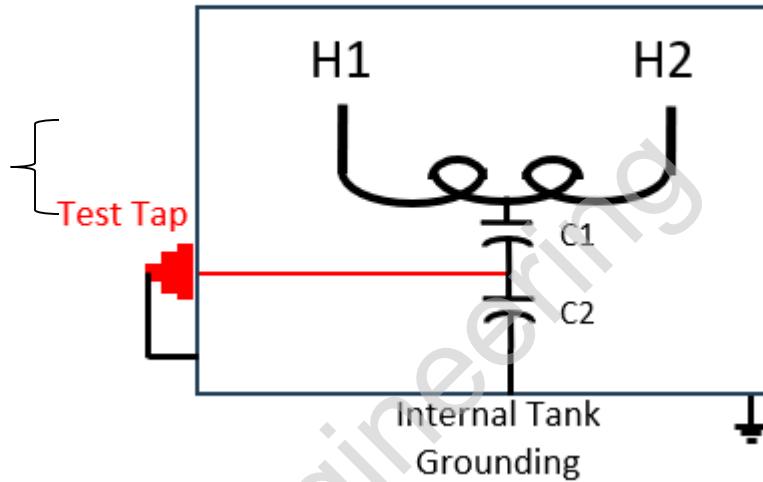
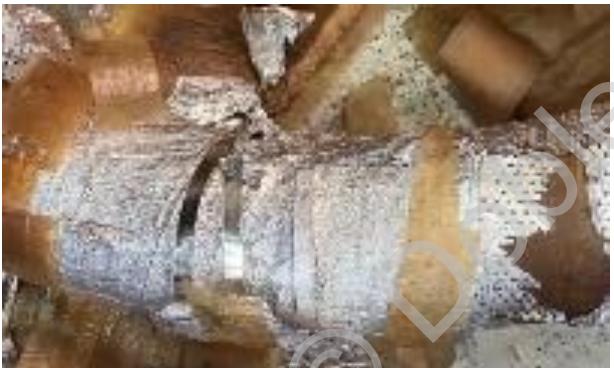
CT Design

Few
insulation
papers
between test
tap and
grounding
layers

Internal test tap connection

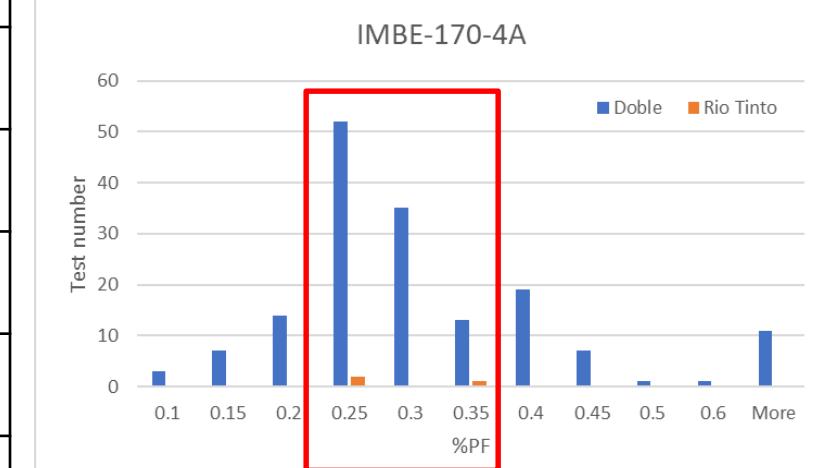
Doble database – DTA Web

- Two sister units were used as benchmark for Root Cause Analysis
- Tested July 10th, 2023 – Overall, C1 & C2 insulation tests
 - PF < acceptable limit and statistically well below the data from Doble database (DTAWeb)
 - Capacitances variation from 5% to 18% suggesting some variation in the CT construction

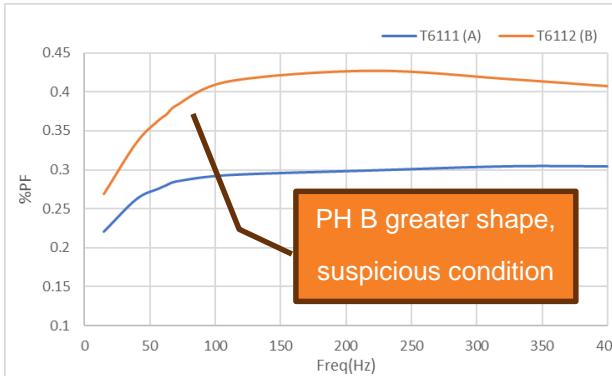
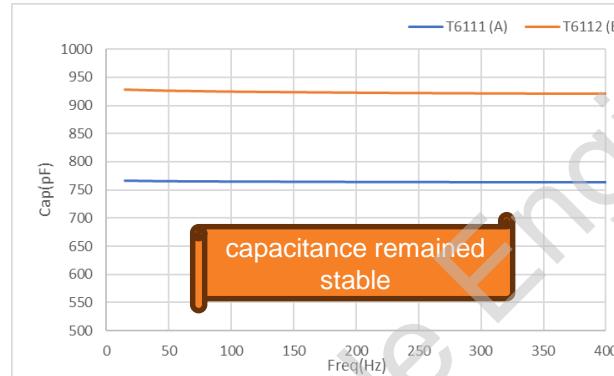
C1 main insulation

- VFPF, PF @2kV from frequency 15 to 400Hz
 - PF consistent with other standard 60Hz PF
 - Typical curve shape “fish-hook” for CT (blue)

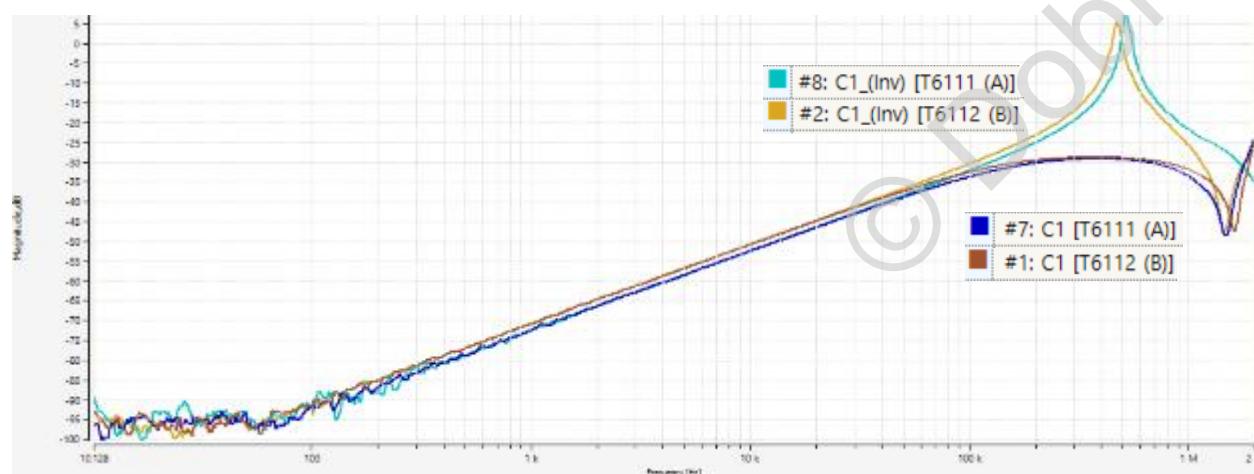
SFRA Test on C1

- SFRA, 6 measurements, 10Hz to 2MHz
 - C1 traces different resonance frequency due to the dissimilarity of their capacitances
 - C1 (Inv) differently from the C1 trace resonance type, was probably caused by the CT magnetization reactance
 - Open-Circuit tests (lex) classified the four secondary windings into two groups: W&X and Y&Z, suggesting that the four windings grouped into two winding structures

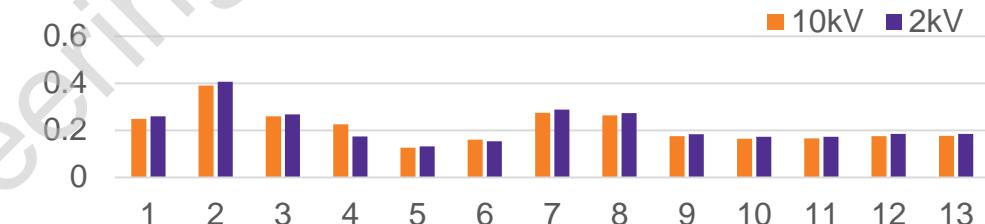
PF for all 13 CT

- Identified 13 CTs of the same type and proceeded with oil sampling and electrical insulation measurements
- Several CTs have relatively high hydrogen levels (H₂)
- Insulation measurements within limits for all CT
- All C2 were also good (not included in this table)

- Replacement program for all IMBE-170 transformers was implemented following the explosion. The priority is based on the insulation measurements, oil analyses and production impact customer

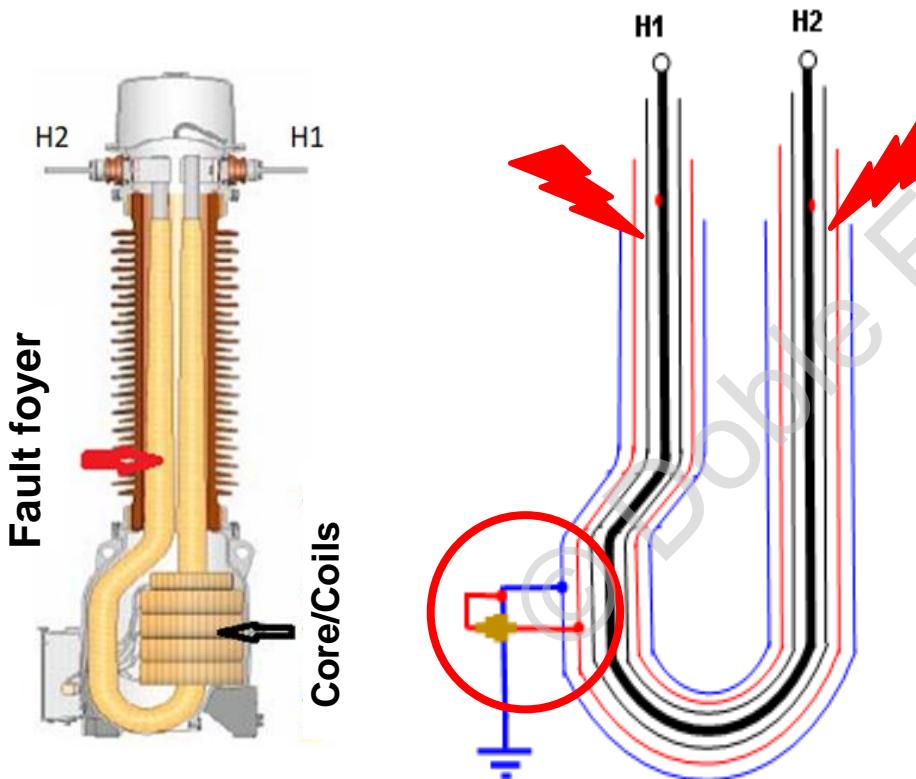
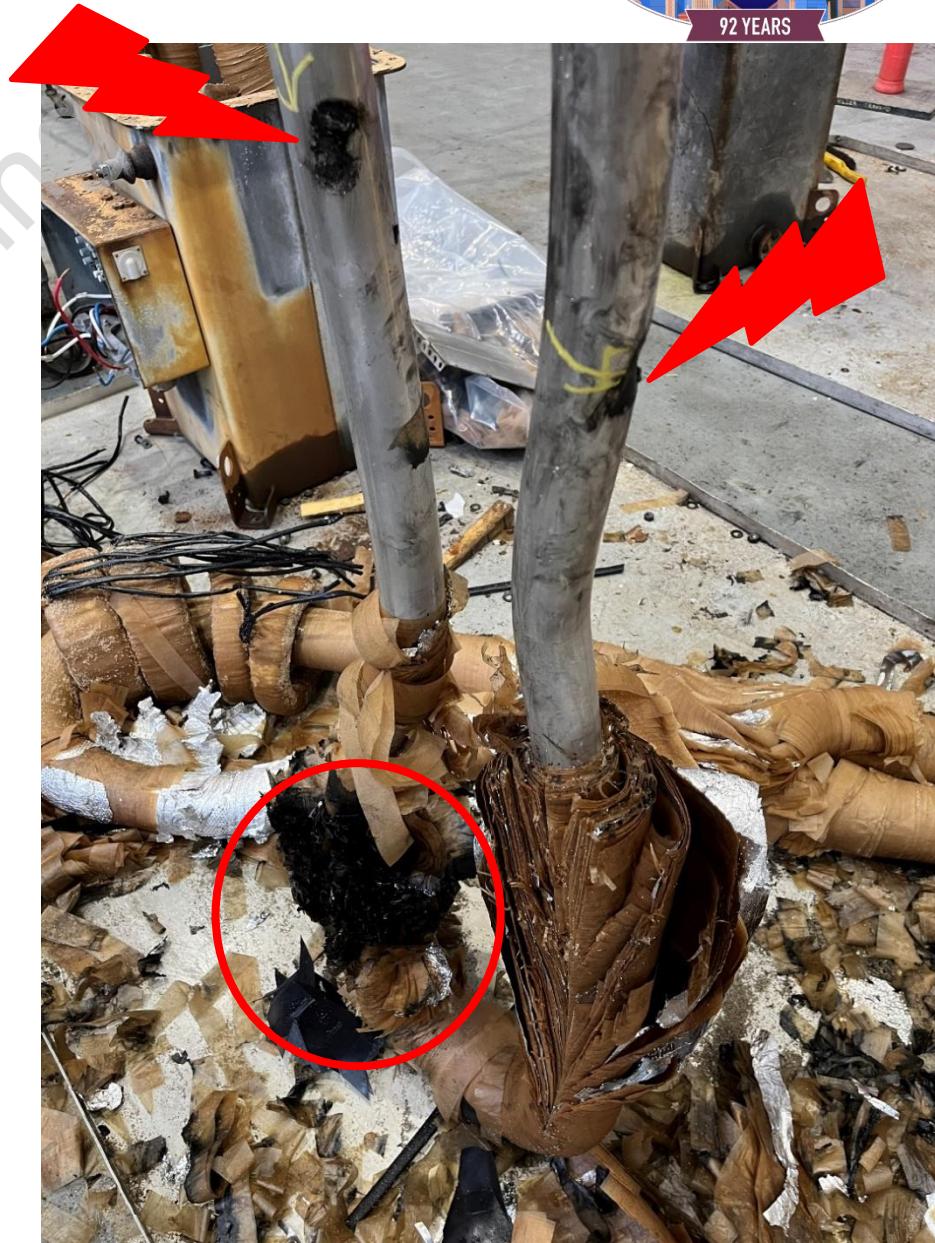
Failure Investigation – Internal inspection

- Disassembly of the 3 CTs to detect clues about the root causes
- Layers of insulating paper were all cut at the same time to inspect internal ground and test tap measurements
