# 2026 International Conference of Doble Clients

Switch Bearing Issues and Solutions

Brazos Electric Power Cooperative, Inc.

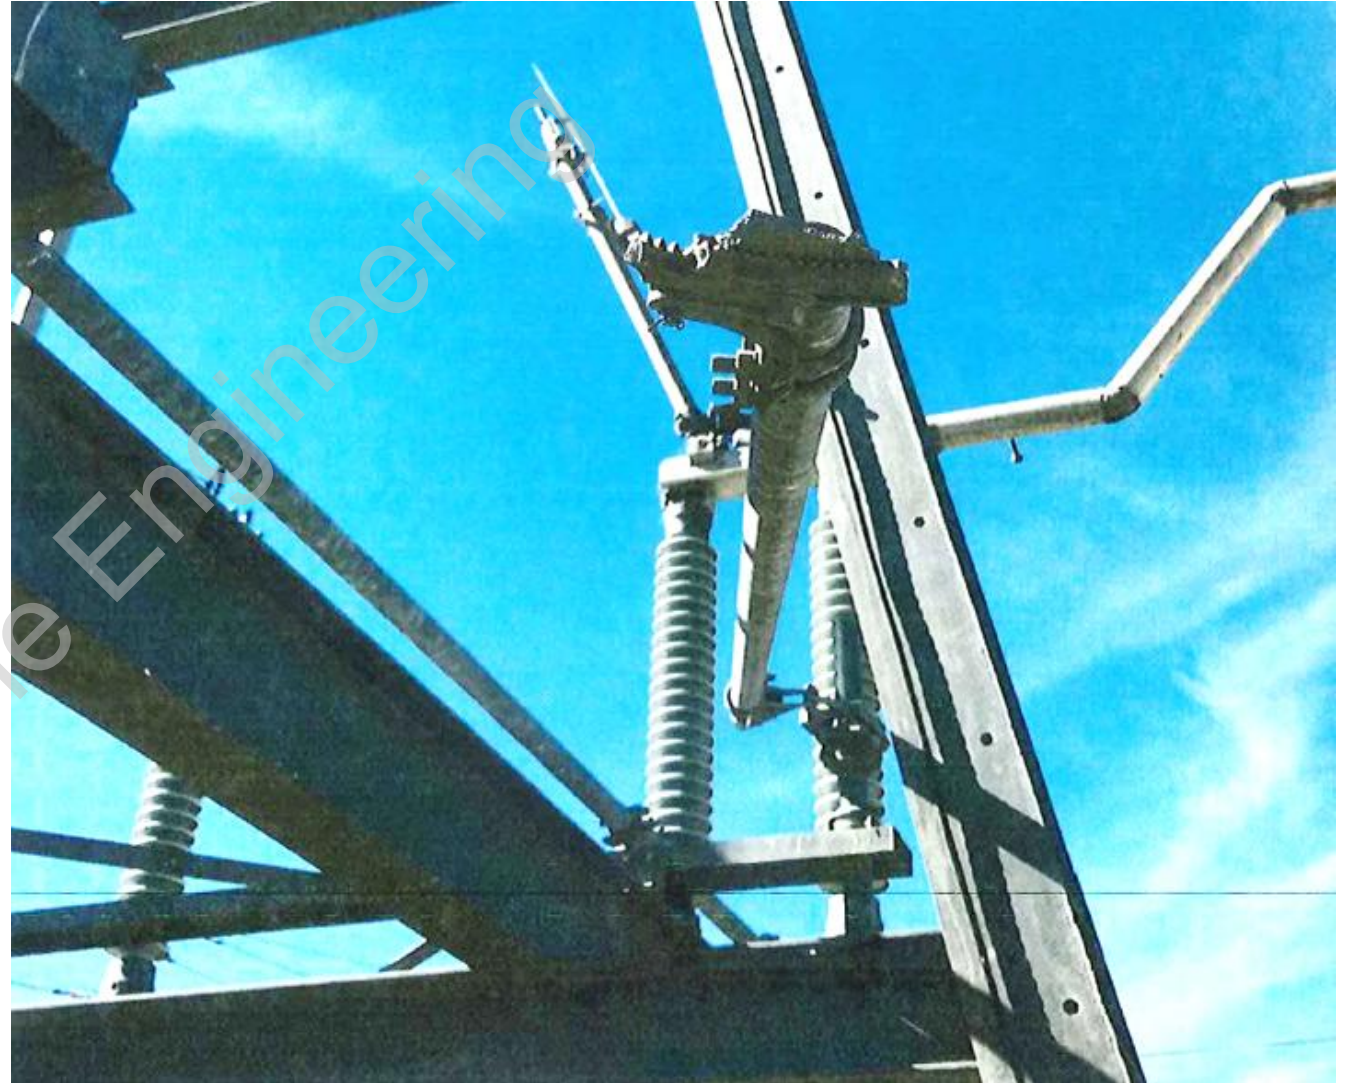
- Itasca M30 switch failed to close
  - 138 kV, 2,000 amp
  - Southern States EV-2
  - Manufactured 2006
  - HMVB
- Attempted repairs
  - Penetrating oil
  - Grease
  - Preload
- Replaced switch

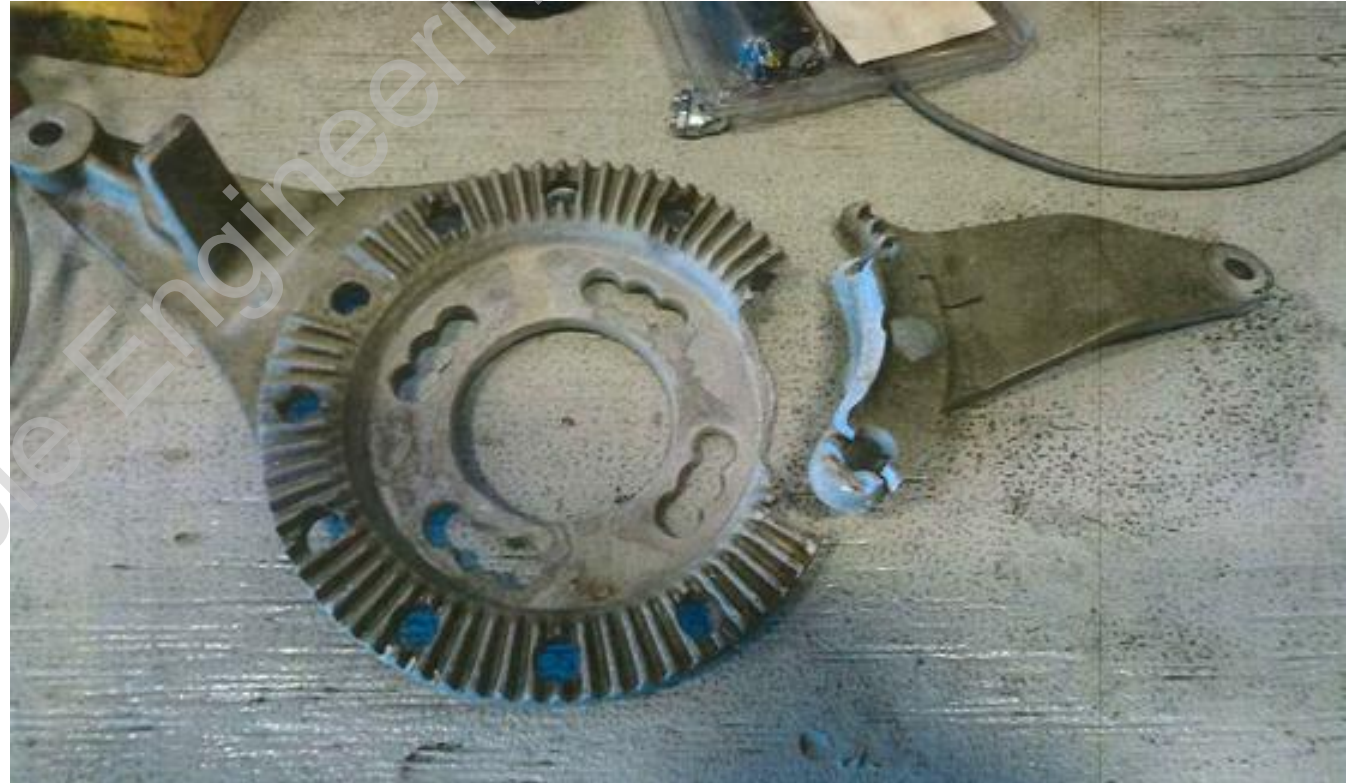
- Itasca M30 switch failed to close
  - 138 kV, 2,000 amp
  - Southern States EV-2
  - Manufactured 2006
  - HMVB
- Attempted repairs
  - Penetrating oil
  - Grease
  - Preload
- Replaced switch

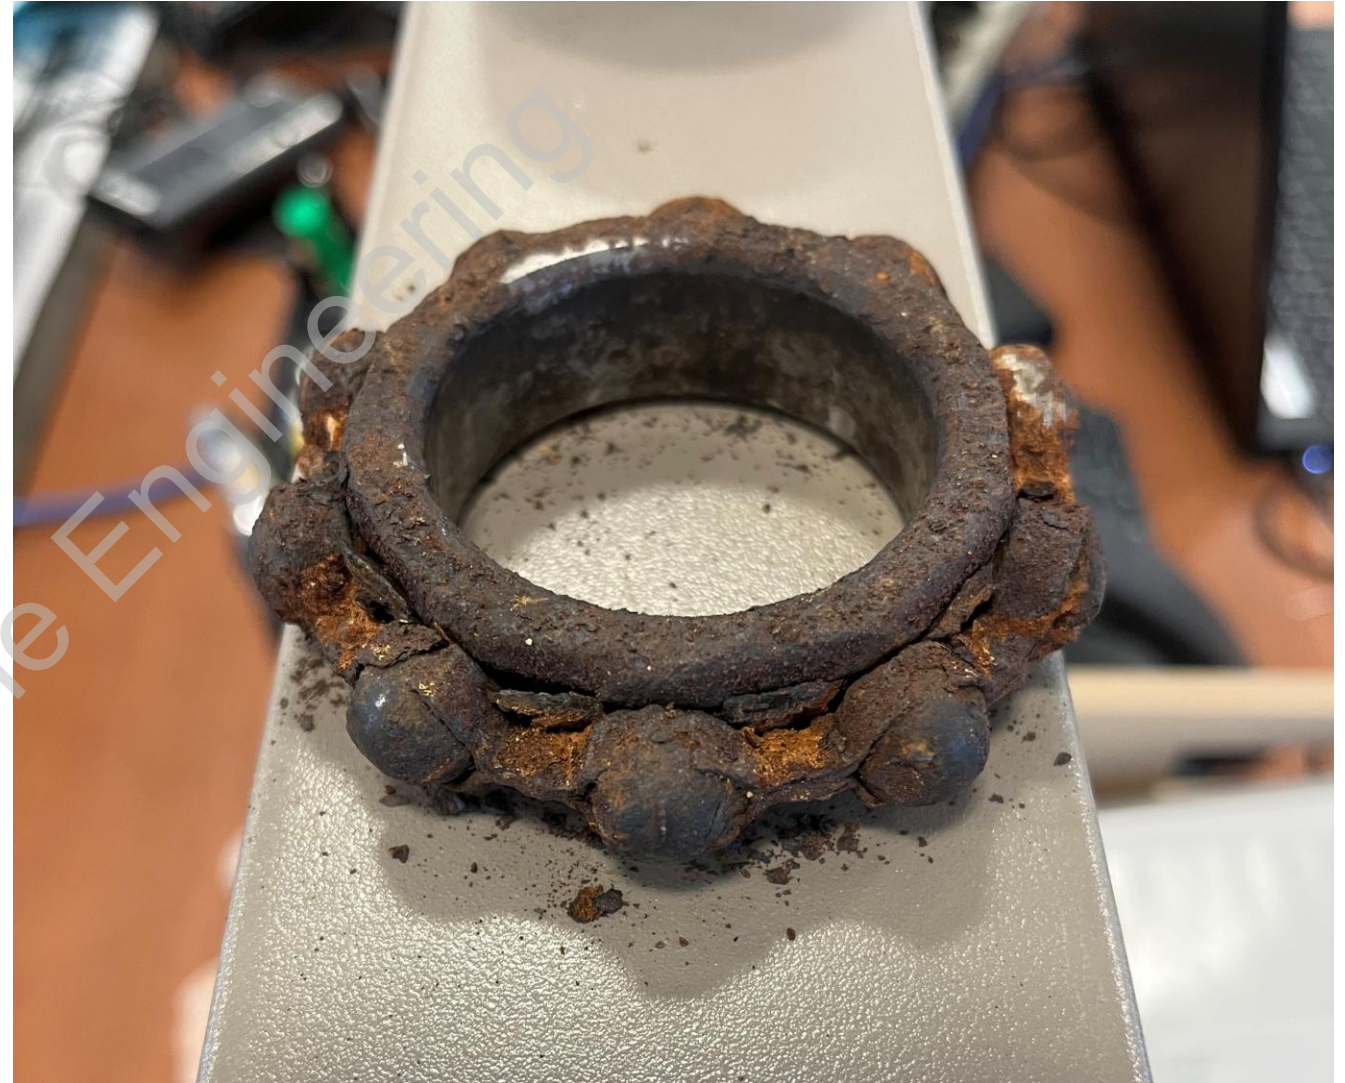
- Third party material testing
- 52100 races
- 400 series balls

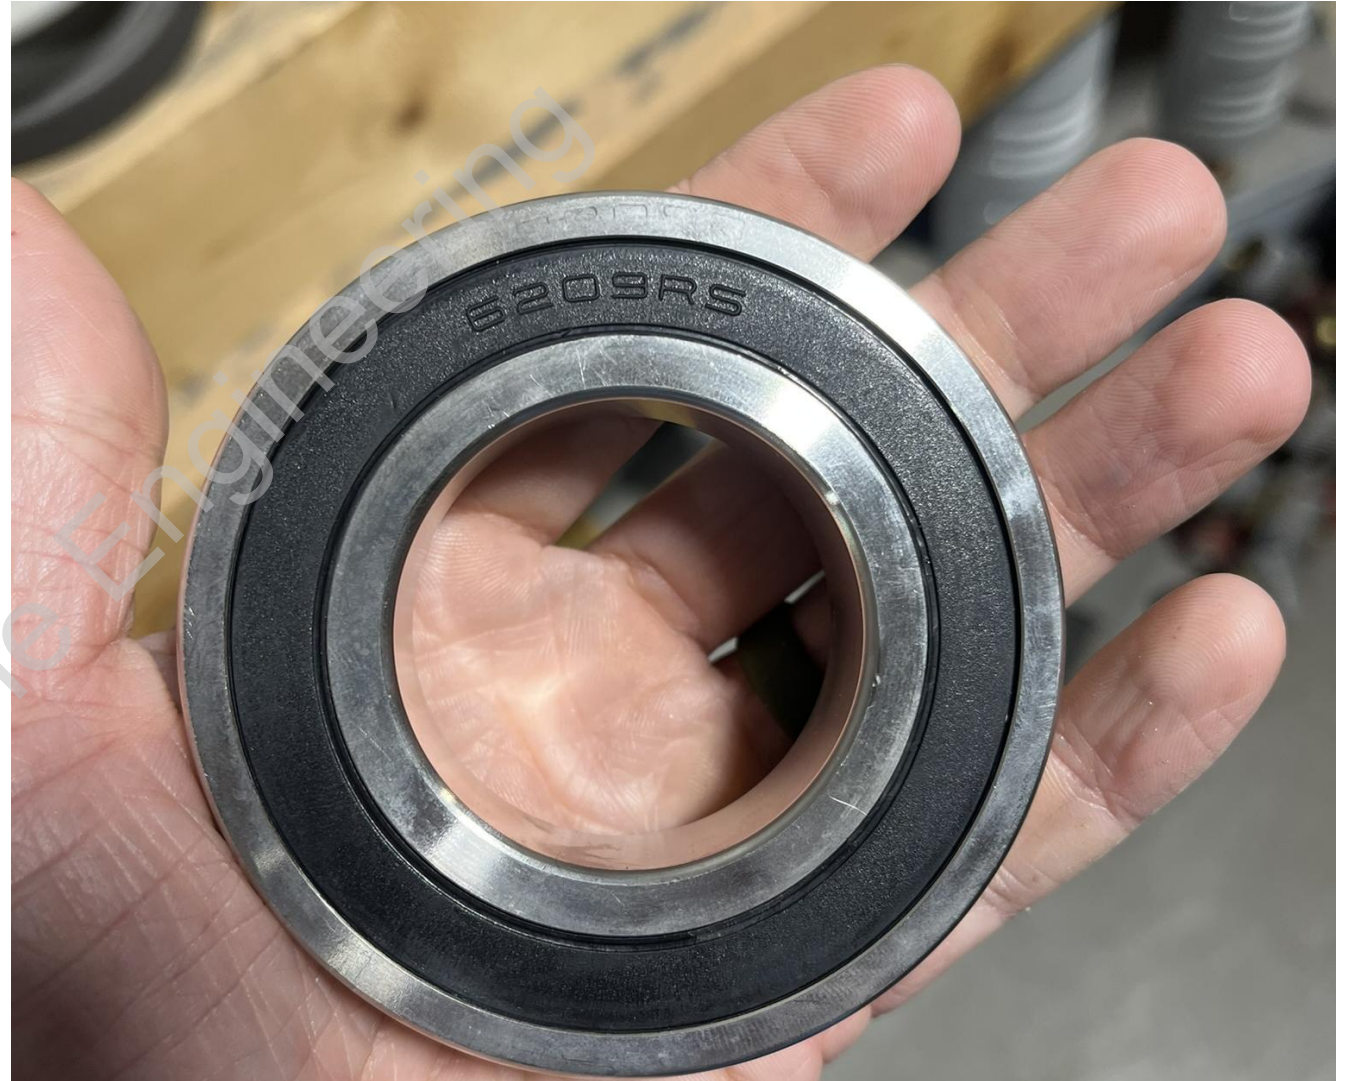
- 6209-2RS ball bearings
- Steel selection
  - Corrosion resistance
  - Mechanical strength
- Mechanical calculations
  - Loading assumptions
    - HMVB
    - Other loads
  - Axial thrust
  - Radial load

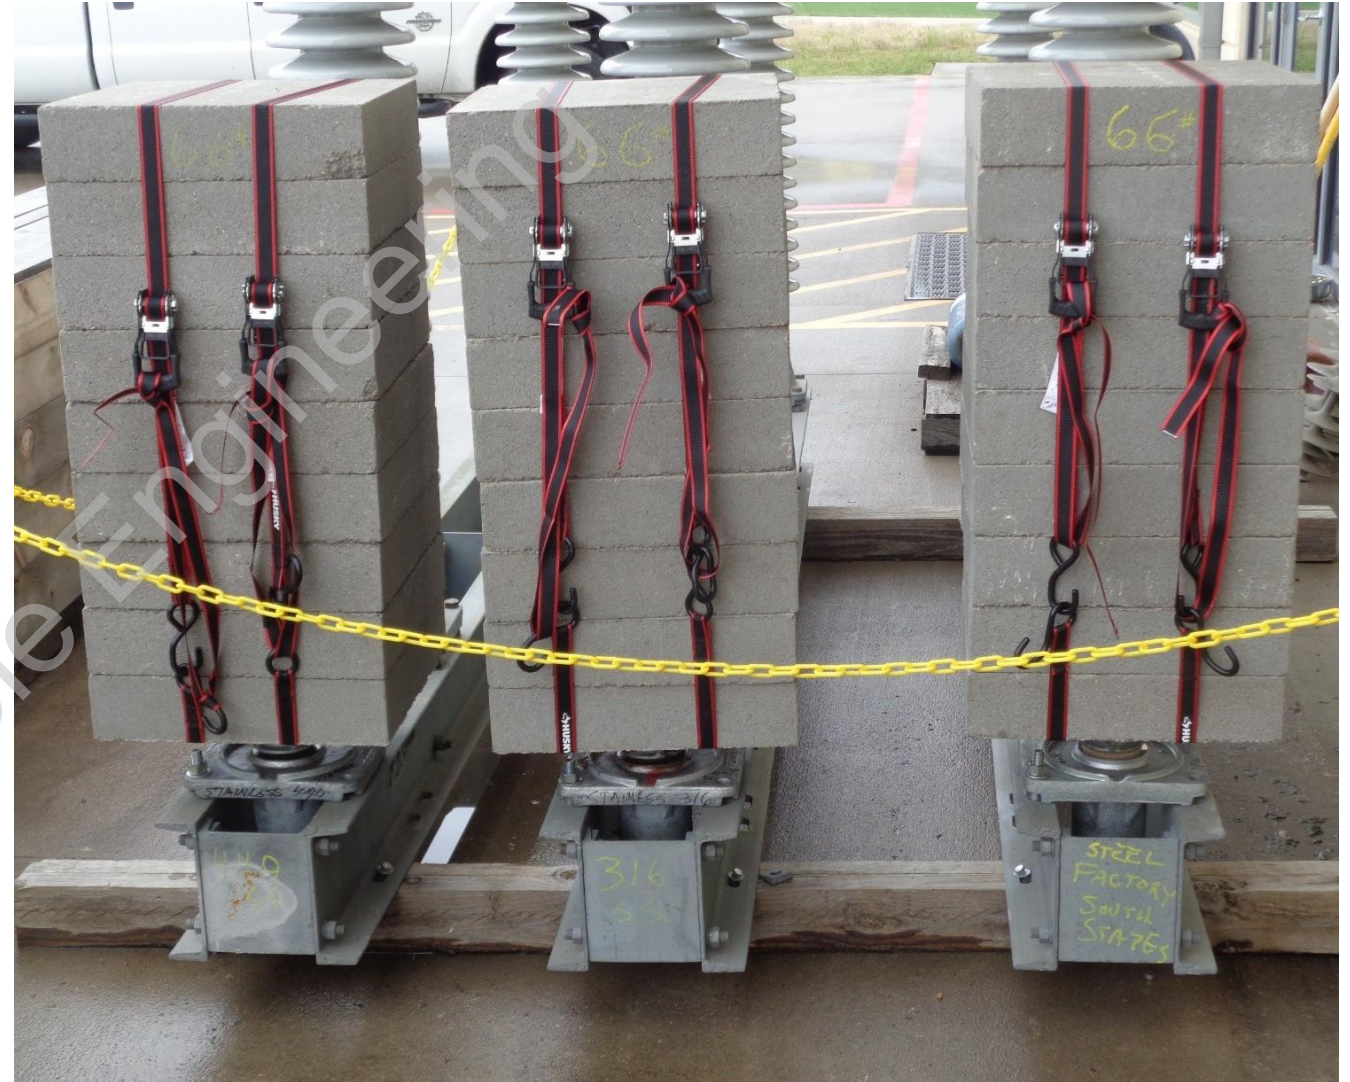
- Non-OEM parts
- Loading assumptions
  - Axial thrust is focus
- 4x weight of insulator
- Side-by-side comparison
- Rotated by hand
  - Regularly to start
  - Left idle
  - 1 year total
  - All passed
