Transformer Design and Sulphur Corrosion: The Missing Link?

**Simon Ryder
Doble PowerTest**

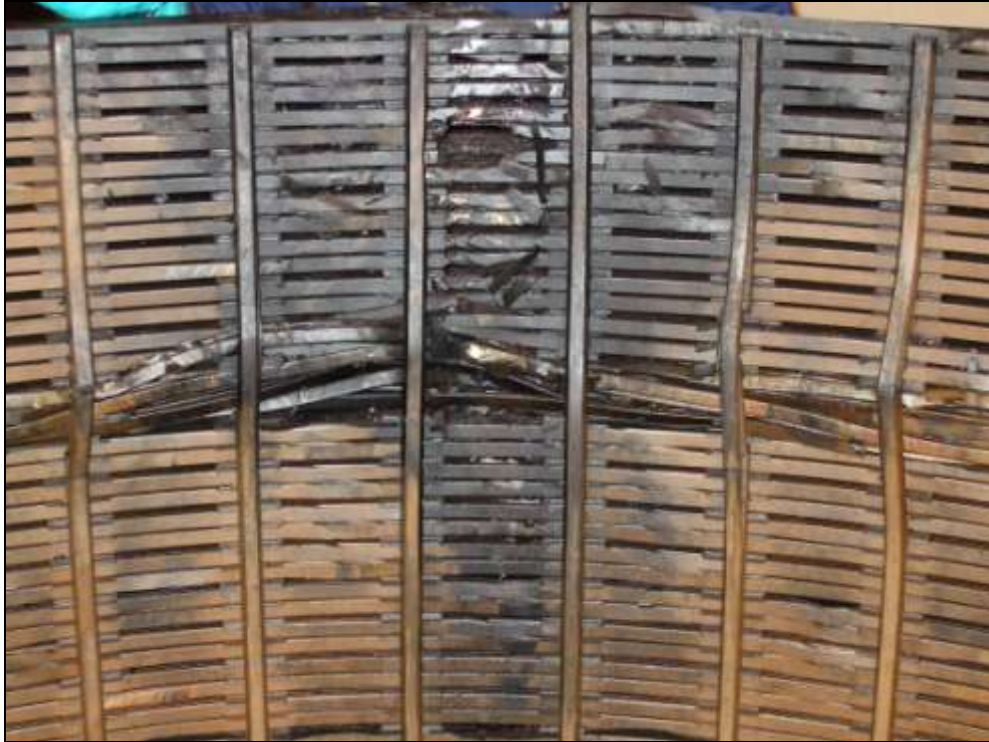
The top eighteen discs of the C phase series winding were found to be extensively damaged. The damage was so extensive that it was difficult to tell where the original point of failure was. On examining the A and B phase series windings, the area close to the radial centre of the top discs was found to be suffering from both severe solid insulation aging and severe sulphur corrosion. No other part of the winding was similarly aged. Some sulphur corrosion was found elsewhere in the series windings, although this was rather less severe.

The series winding was a centre-entry interleaved disc design, wound from double flat conductors. As is standard practice with most manufacturers, the separators between double-discs were substantially thicker than the separators within double discs. The radial width of the winding was such that little if any oil could reasonably be expected to circulate through the ducts within the double discs under ON conditions, therefore each disc was cooled on one side only. The discs at the end of the windings were therefore cooled by oil flow in the duct between the shield ring and the disc. Unfortunately at the top of the winding, the oil guide had been placed next to the top disc rather than next to the shield ring. This effectively blocked the oil flow in this duct, meaning that the top disc received little if any oil circulation under ON conditions. As can be imagined this created precisely the conditions which favor sulphur corrosion – high temperatures and low levels of dissolved oxygen. The high temperatures also resulted in severe solid insulation aging.

**Case Study 1 – Damage to C Phase Series Winding, General View from Inside
FIGURE 1**

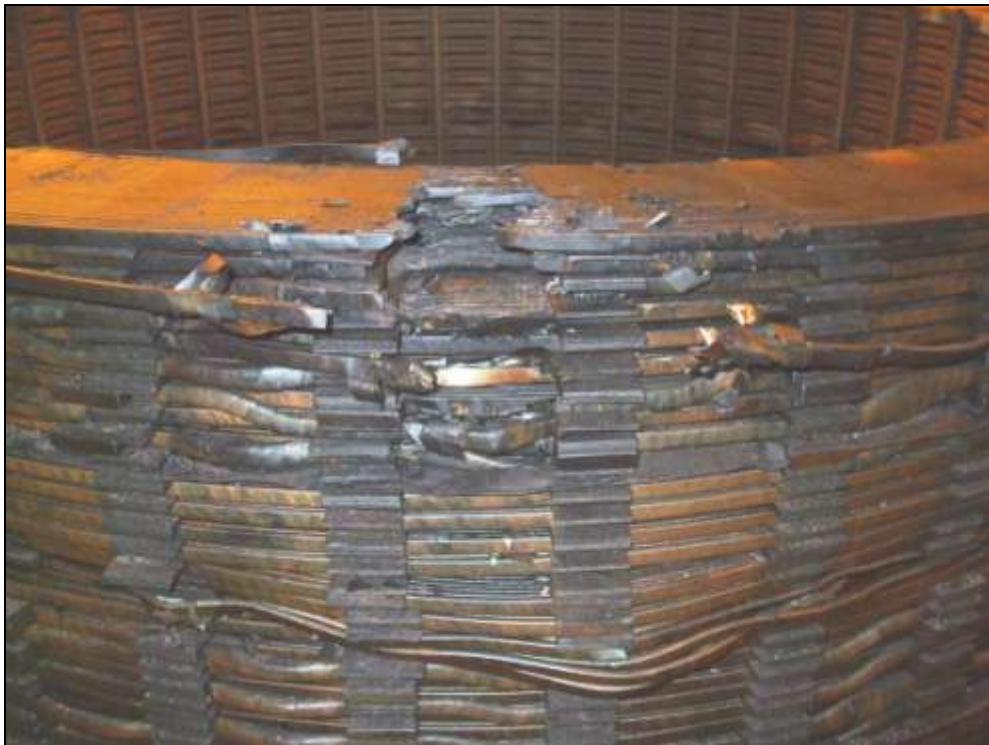
**Case Study 1 – Damage to C Phase Series Winding, General View from Outside
FIGURE 2**

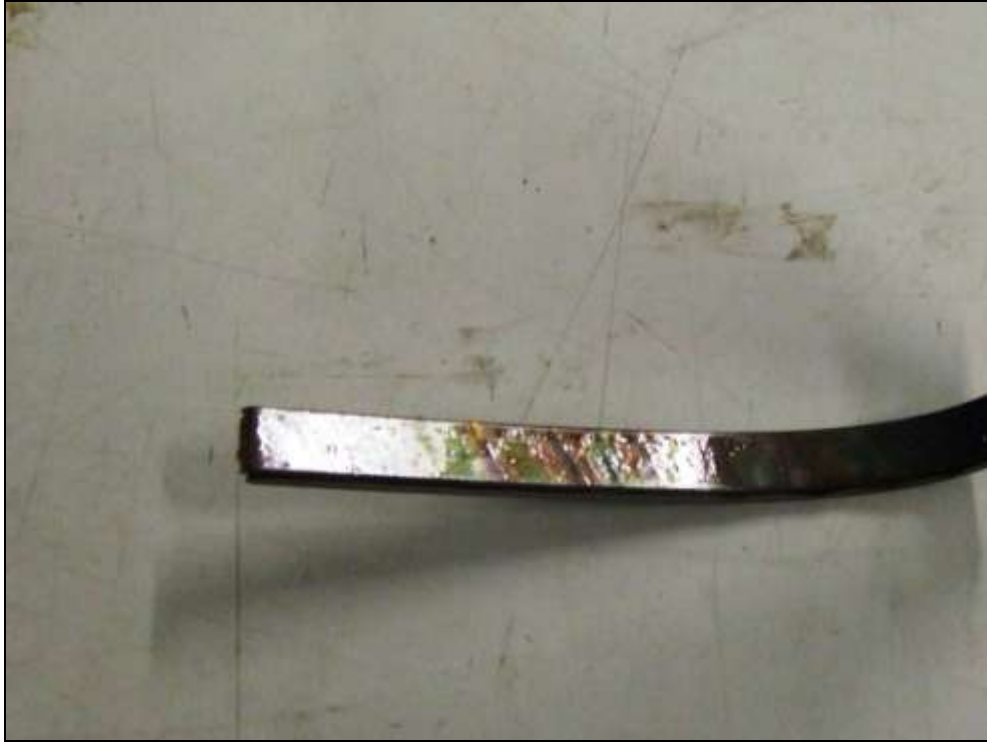
**Case Study 1 – Sulphur Corrosion on Conductor from Top Disc of C Phase Series Winding
FIGURE 3**

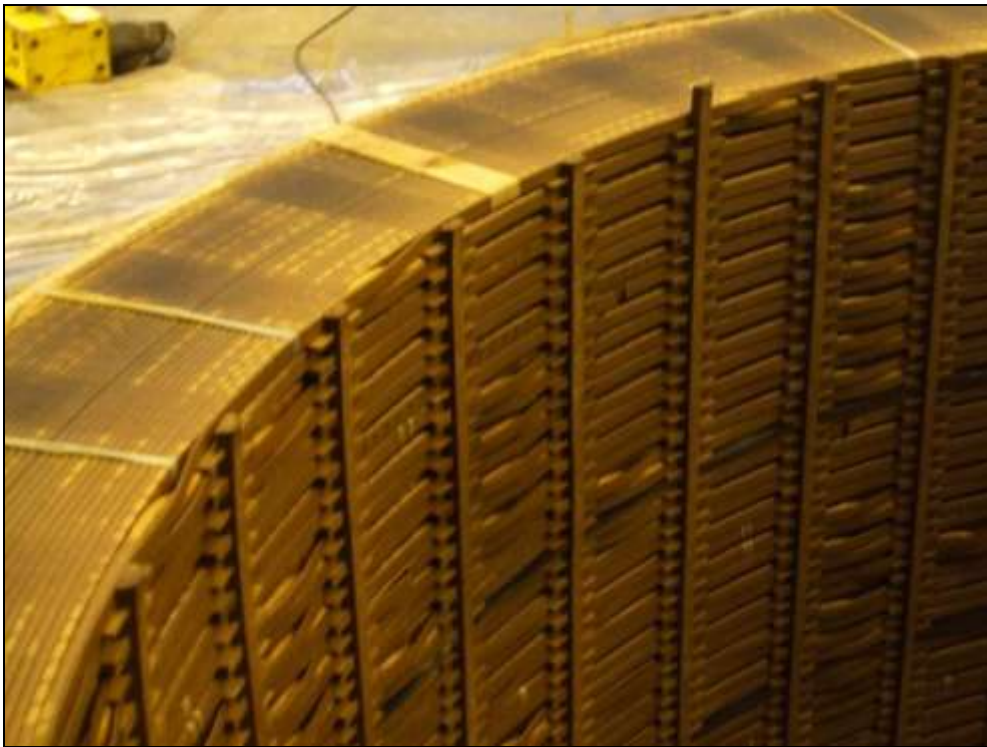
Damage to the C phase series winding is shown in FIGURE 1 and FIGURE 2. Sulphur corrosion on a conductor from the top disc of the C phase series winding is shown in FIGURE 3. A general view of the B phase series winding is shown in FIGURE 4. Note the discoloration close to the radial centre of the top disc. Sulphur corrosion on a conductor from the top disc of the B phase series winding is shown in FIGURE 5.

**Case Study 1 – B Phase Series Winding, General View
FIGURE 4**

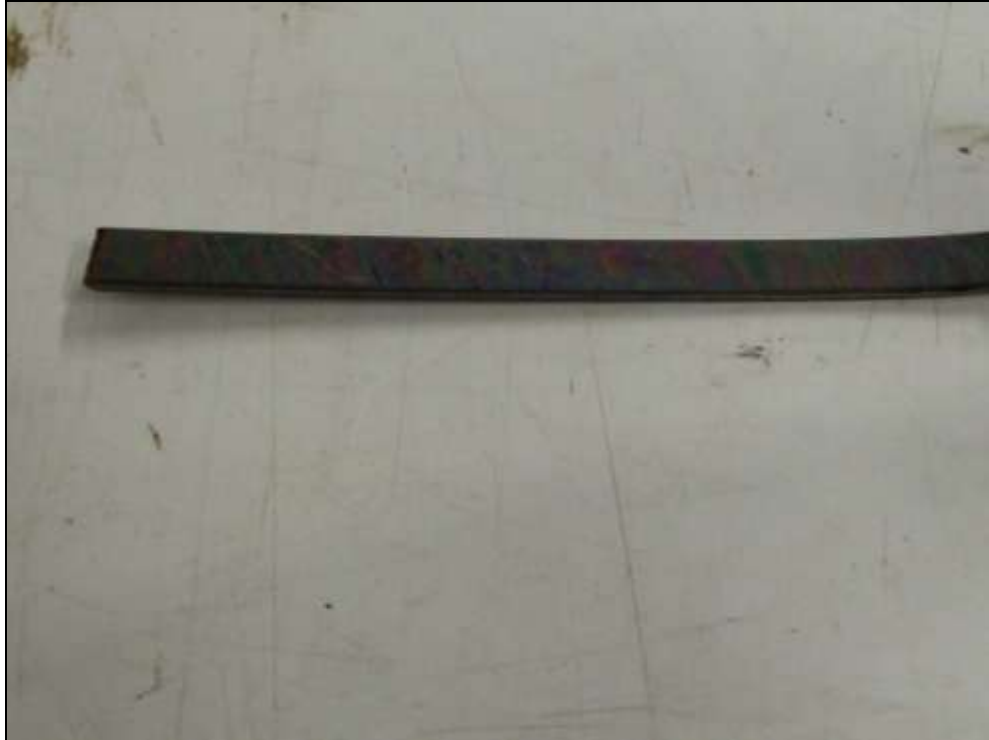
**Case Study 1 – Sulphur Corrosion on Conductor from Top Disc of B Phase Series Winding
FIGURE 5**

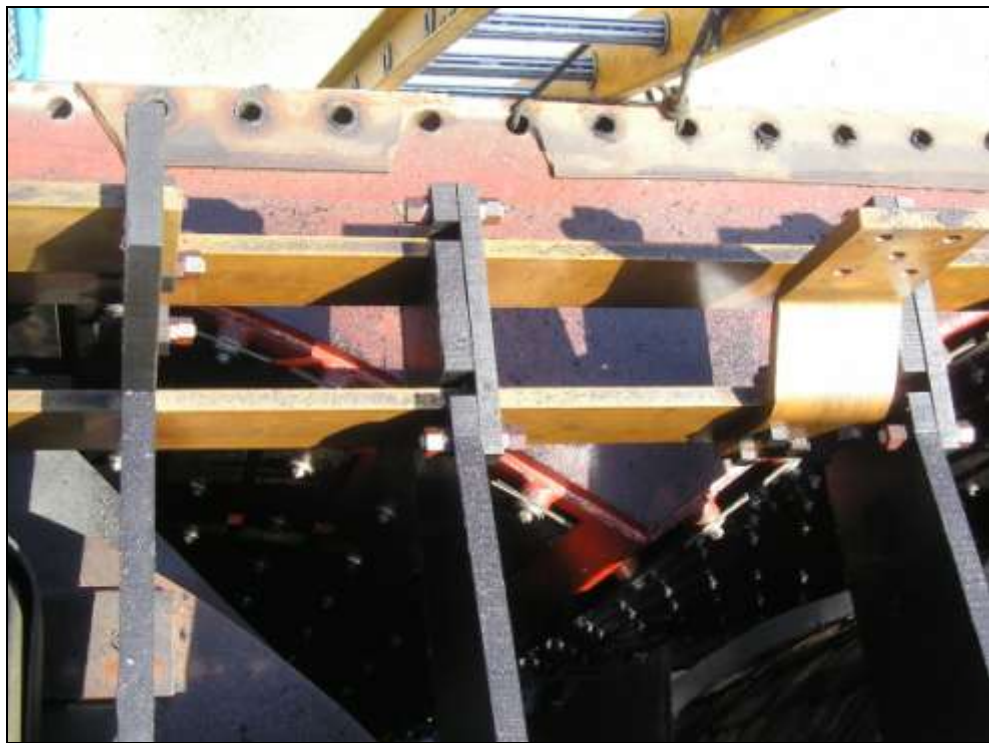
On examination it was found that the main-tank lid flange of the transformer was very leaky on the LV side of the transformer. The gasket was found to be badly deteriorated. It was found that the LV busbars ran close to the tank flange, resulting in image current heating and the gasket deterioration and leaks observed. It has been necessary to top the transformer up with new oil at regular intervals. The main tank-lid flange may have been the origin of the thermal fault indicated by the dissolved gas signature.

**Case Study 2 – LV Busbar Arrangement
FIGURE 6**

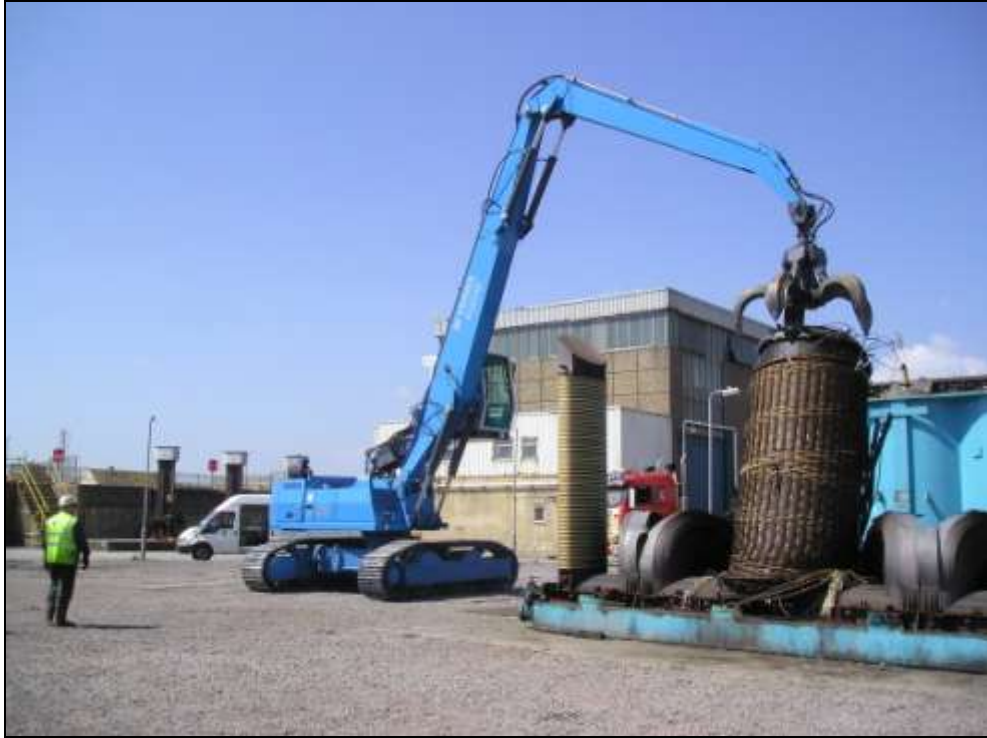
Large quantities of debris from the B phase HV winding, including copper globules, were found spread throughout the transformer. When the scrapping contractor attempted to remove the B phase winding assembly for further examination, it collapsed onto the core. This limited the scope of the inspection somewhat. Damage to the B phase HV winding was very severe. A large proportion of the conductors in discs close to the axial centre of the winding had melted. The melting was worst close to the radial inside of the winding. Consequential damage, including melting of conductors, had affected much of the rest of the winding.

**Case Study 2 – Scrapping Contractor Removing Damaged B phase Windings
FIGURE 7**

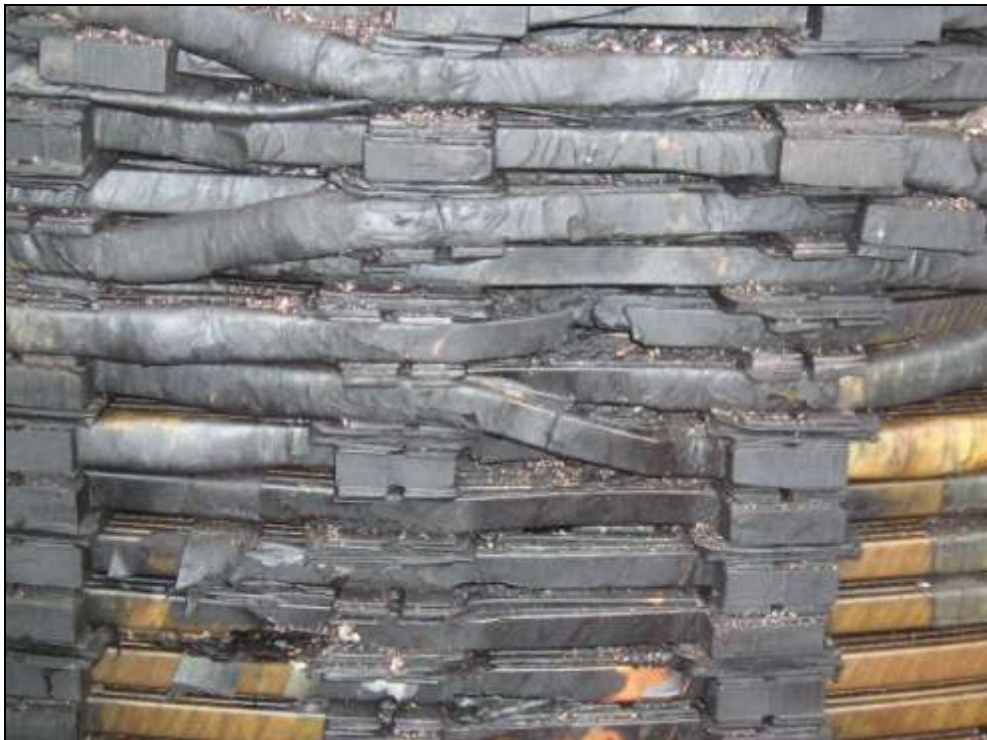
**Case Study 2 – Damage to B Phase HV Winding, Close-up
FIGURE 8**

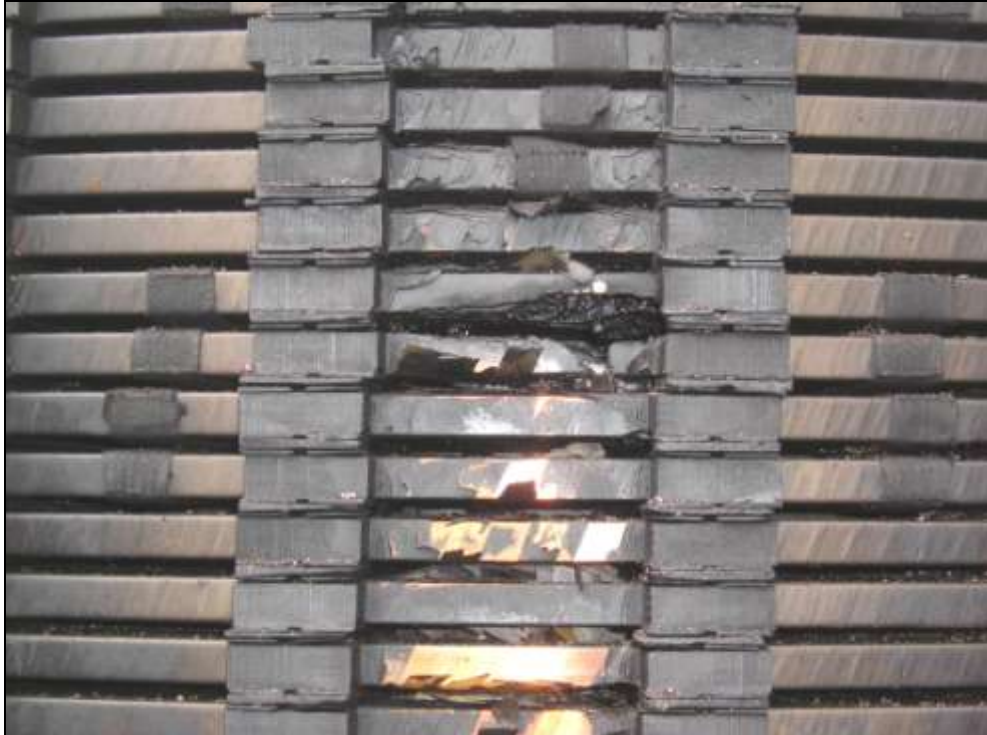
**Case Study 2 – Consequential Damage to B Phase HV Winding, Close-up
FIGURE 9**

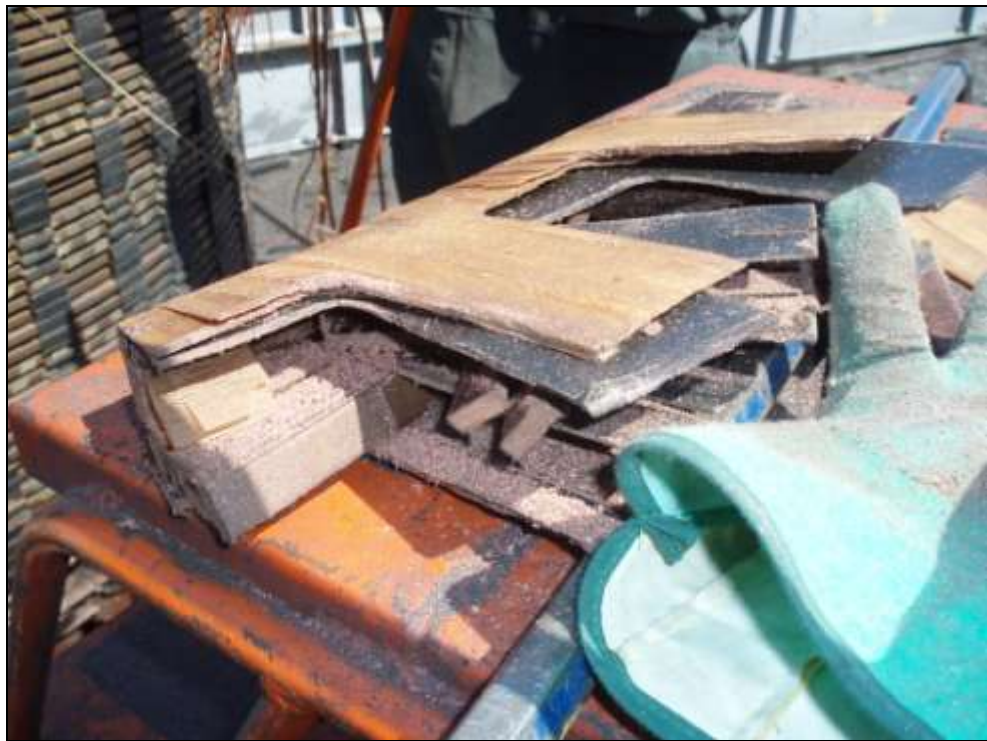
The HV winding was a centre-entry interleaved disc design, wound from flat conductors. It had been assembled from individual double-discs. The double-discs closest to the line end, which was at the centre of the winding, had been over-wrapped with crepe paper. Much of the crepe paper had then been cut away from the radial outside of the winding, although not the radial inside. This crepe paper restricted the oil flow and acted as thermal, as well as dielectric, insulation. Furthermore there were no axial laths at the radial inside of the HV winding to make a cooling duct. Axial oil flow was via two axial ducts in the discs themselves and an oil duct formed by axial laths at the radial outside of the winding. The inner third of the winding thus received little oil flow, especially close to the line end. This created precisely the conditions which favor sulphur corrosion – high temperatures and low levels of dissolved oxygen. The high temperatures also resulted in severe solid insulation aging.

Examination of the other two HV windings revealed both severe solid insulation aging and severe sulphur corrosion close to the radial inside of the winding in the over-wrapped area.

**Case Study 2 – Over-wrapping from A Phase HV Winding
FIGURE 10**

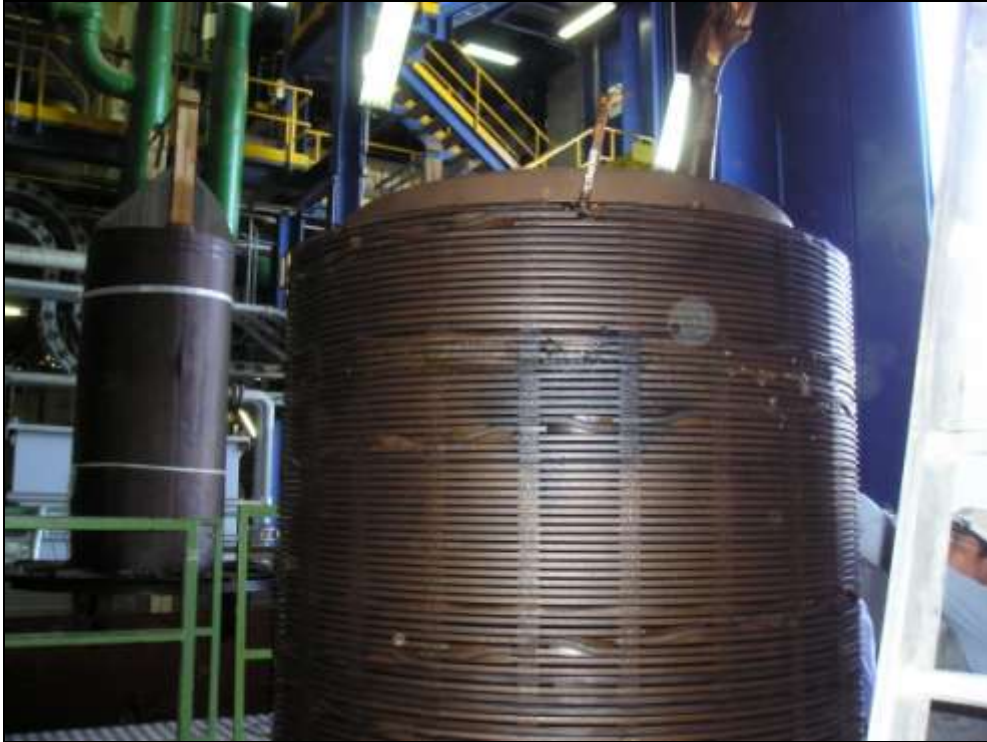
The V phase HV winding is shown in FIGURE 11. Note that there are sixteen discs between oil guides. A limit of ten is widely used within the industry, although not by this manufacturer. The point of failure is shown in FIGURE 12. Sulphur corrosion on conductors from the same disc is shown in FIGURE 13.

**Case Study 3 – V Phase HV Winding
FIGURE 11**

Manufacturers and operators are therefore advised carefully to review designs to ensure that all parts of windings receive sufficient oil flow. The correct positioning of oil guides is of particular importance. It is worth some discussion during design review meetings.

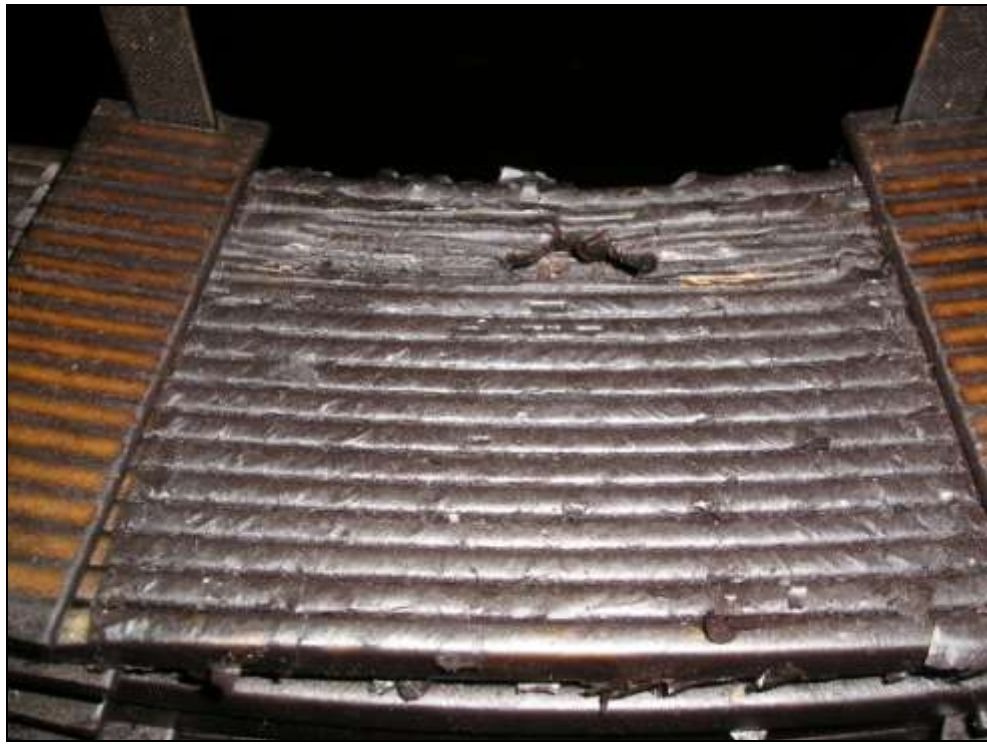
A more detailed examination of the windings was possible during the rewind. This revealed that the cause of the failure was an inter-turn fault in the V phase HV winding, in the disc immediately below the first oil guide from the top of the winding. This disc was found to be suffering from severe solid insulation aging and severe sulphur corrosion.

**Case Study 3 – Point-of-failure
FIGURE 12**

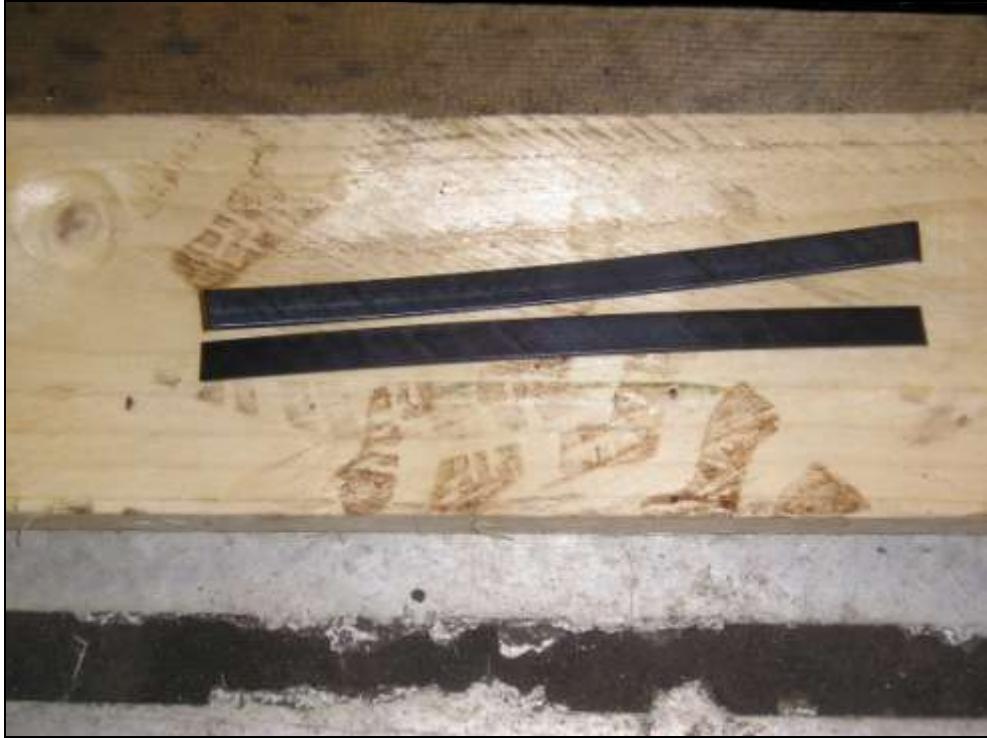
Case Study 3 – Sulphur Corrosion on Conductor Adjacent to Point-of-failure
FIGURE 13

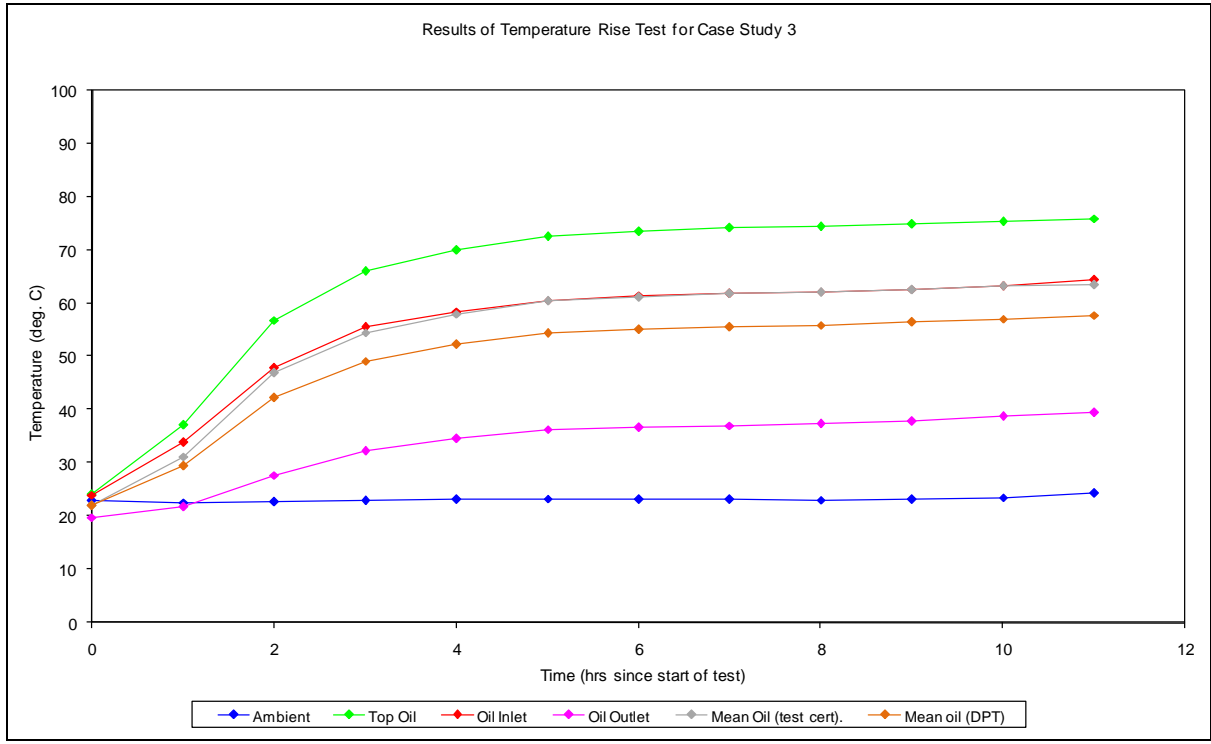
FIGURE 14

The operator provided Doble PowerTest with a copy of the temperature rise type test certificate for review. According to the test certificate the transformer passed the test by a wide margin. However, in the opinion of Doble PowerTest there are a number of irregularities in how the raw results were interpreted. The most important of these is derogation from the method given in IEC standard 60076-2 for calculating mean oil temperature rise. This seems to have been based on the cooler inlet temperature, rather than the average of the top and bottom oil temperatures. Using the IEC standard 60076-2 method gives a mean oil rise around 5K lower. This in turn gives winding temperature gradients 5K higher and a winding hot spot temperature more than 6K higher. According to IEC standard 60076-7, the rate of solid insulation aging doubles for a 6K rise in temperature. The generator transformer failed a little under half-way through its expected useful life.

Some of the temperature rise test results are shown in graphical form in FIGURE 14. Selected results are also listed in TABLE 7.

Manufacturers and operators are reminded that checking the local temperature in windings is now straightforward thanks to the great improvements in fiber optic sensors. Operators are also reminded of the importance of witnessing the temperature rise test and of thoroughly checking the results for any irregularities. Apparently minor irregularities can have significant consequences later.
