"Is it safe?"

By Tony McGrail, Solutions Director: Asset Management and Monitoring Technology at Doble Engineering

There is always pressure to re-energize a power transformer after a fault trips it out – but to do so comes with risks that need to be understood and addressed.

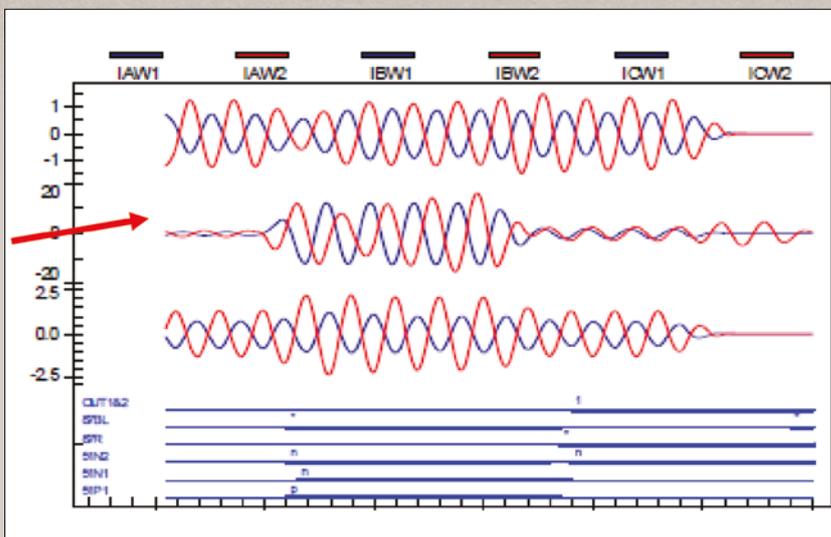
Figure 1. Transformer differential CTs, second fault

The subsequent fault on a different line was also on the B-phase, which initially showed a 180° out of phase pattern, which quickly moved to 132°, which represents

a fault inside the transformer's differential zone taking some current to the ground. The associated line-locked out on over-

current protection, but the transformer B-phase currents come into phase, as the internal fault dominates, with the trans-

B phase is identified with the red arrow. The currents start out 180° out of phase but slowly become in phase, showing an external fault becoming an internal fault.

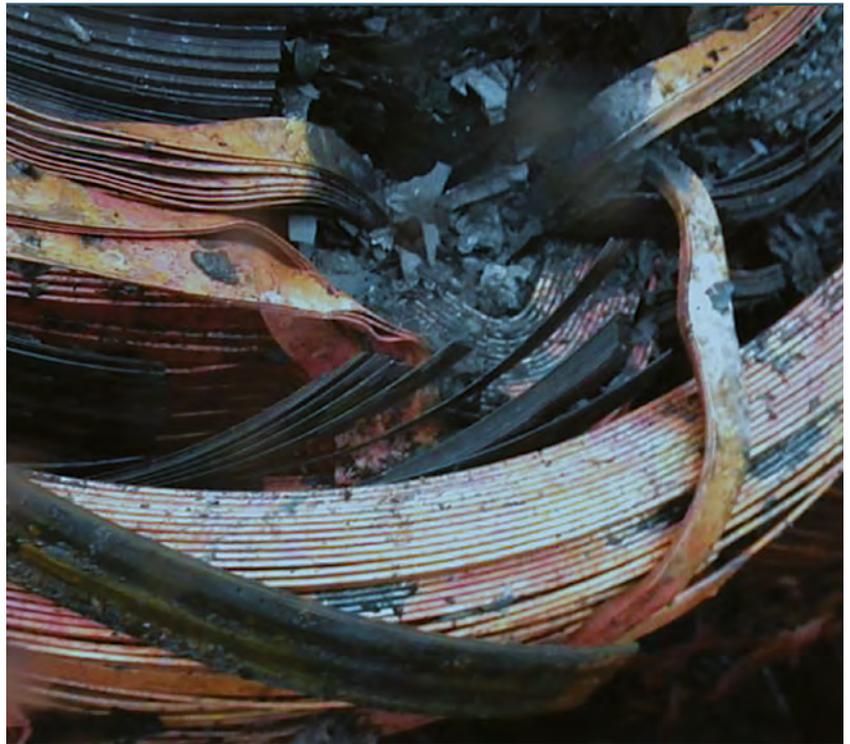
Figure 2. B-phase winding showing radial buckling damage with no shorted turns

The three-phase equivalent is possibly acceptable, being within the Doble recommended guide of 3 %, but the per-phase equivalent is off from the per phase mean by 6.6 %; this was supported

by the reactance for the B-phase being almost 10 % higher than expected. The message of the leakage reactance is clear – a problem in the geometry between the HV and LV windings. Why then only marginal variations in the SFRA? Possibly owing to the presence of a radial buckle with no shorted turns – this could have caused the change in CL earlier and is less detectable using SFRA alone – hence the application of SFRA and leakage reactance in tandem.

The data could support a scenario where: the second of two close in faults caused a B-phase winding failure; a radial buckle outward into the leakage channel; no shorted turns, thus maintaining the bulk of the insulation integrity; an internal flashover producing raised key gas levels, most notably acetylene.

A subsequent teardown of the transformer showed significant radial buckling on the B-phase – with no shorted turns, as shown in Fig. 2. This explains all the findings. The fault was not ‘visible’ with standard electrical tests but was found using ‘advanced’ tests. Deep analysis of all results, taken as a whole and in the context of the location and application of the transformer, gave a credible picture of internal winding deformation of a specific type and location.

It was decided that re-energization would be inappropriate, and replacement of the transformer was planned. Further motivating the decision to replace the transformer was the proximity of a spare unit, possible exposure of personnel at the station to a catastrophic failure, the system importance of the transformer, and the high-profile regional construction project ongoing at the station.
