UPDATE ON THE CORROSIVE SULFUR ISSUE IN OIL-FILLED ELECTRICAL EQUIPMENT

by
Lance R. Lewand and Paul J. Griffin
Doble Engineering Company

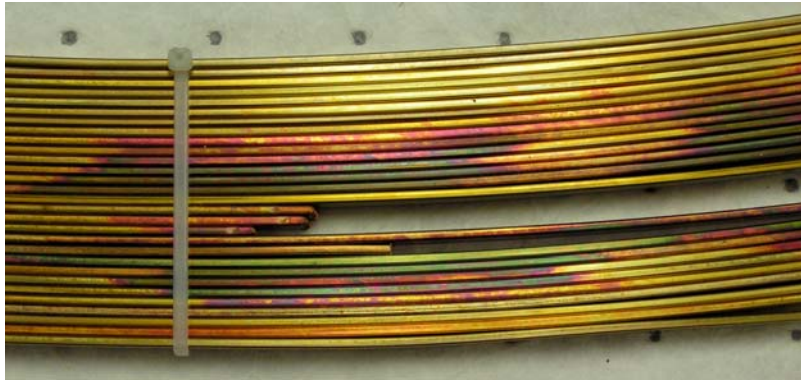
EVIDENCE OF COPPER SULFIDE, PURPLE, GREEN, BLUE AND GREY DISCOLORATION OF CONDUCTOR FROM TRANSFORMER WITH FOUR YEARS OF SERVICE
FIGURE 1

To date the best means for detecting corrosive sulfur problems have been by internal investigation. Testing of the oil can determine if the apparatus could develop a problem, but it is the internal inspection that has revealed the evidence of copper sulfide formation. Often the most visible evidence is on copper surfaces. If there is exposed copper, the tarnish will be visible. As the tarnish gets worse it turns gray and can be mistaken for carbon from overheating or a failure. Unwrapping the copper conductor can reveal further tarnish. The amount of corrosion is not uniform in a disk (as can be seen in Figure 1), or throughout the windings.

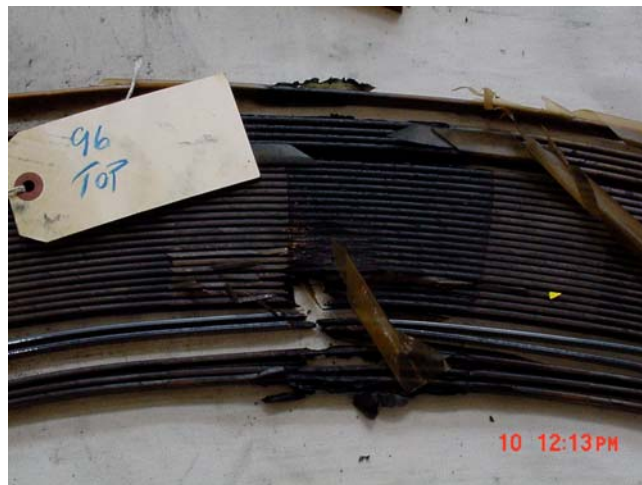
EVIDENCE OF DISCHARGE ACTIVITY ON A DISK FROM A FAILED TRANSFORMER
FIGURE 2

The second mechanism appears to be the cause of the recent rash of failures. It is believed that over time, particularly at warmer temperatures, corrosive sulfur in the oil or sulfur compounds that become corrosive reacts with copper, silver and other reactive metals to form metal sulfides. Most of the sulfides are formed with copper. Although the mechanism is still unclear, it appears that the copper sulfide is deposited on the paper or formed when copper ions migrate to the insulating paper and react with corrosive sulfur compounds to form copper sulfide deposits. It is also believed that some of the copper sulfide on the conductors is physically deposited by contact with the adjacent paper insulation. The copper sulfide causes a reduction in the dielectric breakdown strength of the paper which if sufficient can result in arcing between two or more strands and a subsequent burn through (failure) (Figure 2) [2].
