UNDERSTANDING CORROSIVE SULFUR PROBLEMS IN ELECTRIC APPARATUS

Paul J. Griffin and Lance R. Lewand
Doble Engineering Company

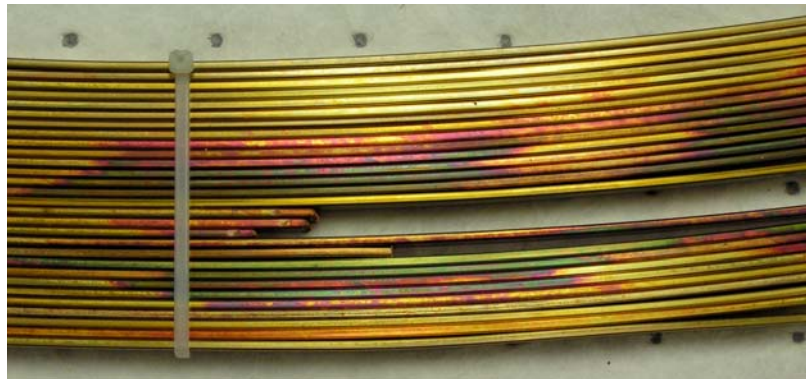
Evidence of Copper Sulfide, Purple, Green, Blue and Grey Discoloration of Conductor
FIGURE 1

These failures have occurred even though the oils, in most or all cases, passed internationally recognized industry specifications at the time for the corrosive sulfur test including ASTM D 1275A or DIN 51353. The problem occurs because the corrosive sulfur reacts with copper conductors (FIGURE 1) and silver contacts, to form metal sulfides that contaminate the insulating paper [1]. This section of the high voltage disk was from a transformer that failed after four years of service. Since the metal sulfides are conductive, the dielectric breakdown strength of the paper is reduced. Under some conditions, a breakdown occurs through the insulation between conductor strands on a disk or between disks (FIGURE 2). This ultimately leads to the failure of the apparatus. Another failure mechanism is the flaking of copper sulfide from the conductor that then bridges across electrical insulation.

To date the main means for detecting corrosive sulfur problems have been by internal investigation. Testing of the oil can determine if the apparatus could develop a problem, but it is the internal inspection that has revealed the evidence of copper sulfide formation. Often the most visible evidence is on copper surfaces. If there is exposed copper, the tarnish will sometimes be visible especially in areas where there are connections. As the tarnish gets worse it turns gray and can be mistaken for carbon from overheating or a failure. Unwrapping the copper conductor can reveal further tarnish. The amount of corrosion is not uniform in a disk (as can be seen in FIGURE 1), or throughout the windings.

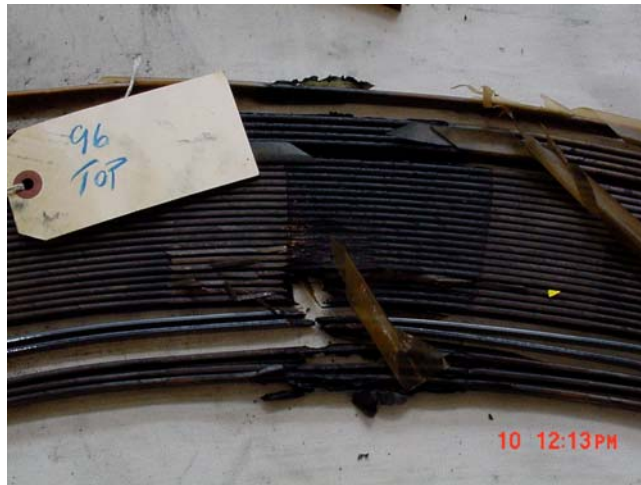
**Evidence of Discharge Activity on Disk from Failed Transformer
FIGURE 2**

The second mechanism appears to be the cause of most of the recent rash of failures. It is believed that over time, particularly at warmer temperatures, corrosive sulfur in the oil or sulfur compounds that become corrosive reacts with copper, silver and other reactive metals to form metal sulfides. Most of the sulfides are formed with copper. Although the mechanism is still unclear, it appears that the copper sulfide is formed on paper in two ways. One is by reactions of soluble copper or copper compounds with sulfur compounds on the paper layer surfaces that then continue to grow on themselves. The other is by deposition from the metal surface over to the adjacent paper surface in close contact with it. The copper sulfide causes a reduction in the dielectric breakdown strength of the paper, which if sufficient, can result in arcing between two or more strands and a subsequent burn through dielectric failure as is shown in FIGURE 2 [2].

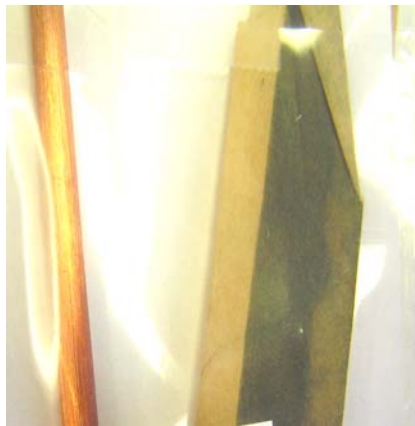
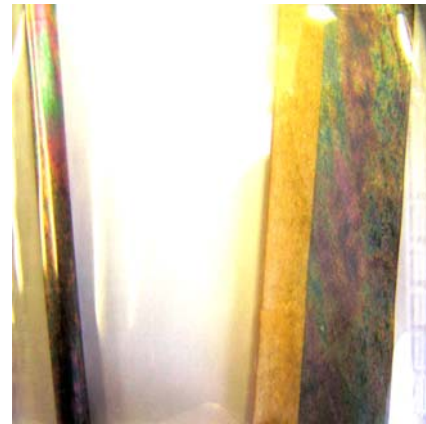
**Deposits of Varying Composition on Paper from CCD Test
FIGURE 9**

In addition to the bare copper test it is important to have a measure of the propensity to form copper sulfide deposits in the paper insulation. For this a covered conductor deposition (CCD) test is used. This test was first described by ABB [3] and has since been used in various forms by other researchers. Doble recommends that the test be performed with both sealed and breathing tubes as oils vary in their deposition behavior as influenced by the amount of oxygen available. This is very important, as we have found some oils will pass the sealed tube test and fail the breathing tube test. It is extremely important to characterize the deposits, as some appear to be relatively benign aging byproducts, while others are copper and copper sulfide deposits. Differences in deposits can be seen from FIGURE 9.

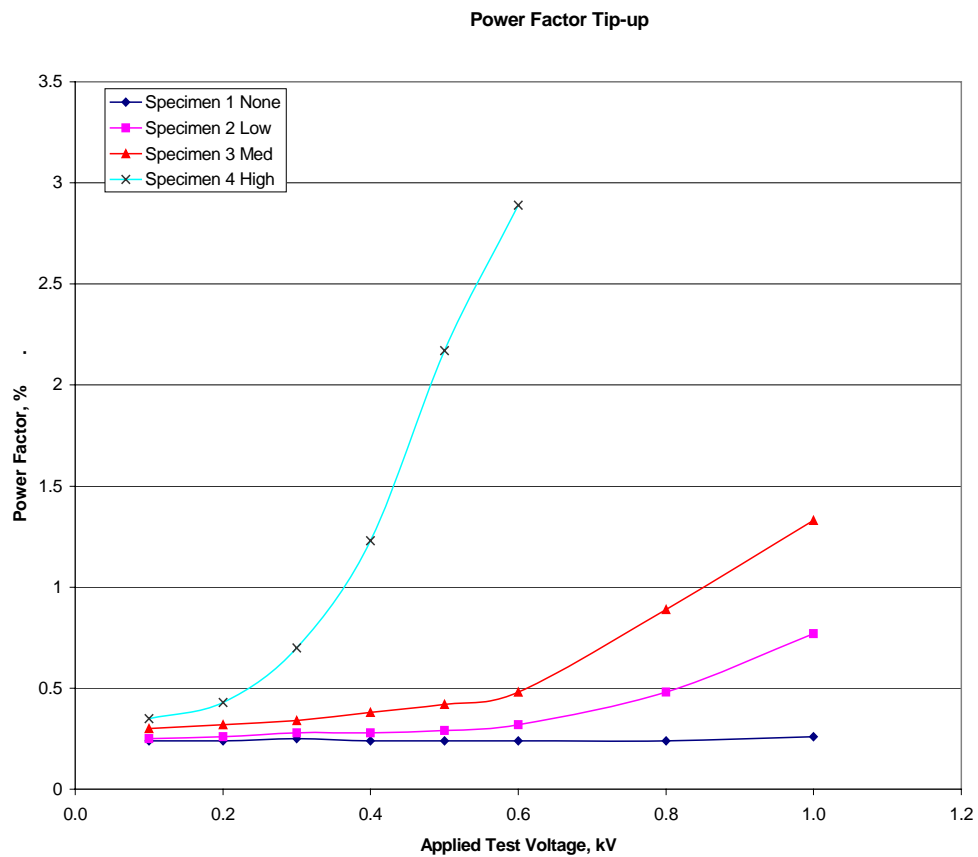
**Power Factor Tip-up of Laboratory-Prepared Oil-Impregnated Kraft Paper
FIGURE 11**

The best indicator of copper sulfide in the solid insulation has been power factor testing. Power factor tip-up, the change in power factor with applied voltage appears to be a distinctive characteristic to certain types of uncommon contamination/deposition such as that from conductive copper sulfide deposits. Normally, oil-paper insulation systems do not exhibit power factor tip-up. Power factor tip-up results from laboratory tests on paper purposely contaminated with purchased copper sulfide are shown in FIGURE 11. The dry oil-impregnated Kraft paper specimens were contaminated with different visible amounts of copper sulfide on the surface and the power factor was then measured. The relative amounts of copper sulfide were given as none, low, medium and high. The results show that the power factor and the tip-up increases with increasing degree of contamination.

To date the best means found for detecting corrosive sulfur in transformers and reactors has been the measurement of the power factor of the main apparatus insulation at high voltages. With high voltage apparatus, insulation power factor tests of the main insulation have been performed up to 35 kV. Tip-up has been detected with some units that have had oils that failed the ASTM D1275B test. The units tested had other characteristics of transformers at risk for corrosive sulfur deposition.
