## DESTRUCTION OF DIBENZYL DISULFIDE IN TRANSFORMER OIL

**Lance Lewand**  
**Doble Engineering Company**

**Scott Reed**  
**Power Substation Services**

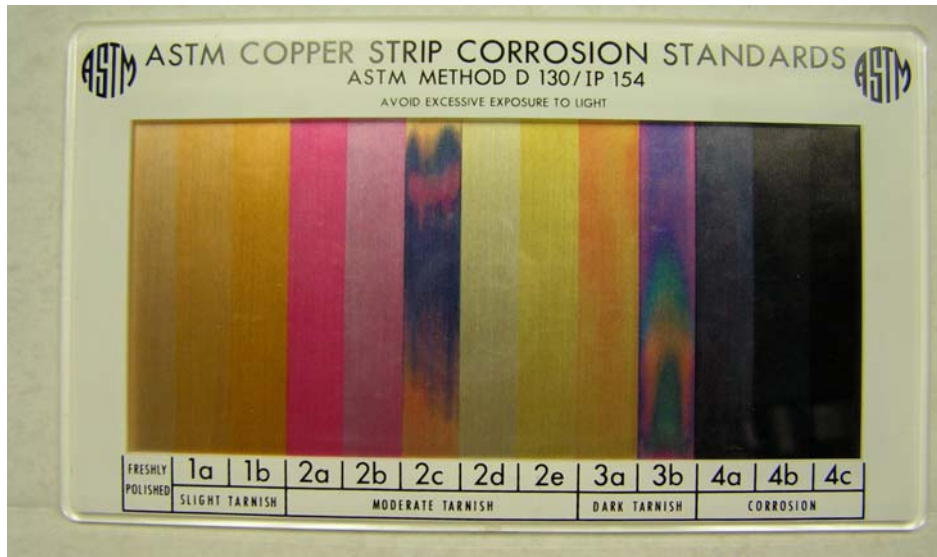
**D 130 Tarnish Level Chart**  
**FIGURE 8**

Figure 8 is a picture of the D 130 scale used to determine the tarnish level as a reference for the results.

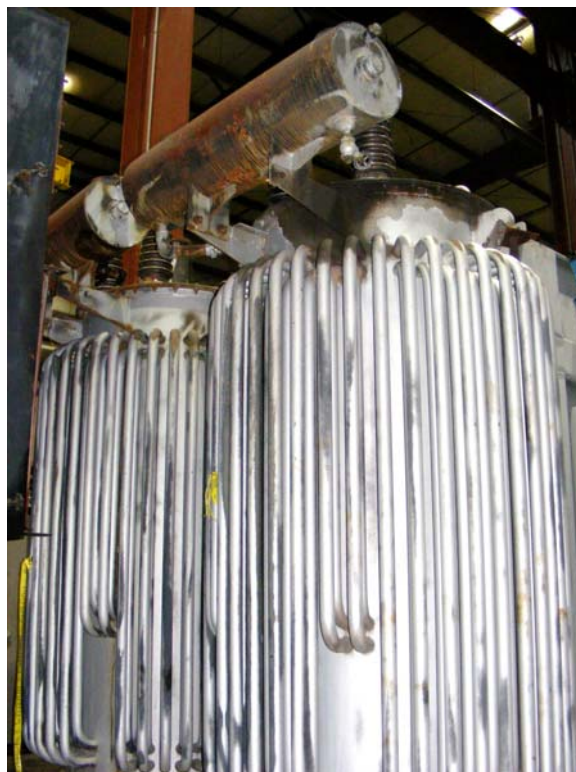
**Photograph of GE Transformers contaminated with DBDS  
FIGURE 11**

Both transformers were single phase, substation type transformers that were retired from service. The primary voltage was 7.2 kV and the secondary voltage was 480 Volts. Each transformer was 667 kVA and contained approximately 350 gallons each. Figure 11 is a photograph of the two sister transformers.

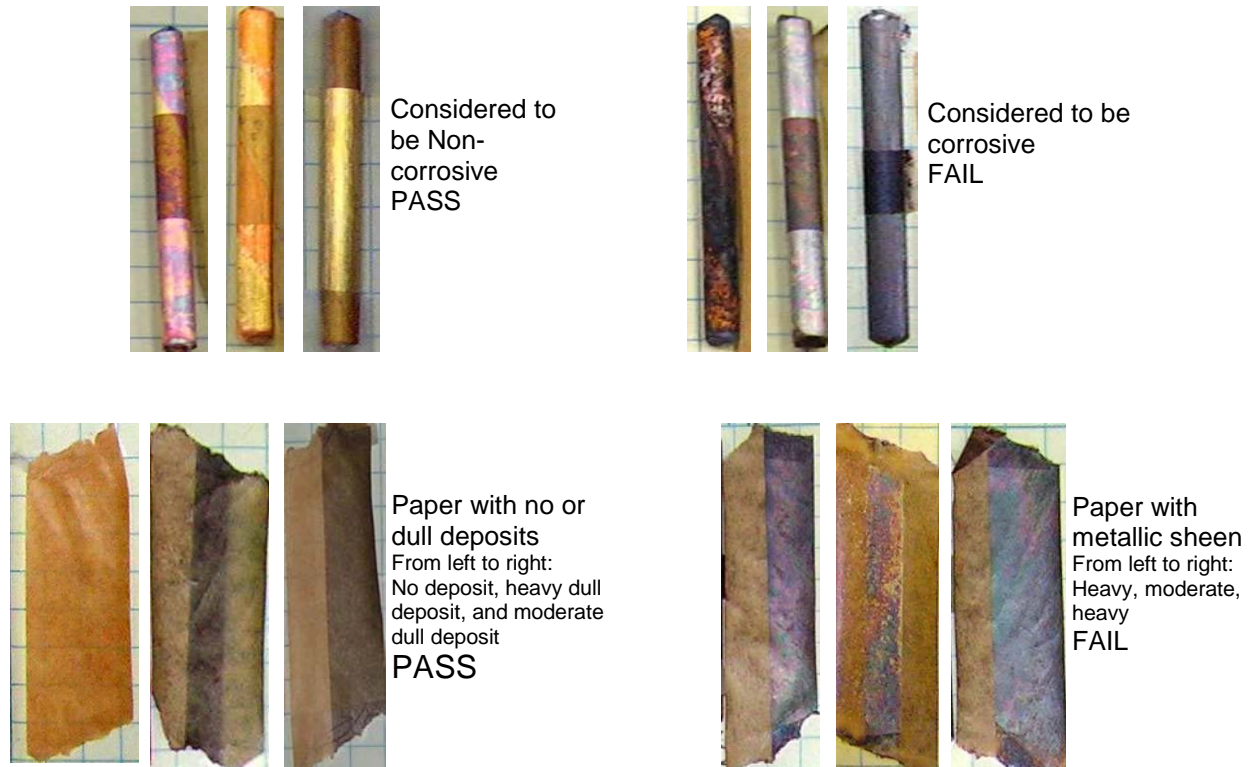
**Examples of Copper and Paper from the Doble CCD Test**  
**FIGURE 1**

The Doble CCD test is performed in two different ways in order to cover different responses to oxygen. Vials with oil and a Kraft paper covered copper rod are used. In one vial, a needle is inserted to allow a moderate amount of oxygen to enter the vial over the duration of the test. In another vial, the cap is completely closed and the only oxygen available is that which was present at the beginning of the experiment. The vials are housed in an aluminum block to maintain a constant temperature. They are aged for 4 days at 140°C. After the test, the paper covered copper rods are removed, cleaned of oil and both the copper and the paper are inspected. The evaluation of the copper rods is done using the ASTM D 1275B/D 130 standards for definition of corrosivity and tarnish level. The paper is inspected for the presence of a deposit. The result "deposition" whether heavy, moderate or light means that there was a visible deposit on the paper but does not characterize this as good or bad. The interaction of the copper, oil, and oxygen with the paper insulation over the duration of the test can result in the formation of deposits of copper sulfide, or copper, or oil/paper degradation byproducts. Many oils form some sort of deposit but some do not pose any risk in service. It is the paper deposits with a metallic sheen that reduce the dielectric strength of the paper that are considered a "fail" from corrosive sulfur and are considered to pose a risk. Other deposits that do not form a metallic sheen are considered a "pass". Figure 1 is a picture of examples from the Doble CCD test.
