# On-line Power Factor Measurement on a 6MVA Cast Resin Transformer

Steve Harpham  
Doble TransiNor As.

John Lapworth  
Doble PowerTest Ltd.

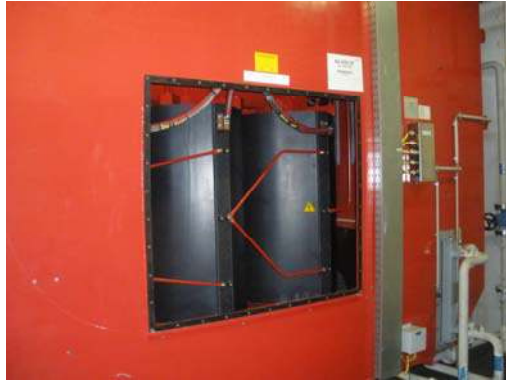
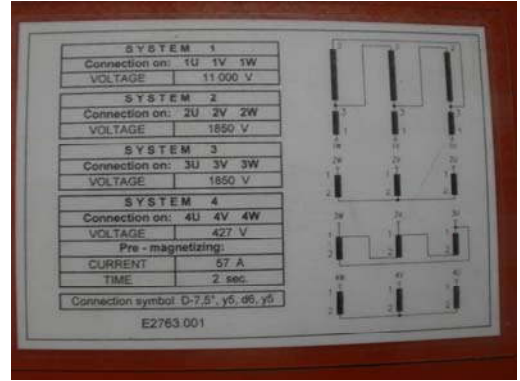
Instead of bushings, the monitoring on this transformer is of the insulation between the high voltage winding and the normally-grounded electrostatic shield. This shield is designed to prevent high frequency noise, generated by the rectifier/motor control system, feeding back into the primary winding and from there into the ship's network.

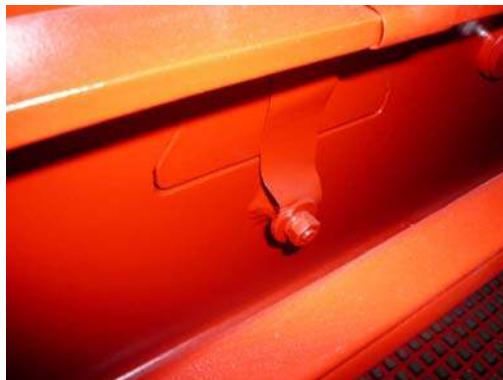
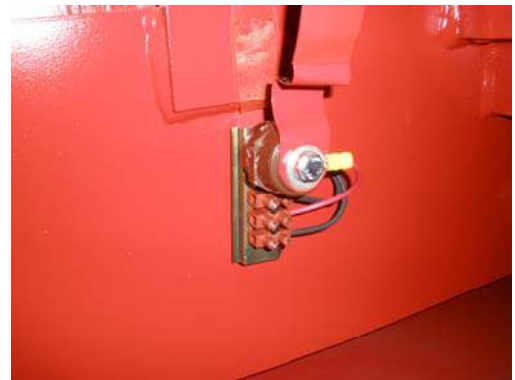
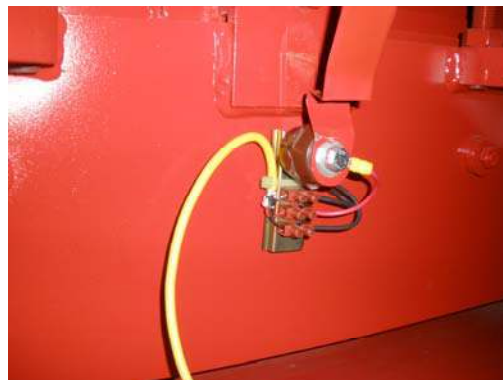
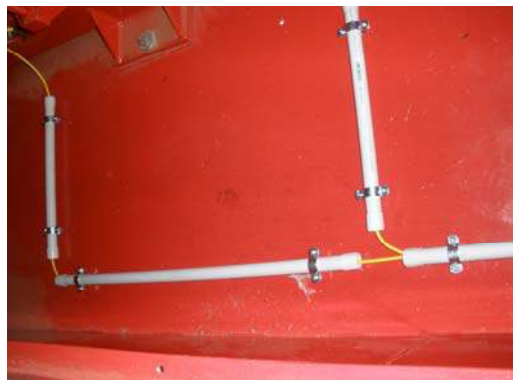
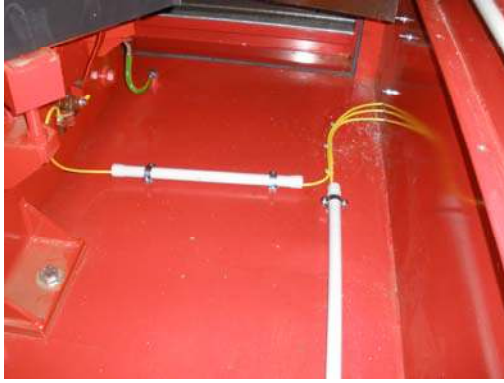
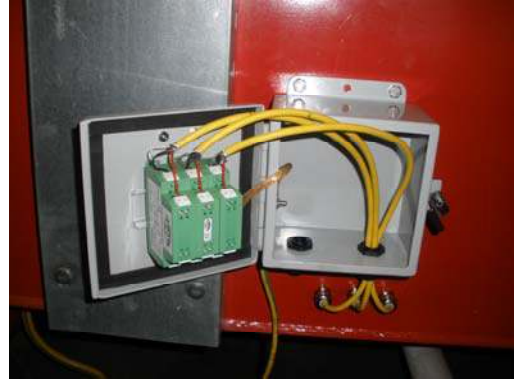
In order to make connection to the shields on each phase, the copper foils normally bolted to the frame were removed and isolated using custom-made brackets with terminal strips and insulating stand-offs. See photos below.

Engineers ran cable via conduits installed in the base of the transformer housing from the terminal strips to the CT sensor enclosure mounted on the outside. See photos above.

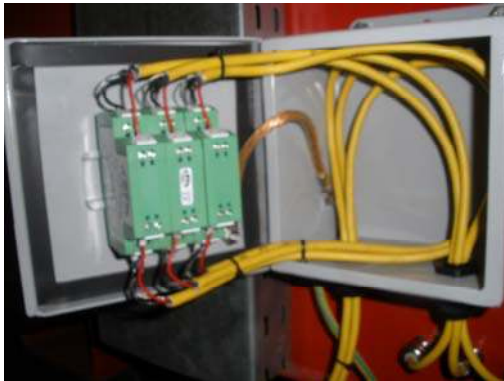
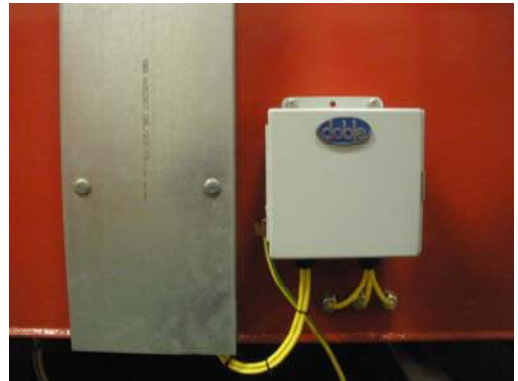
Allseas engineers then mounted the IDD and ran cable from the sensors to the shorting block. See photos below.

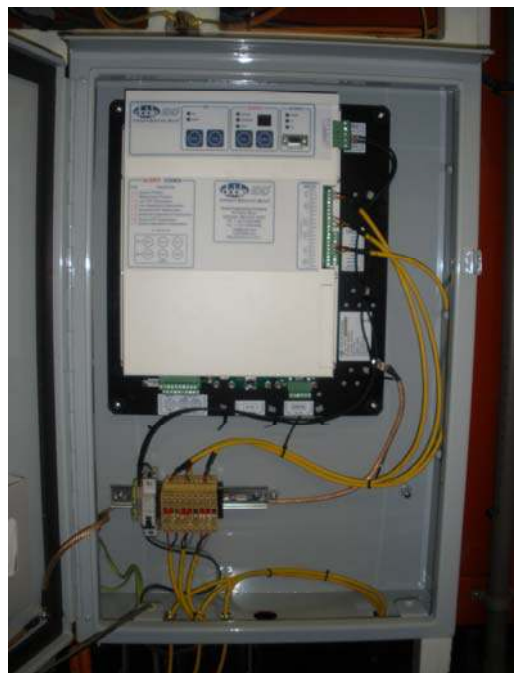
The addition of an extra ground wire and some tidying of the cables remained to be done in the photo right.

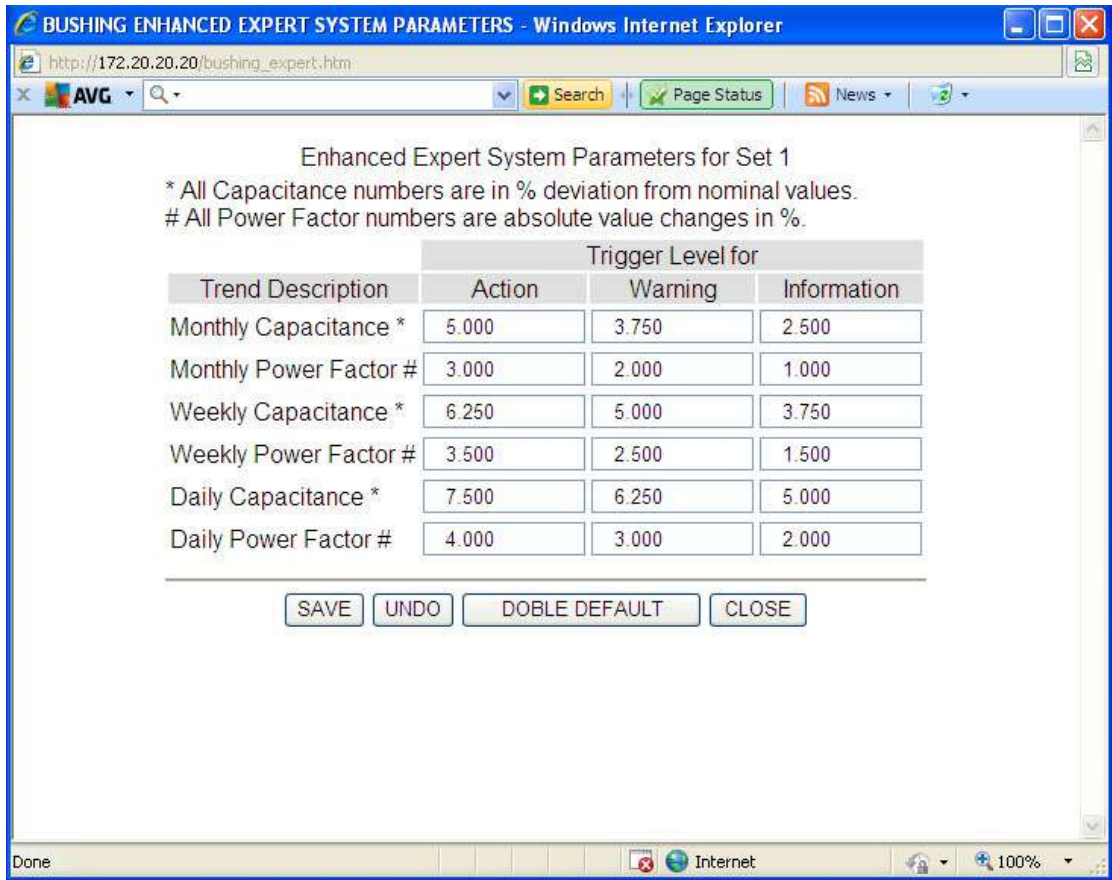
**Figure 1**

Following brief discussions it was decided to modify the Expert System trigger levels for Capacitance but, despite the novel application, to leave the Power Factor levels unchanged. New levels are shown in Figure 1 below.

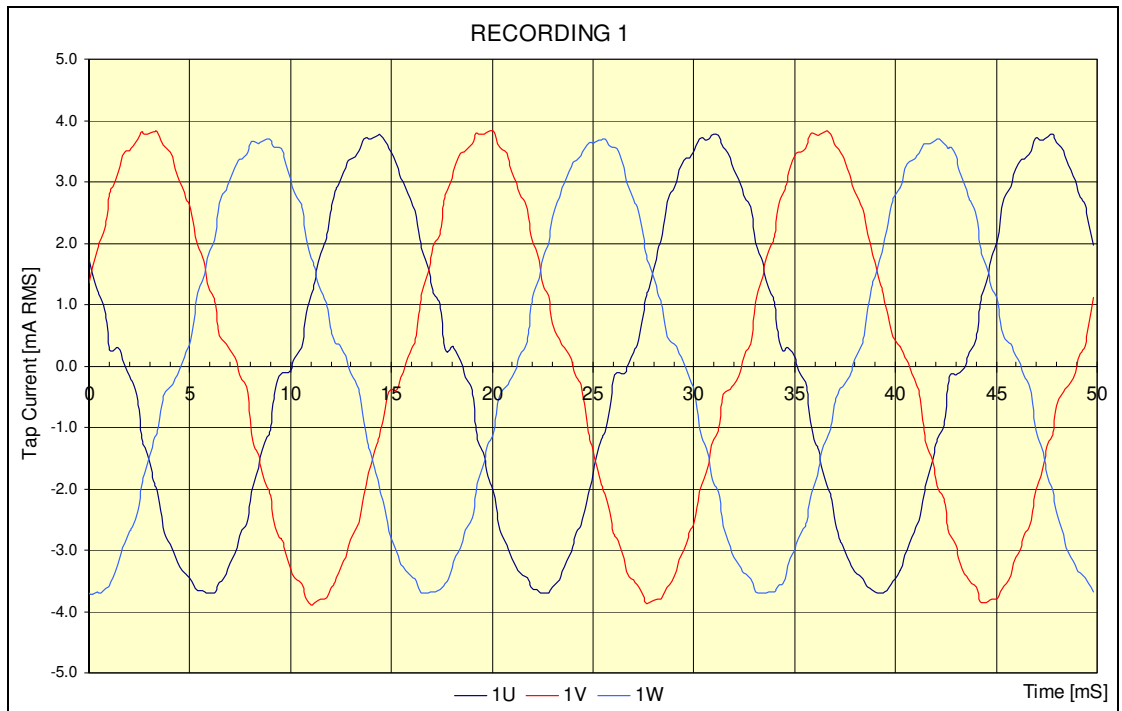
The transformer was energised with the rectifier/motor control deactivated. Based on measurements performed on sister transformer TM8, the measured currents were a little higher than expected at an average of 2.57mA per phase.

The Recordings file was downloaded and viewed with an Excel Template. Plot of waveforms is shown as Recording 1 in Figure 3 below.

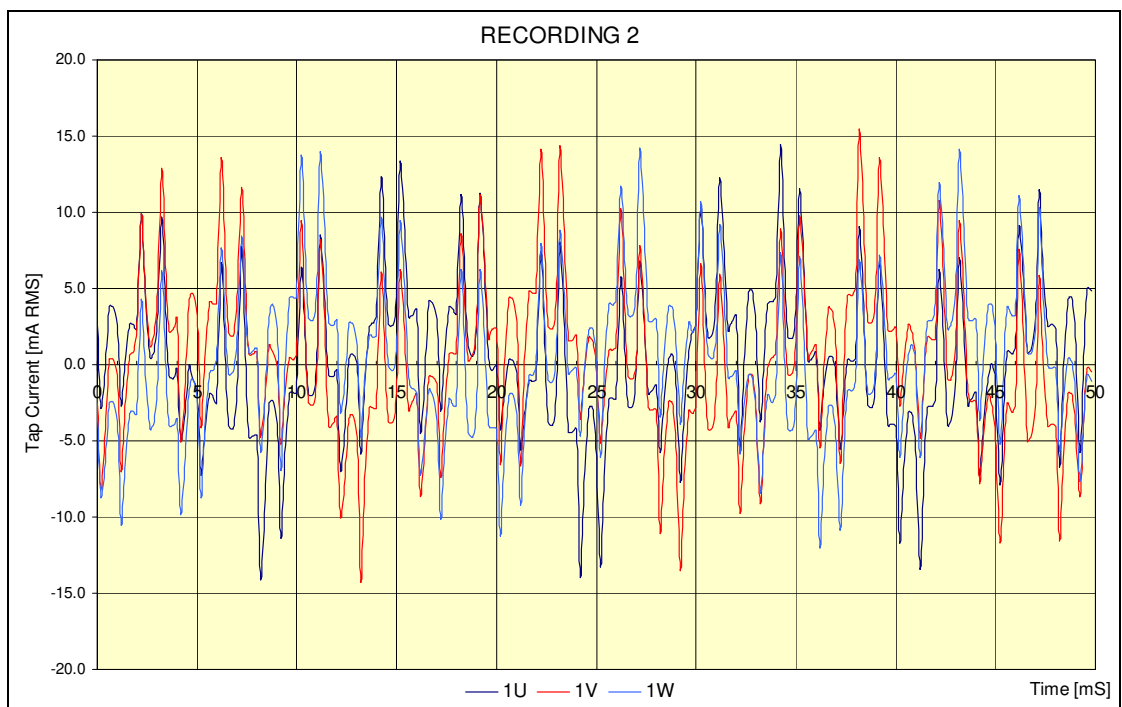
The motor control was then activated and the measurement repeated. Plot of waveforms is shown as Recording 2 in Figure 4 below. Note amplitude scale is 4-times that of Recording 1. Despite the high frequency noise the calculated currents and phase angles were very similar to those obtained from Recording 1. Two more recordings were made with similar results. The Calculated Features summary is shown in Figure 2 below.

A program was made available to convert the .CSV Recordings file into the COMTRADE format. With the Doble TransWin program and an F6150 relay test set the Recording 2 current waveforms shown above were “looped” and applied to a demo IDD with the same modified Expert System parameters. In combination with a special routine for the IDD which speeds up the measurement cycle by 180 times (IDD makes a measurement every 20 seconds instead of every hour), the response of the Features Calculation was investigated with data equivalent to a month of continuous operation. Initial results were very encouraging with both capacitance

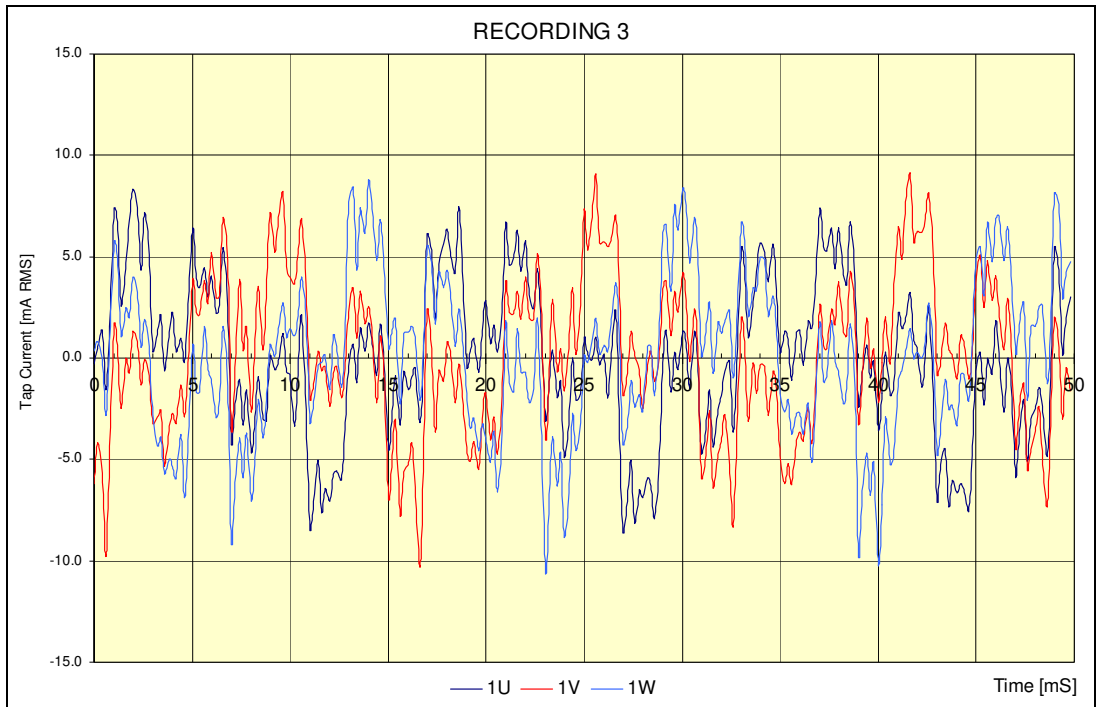
**Figure 5**

Following a period of in-service operation the Waveform and Features files were retrieved from the IDD on 2<sup>nd</sup> August 2011. An example of the current waveforms with the thruster motor running is shown in Figure 5 below.

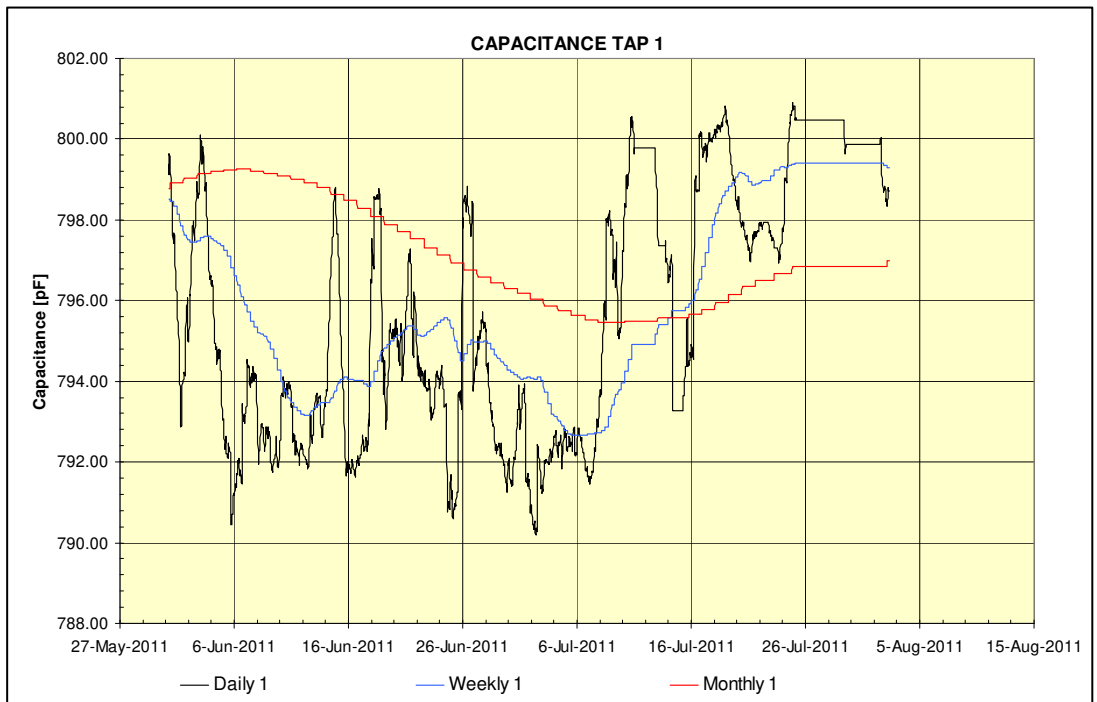
**Figure 6**

The Daily, Weekly and Monthly rolling averages for both Capacitance and Power Factor were then plotted from the Features data. Tap 1 (Phase U) and Tap 3 (Phase W) are shown in Figures 6 to 9 below [Tap 2 (Phase V) is the Reference channel and therefore not plotted].

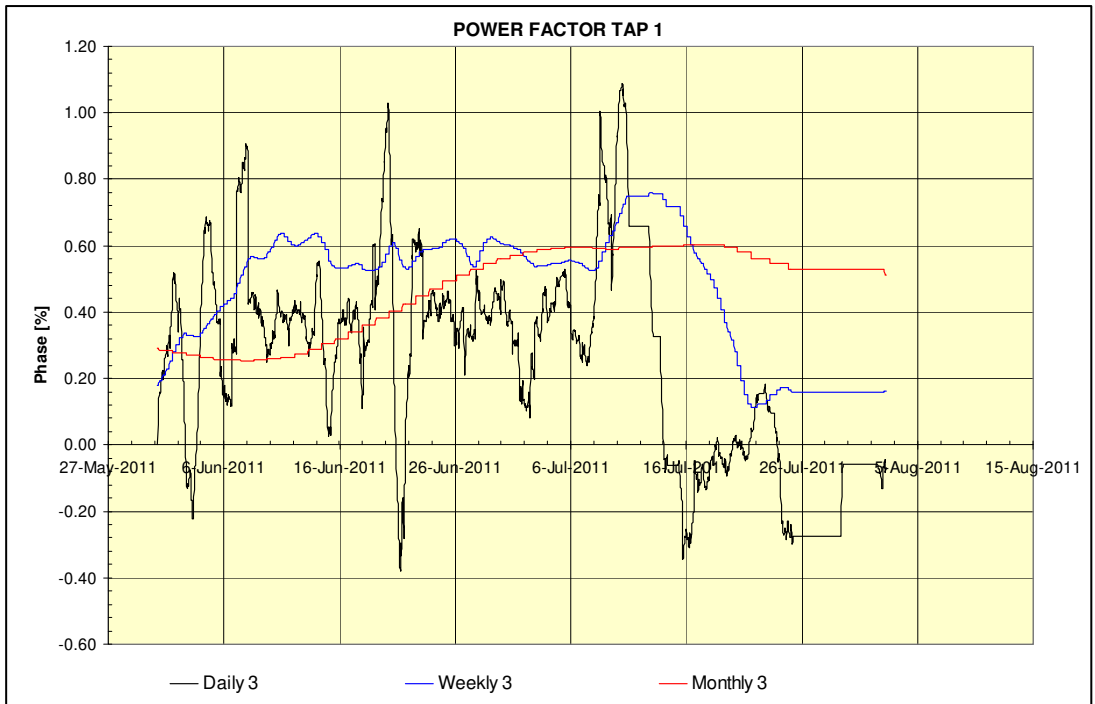
**Figure 8**

(Due to an error in the Features Template the labels read “Daily 3” etc. instead of “Daily 1” etc.)
