POWER FACTOR/CAPACITANCE AND INSULATION RESISTANCE TESTING ISSUES ON 138 KV DRY TYPE CT

**May Wang, Eric Tan, and John Vandermaar
BC Hydro Site Engineering and Commissioning Dept.**

POWER FACTOR/CAPACITANCE AND INSULATION RESISTANCE TESTING ISSUES ON 138 KV DRY TYPE CTS

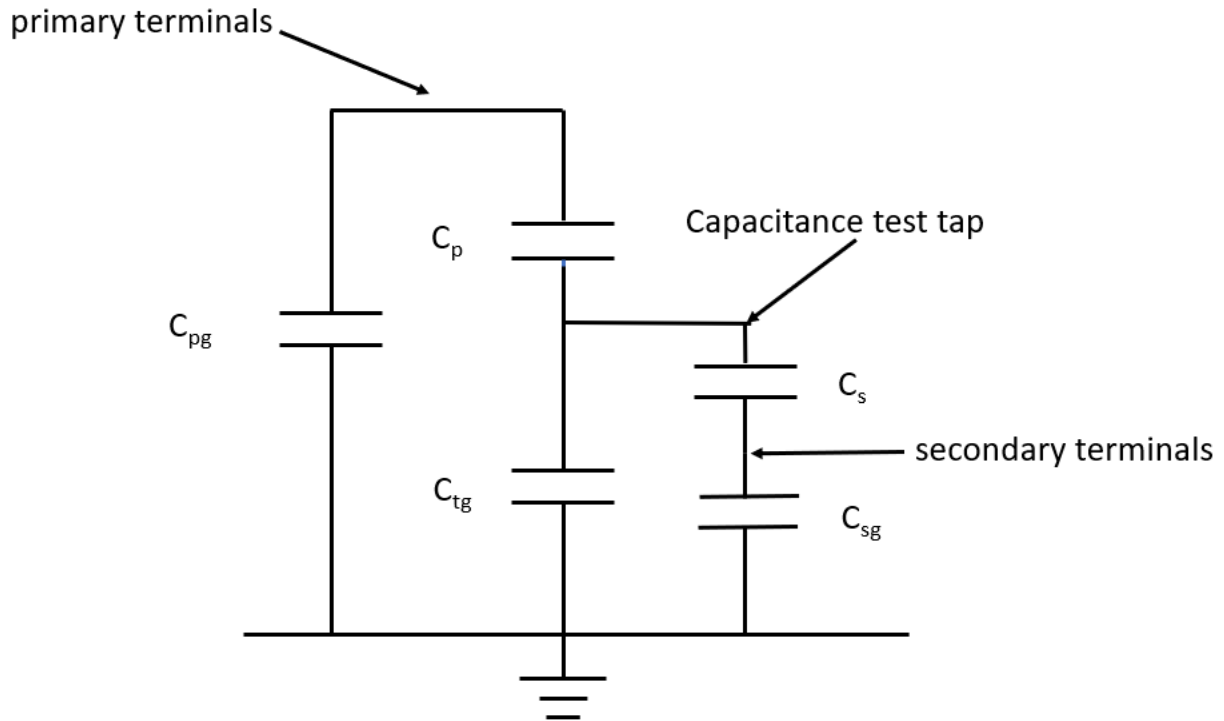
**CT Equivalent Circuit
Figure 2**

To investigate and analyze the above issues on dry type CTs, an equivalent circuit was constructed in accordance with the CT's physical structure and connections. The equipment circuit is shown in Figure 2.

C_p – Capacitance between the high voltage primary terminal and test capacitance tap.

C_s – Capacitance between the test capacitance tap and CT secondary winding terminal ($C_s = C_{s-1}$ (cable composite part) in series with C_{s-2} (air part)).

C_{sg} – Stray capacitance from secondary terminals to ground.

C_{pg} – Stray capacitance between the high voltage primary terminals and ground with capacitance tap guarded.

C_{tg} – Stray capacitance between the test capacitance tap and ground ($C_{tg} = C_{tg-1}$ (composite part) in series with C_{tg-2} (air part)).

C_{ps} – Capacitance of C_p in series with C_s

C_{t-grd} – Capacitance of C_{tg} plus C_s with the secondary terminal grounded.

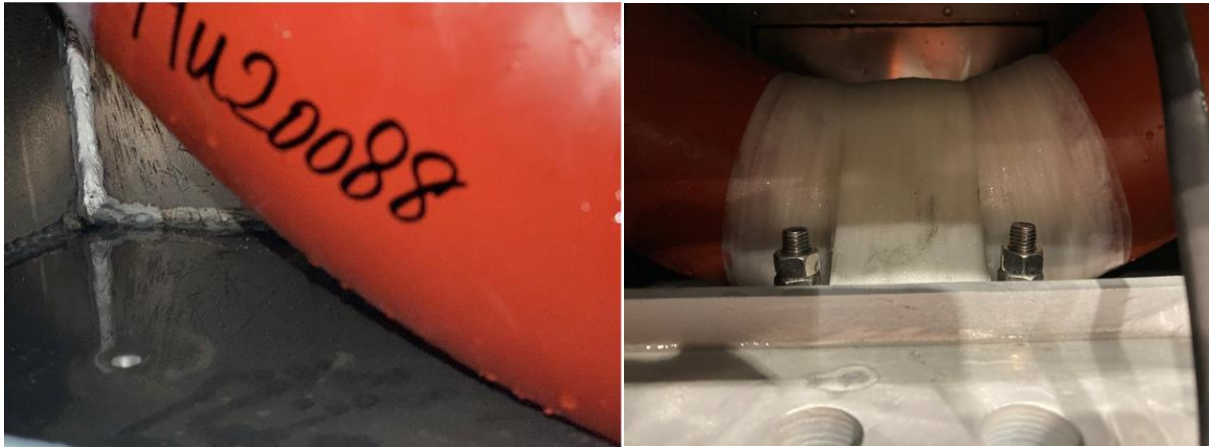
**CT Internal Wet Condition
Figure 3**

- The power factor and capacitance test results showed that it seems to have another unstable shield in the CT.
- The CT design/drawing does not have any other shield in the CT structure.
- After checking the inside of the CT, again no other shield was found.
- Water was observed on the surface of the CT cable insulation during shop testing.
- Testers wondered if water formed a shield and caused these changes.
- The following needed to be done:
 - Draw an equivalent circuit for the water situation in the CT.
 - Simulate the water/moisture situation to perform investigative testing.

Was this water layer the cause of the negative power factor, and did it cause the capacitances changes? Figure 5 shows the CT internal structure drawing in a dry condition, and Figure 6 shows the CT internal structure drawing in a wet condition.

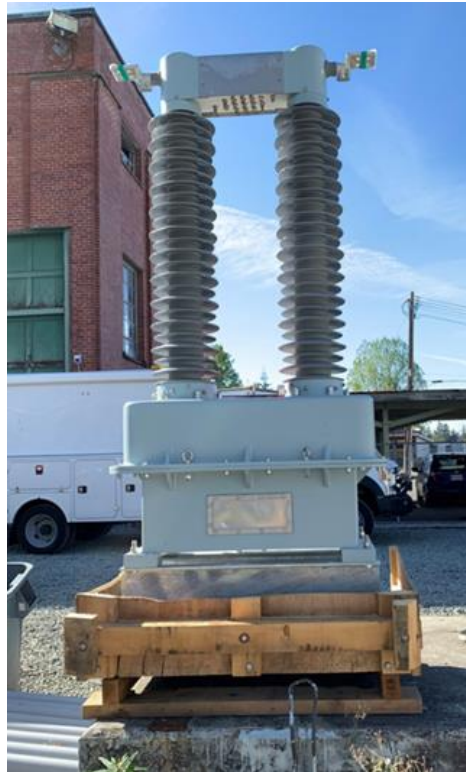
**Site Testing CT
Figure 9**

The above differences (Table 6) could be caused by definition or test circuit differences. First, the FAT reports show the results as capacitance and the losses as $\tan \delta$, so this indicates that the FAT testing was done by using a $\tan \delta$ bridge. In fact, when using a $\tan \delta$ bridge the tested equipment usually required isolation of the base of the tested CT from the ground to input the signal to the $\tan \delta$ bridge. Therefore, the CT cannot be tested in the base grounded condition, the CT base must be floating for the comparison testing. A UST (unground specimen test) test mode can be used with the CT base in the floating condition. Fortunately, the CT unit onsite was on a wooden frame (Figure 9). Therefore, a UST mode could be performed for the FAT comparison.

To simulate the FAT conditions and to compare with the FAT results, the following test configurations were applied and found to be the closest to the FAT configurations for comparing C_p , C_s and C_{ps} , (Table 6):

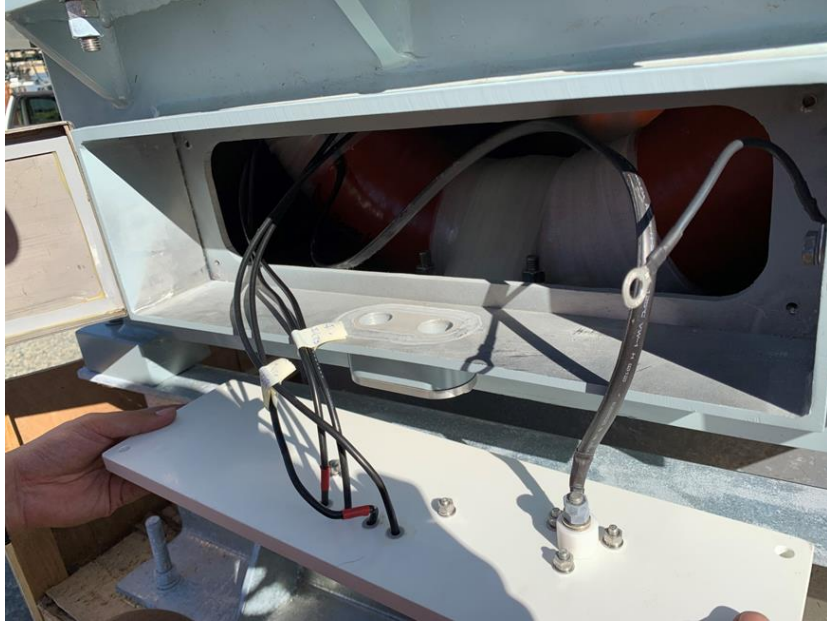
CT Terminal Box
Figure 10

Both the insulation resistance test and the power factor/capacitance test results showed that the CT moisture problem could be deeper than just the terminal box and leads parts, the moisture could go into the CT secondary winding section and take a long time to dry out. Figure 10 shows the CT terminal box and Figure 11 shows a CT secondary winding. The power factor and capacitance testing was more sensitive than the insulation resistance testing to detect the moisture problem and the dry out condition.

Based on the testing and internal inspection, the moisture problems were not just on the secondary terminal board, and they can go deeper in the CT secondary winding parts. If the moisture gets into the CT secondary winding parts, it can take a long time to dry out, so that is why drying the terminal box will not be effective and the natural dry-out can take weeks.

- If possible, these dry type CTs should be stored in a vertical position and in a covered storage area.
- Ship the CT to site/shop at least a week before the testing and put them in a vertical position.
- Suggest, if possible, to test each CT secondary seal in the factory to make sure the secondaries are well sealed, and no moisture can get into the secondary windings.
