## **24/7 INFRARED AND VISUAL MONITORING SYSTEMS**

**Drew Mohundro, Roger Ely  
Southern Company**

Southern Company is deploying two distinct infrared (IR) camera systems in substations to provide continuous thermal monitoring of in-service equipment. Each of these systems detects the formation or worsening of thermal hotspots through real-time data collection of temperature readings as well as monitors the condition of equipment through this data paired with visual images. Access to such data provides a better understanding of historical, present, and potential future health of major substation equipment, allowing equipment owners to make better informed maintenance decisions.

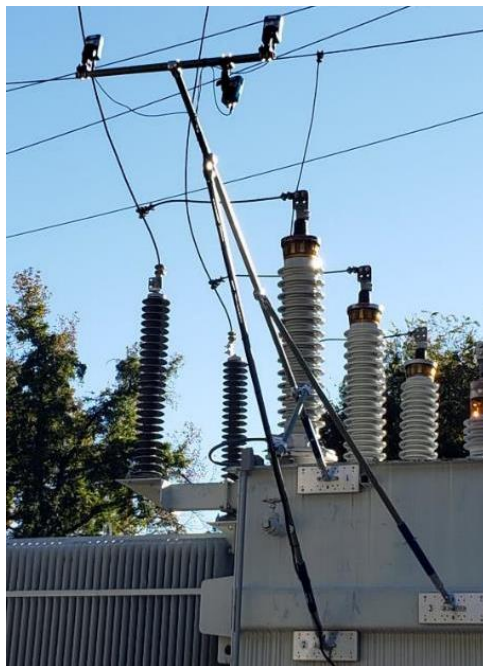
**Example of Static Camera System Installation**  
**Figure 2**

The static camera system deployed by Southern Company provides a close focus on the bushings and arresters of the specific power transformer it monitors. This system utilizes a package of three individual camera modules that are installed in separate locations around the top of the transformer itself. Each camera connects to an extended structure that magnetically mounts to the transformer tank, which allows all cameras to be strategically positioned to ensure proper thermal coverage. Due to the coastal proximity of some of the substations, this magnetic mounting system is rated to withstand Category 2 hurricane wind conditions. Such resiliency also combats potential camera-drift over time, which could impact the quality of data collected. Additionally, the design of this mounting system, as shown in Figure 1 and Figure 2, creates a consistent, safe installation and commissioning process for each project that can be completed without needing to take any equipment outages.

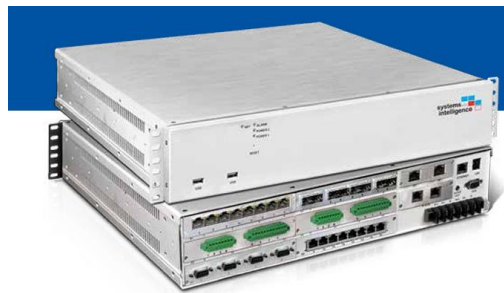
**Dynamic Camera System Local Video Server**  
**Figure 6**

The dynamic camera system offers the same impactful collection of thermal data as the static camera system but comes with its own benefits and options for implementation. While both systems provide thermal and visual resources for monitoring equipment, the details of these resources and how they are collected differ greatly. The dynamic camera system utilizes a more complex camera that provides extra flexibility and options for installation and commissioning. However, this system also requires in-depth project designs and additional system components. The main components of the dynamic camera system are the physical camera housing, Figure 5, and a local video server, Figure 6.

The video server is a rack mounted device that is installed in the substation control house or outdoor control cabinet, and this server drives the operation of each camera housing and the dynamic system as a whole. The video server utilizes fiber connections to communicate over a local area network with each camera housing individually through a smart-junction box that is installed with each housing. The camera housing connects to the smart junction box using a CAT-6 ethernet cable. Through these connections, the video server both receives data streams from the thermal and visual camera lenses and sends commands to move the cameras through preset thermal configurations for each thermal target. The server can process up to eight camera housing connections simultaneously and run these systems independently of each other. Each of these thermal configurations contains up to six numbered rectangular boxes that measure minimum temperature, average temperature, and maximum temperature of the area within. These boxes are drawn around areas of interest such as transformer bushings, arresters, and fans. Figure 7 gives an example of a configured preset with a box drawn for each bushing of the transformer. Each camera housing can be programmed with a maximum of 32 preset configurations for a total maximum of 256 thermal scenes for each dynamic camera system.

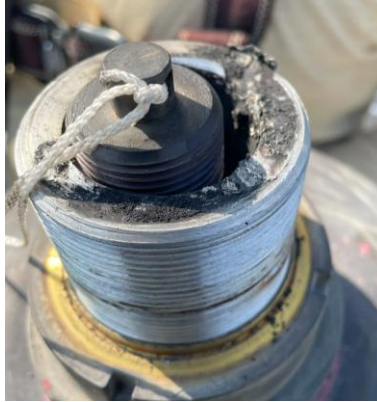
**Physical Damage to Bushing from Arcing**  
**Figure 10**

Personnel scheduled an emergency outage for investigation and repairs, during which they found a loose draw lead nut on the bushing lead and evidence of severe arcing between bushing components as shown in Figures 10 and 11. The bushing pin had severe pitting and was close to complete failure which could have catastrophically failed the transformer.

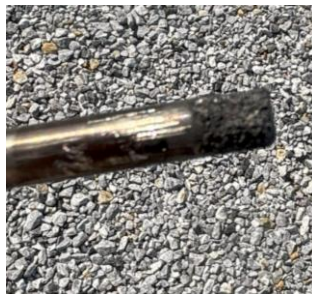
**Physical Damage to Bushing Pin**  
**Figure 11**

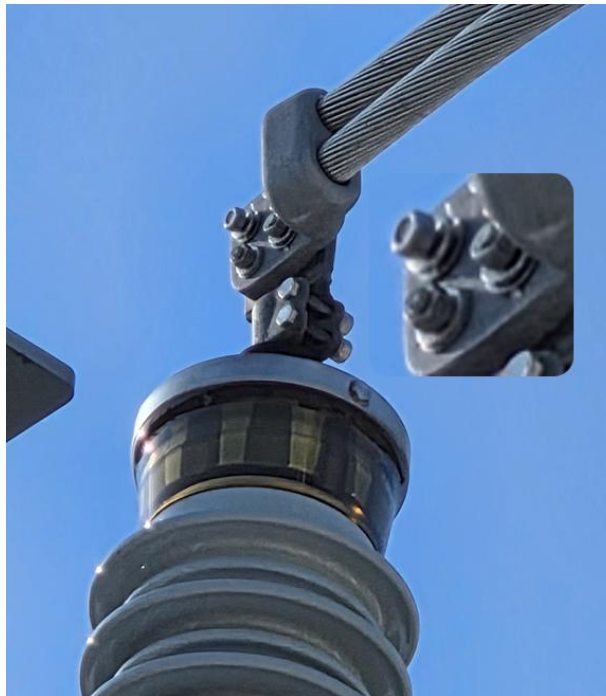
**Image Showing Loose Bolted Connection on Bushing Pad**  
**Figure 16**

Figure 14 gives another example of an external thermal issue where the bolts between the bushing pad and the lead were not properly tightened, and the thermal image clearly shows the exact area of issue that had developed approximately a 30°C delta, as shown by the data in Figure 15, compared to the other phases. Personnel knew to suspect possible loose connections before arriving onsite for their investigation based on the location and behavior of the thermal hot spot. The loose bolted connection was visible from the ground, and Figure 16 contains the original picture taken onsite during the investigation and includes a zoomed portion to showcase the loose bolts between the lead wire and the pad connection.

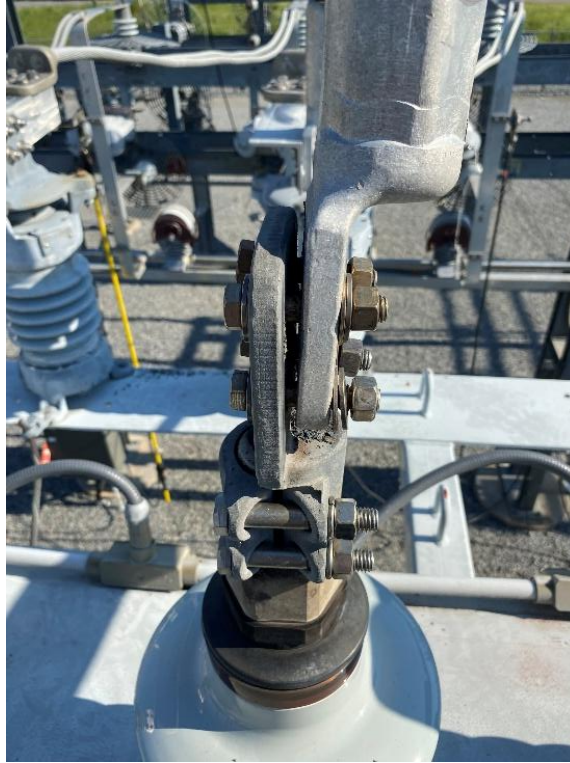
**Image Showing Loose Connection and Damage  
Figure 19**

Because of the static camera system insight, personnel immediately scheduled an emergency outage and prepared the necessary equipment for a full bushing replacement due to the extended exposure to such high temperatures. During the outage, field personnel confirmed physical damage to the bushing and evidence of arcing between the connection points. This damage at the connection point is seen in Figure 19 as well as Figure 20, which shows degradation away from the bolted connection.

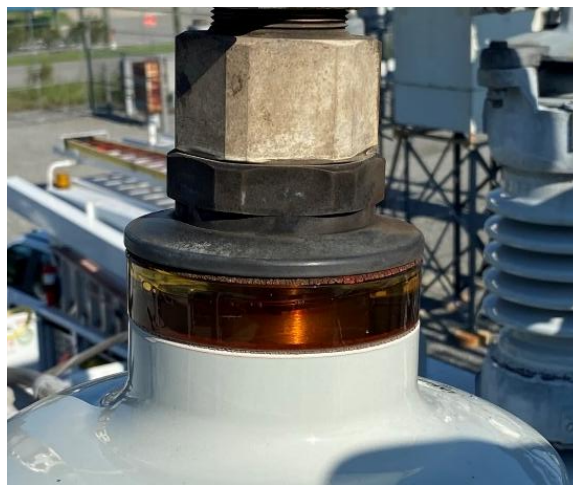
**Image Showing Impact of Extreme Heat on Bushing Seals and Oil  
Figure 20**

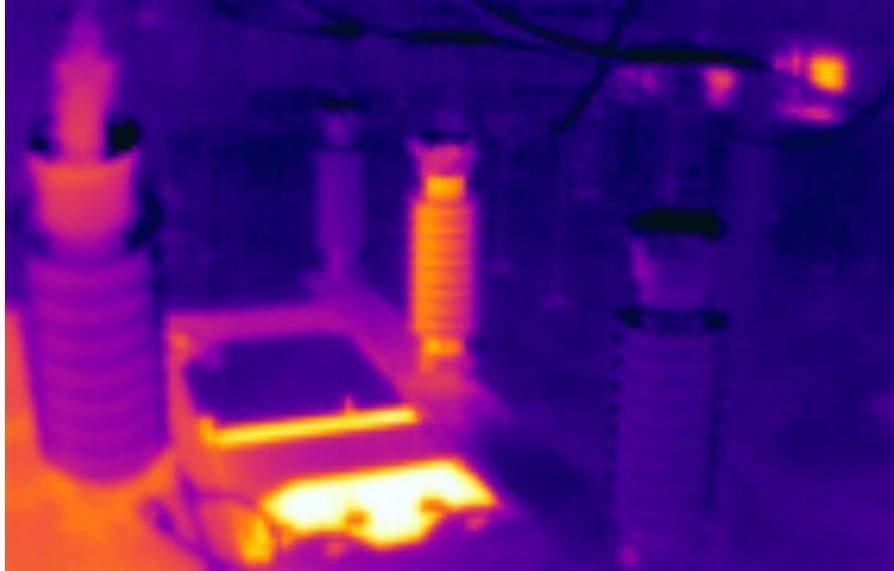
**Thermal Snapshot Showing Arrester Heating During Open-Delta Situation**  
**Figure 21**

In addition to traditional hot spots and thermal heating, the continuous monitoring of the static camera system also can capture unexpected behavior or abnormal developments like the high-side arrester shown in Figure 21. This transformer suffered a blown high-side fuse, which resulted in an open circuit configuration on the high side. Immediately, the arrester between the blown fuse and the transformer bushing began rapidly heating and soon produced over a 20°C delta compared to the adjacent arresters with intact upstream fuses, as shown in Figure 22. Thanks to this additional information, field personnel knew to take additional precautions to ensure effective and safe repairs to the affected equipment.

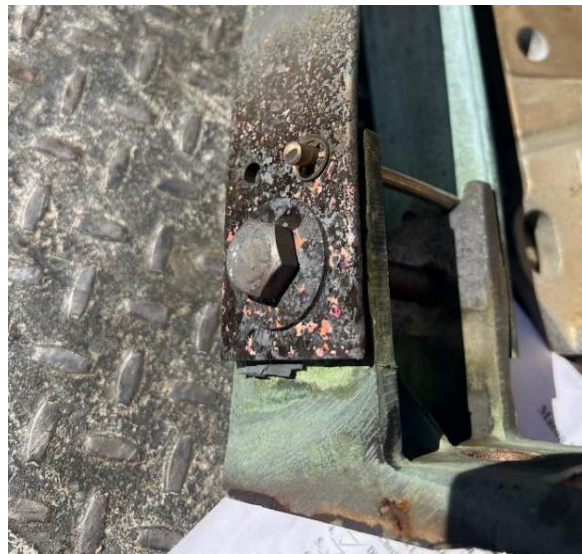
**Image Detailing Damage on Monitored Switch**  
**Figure 24**

One of the only drawbacks of the standard application of the static camera system comes from the limited types of equipment it can monitor; however, the development of the mobile static camera system greatly expands the coverage that these cameras can now provide to new points and equipment of interest. The mobile system excels in situations where any additional thermal data is beneficial or where equipment may be difficult to access for manual IR scans. The snapshot in Figure 23 shows a situation of a known distribution switch that was heating. However, it was part of the system feeding power to an important customer that could not immediately come offline without major impact. Personnel deployed the manual camera system to provide continuous monitoring of the situation and to ensure the issue was not worsening. This extra time allowed the customer to safely come offline and allow personnel to replace the damage switch that is shown in Figure 24.

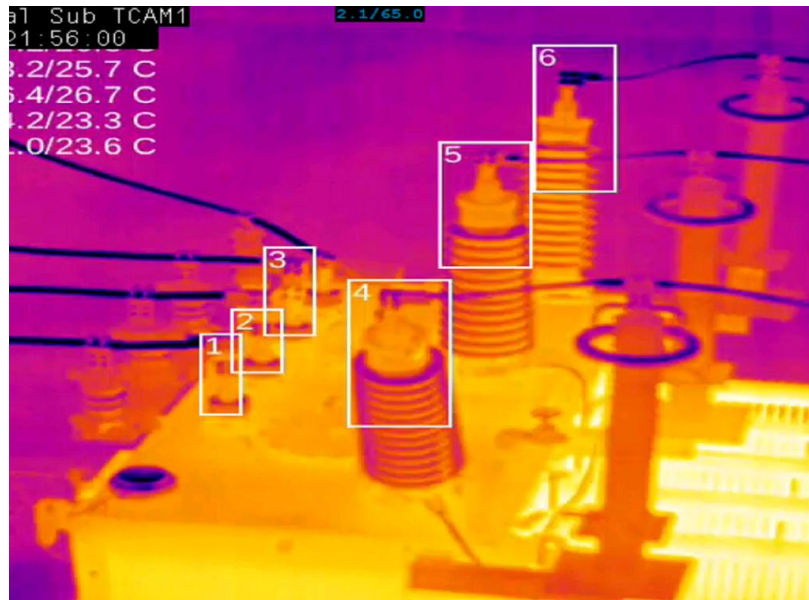
**Thermal Image Showing Low-Side Bushing Temperature 25.7 °C before Load Increase  
Figure 25**

The first phases of Southern Company dynamic camera systems have been in service for just over a year and have already contributed to several thermal observations across a variety of equipment. This access to equipment thermal data is another tool that is being utilized to build a full picture of equipment health and performance. For example, Figure 25 and Figure 26 show the changing status of a substation transformer approximately four hours apart during a night in early January 2026. The first figure shows 25.7°C as the maximum temperature of its third box which is drawn around a low-side bushing. The maximum temperature of that same box increases up to 32.3°C over the next four hours while all the other boxes' maximum temperatures decrease with the falling ambient temperature of the winter nighttime. This unexpected behavior is one of the anomalies that signifies some sort of equipment issue.

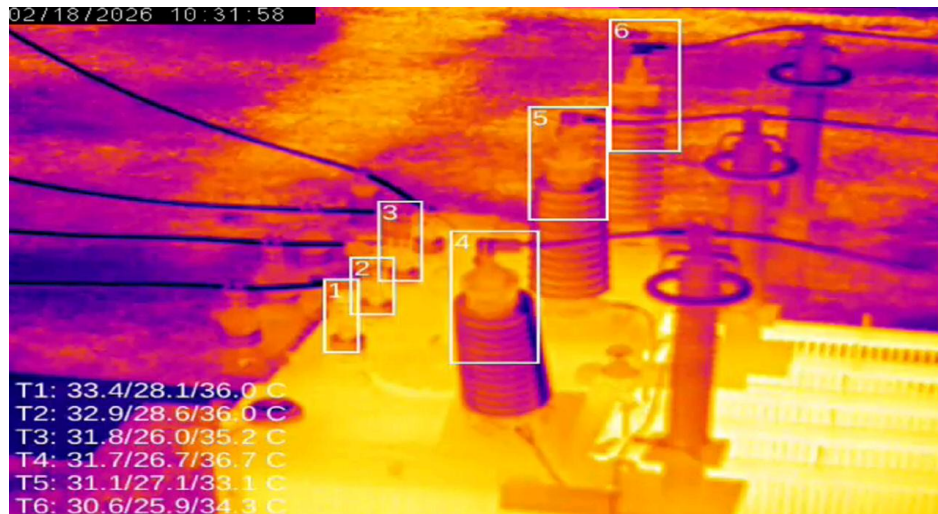
**Thermal Image Showing Bushing Temperatures after Repair**  
**Figure 29**

A maintenance outage was scheduled for the bank where the bushing was thoroughly inspected and cleaned before returning to service with confirmed tight connections. Similarly to the static camera system, the dynamic camera system also provides the benefit of confirming the impact of repairs on thermal hot spots. This is especially important in a situation such as this one where the issue was dependent on the load of the equipment, and it may be difficult to complete a thermal scan during the desired conditions. The following figures show the ability to fully monitor and confirm the effectiveness of repair work or equipment replacement. Figure 29 shows a snapshot taken at the 10:00 timeframe several days after the outage whereas Figure 30 and Figure 31 show the correlation between loading on the transformer and the delta between the maximum temperature readings of the low-side bushings.

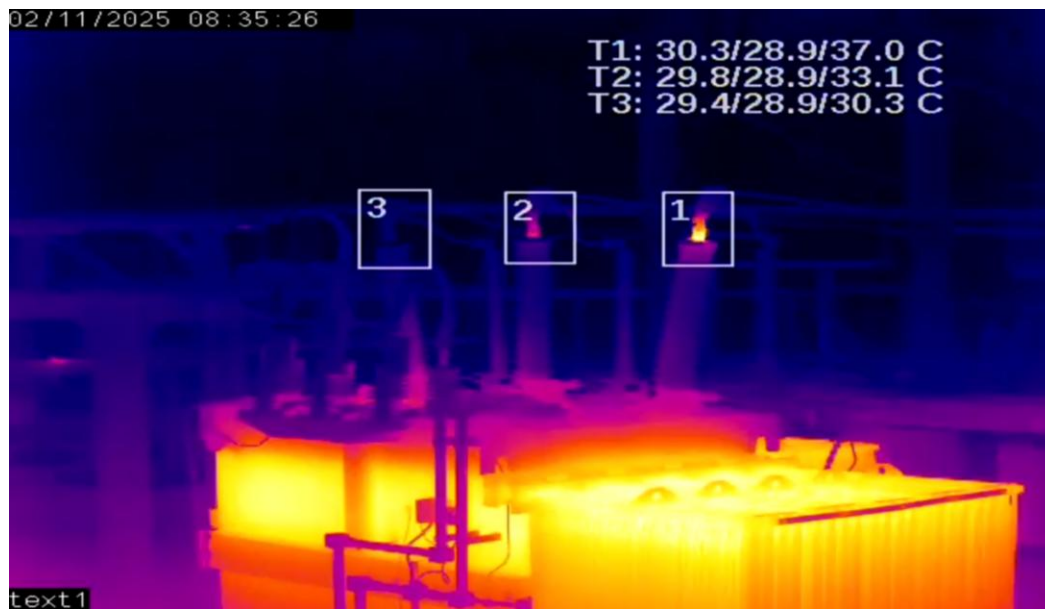
**Thermal Image Showing High-Side Temperature Delta During Commissioning**  
**Figure 32**

The thermal lens and its data are crucial to detecting the presence of unwanted hot spots on equipment and highlighting the affected areas. The visual lens and its pan, tilt, and zoom capabilities add another level of investigation that can further the effectiveness of the dynamic camera system as shown in the following example. Figure 32 comes from the commissioning process on a newly installed camera system that measured a difference between maximum temperatures of high-side bushings. The largest delta in this observation equals about 7°C, which is notable but does not usually create an emergency response.

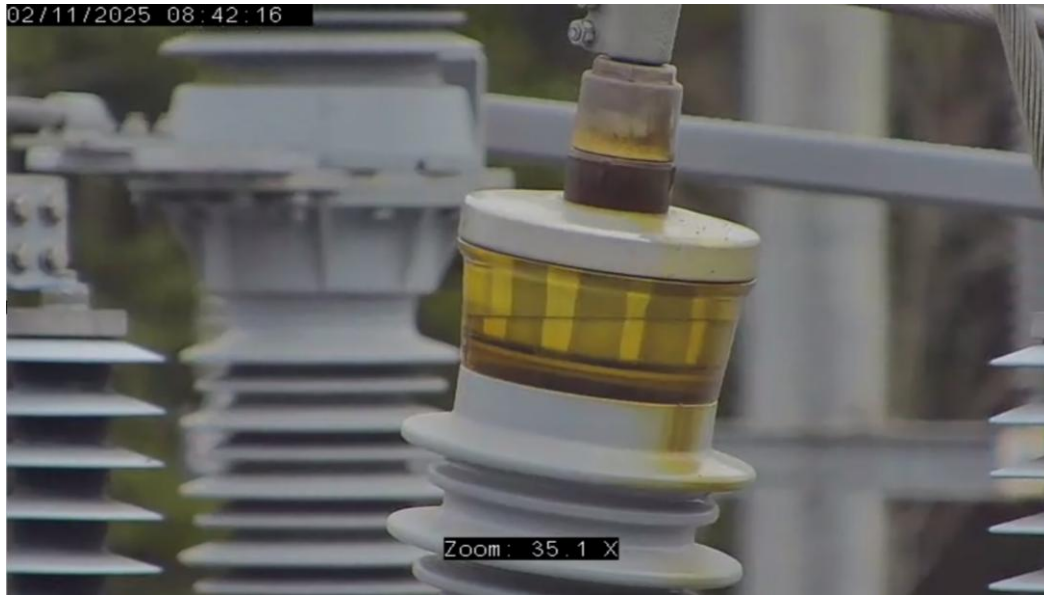
**Image from Visual Camera Lens Showing Residue and Discoloration on Heating Bushing  
Figure 33**

However, while continuing with the commissioning process of the camera system, the feed from the visual lens showed discoloration on the same bushing with the highest temperature. Figure 33 is a snapshot taken by manually controlling the visual lens and utilizing the variable zoom to better inspect the areas of high temperature. This image shows discoloration across a majority of the top of the bushing as well as the presence of residue that seems to be tracking down the equipment. This additional information pushed personnel to take an outage to quickly correct the issue before the condition could worsen. All bushing connections were tightened, and the bushing was thoroughly cleaned before returning to service. Figure 34 shows the performance of the bushing five months after repairs during the peak loading of summer with almost no delta present between the high-side phases.

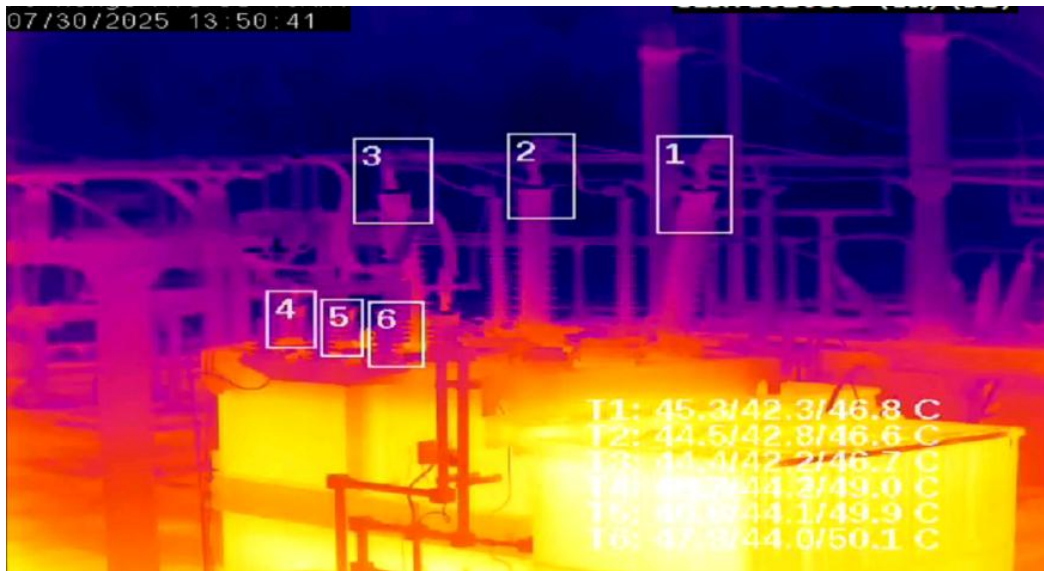
**Thermal Image 5 Months after Repairs with No Temperature Delta  
Figure 34**

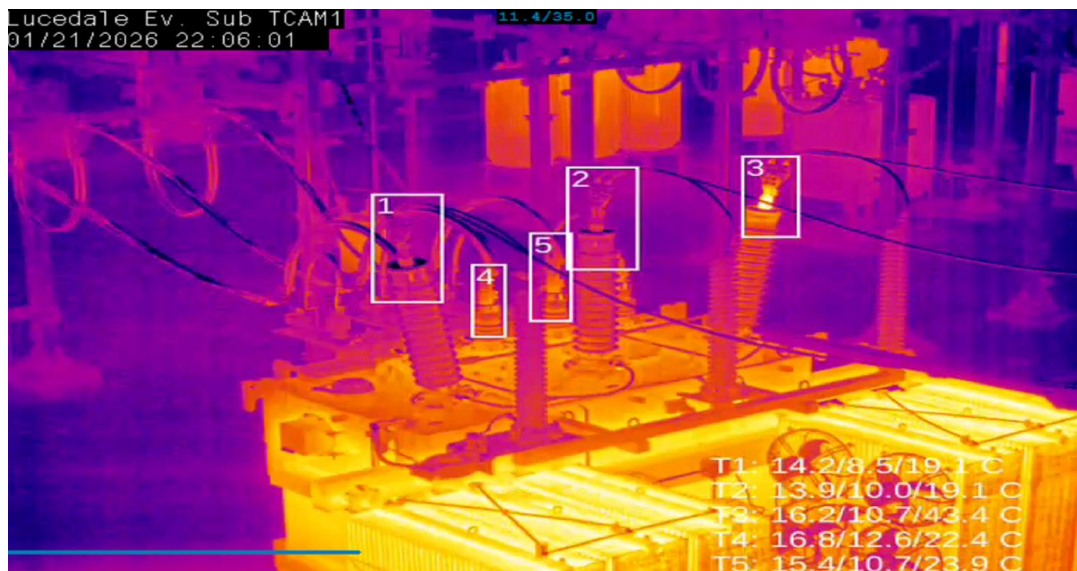
**Thermal Image Showing 20°C Delta Between High-Side Bushings**  
**Figure 35**

As mentioned in the static camera system section, one of the main benefits of continuous monitoring systems comes from being able to actively watch known issues to see how they progress over time until repairs or replacement can be completed. Figure 35 shows another example of a temperature delta between high-side bushings on a distribution transformer feeding a large industrial customer. The historical data confirmed the presence of this delta over a wide timeframe with it steadily reaching 20°C and holding overnight as evidenced by Figure 36. Once again, this nighttime period highlights the difference between phases since there is no solar heating to skew the measurements.
