POWER FACTOR/CAPACITANCE AND INSULATION RESISTANCE TESTING ISSUES ON 138 KV DRY TYPE CT

MAY WANG, BC HYDRO

91ST International
Conference of Doble Clients

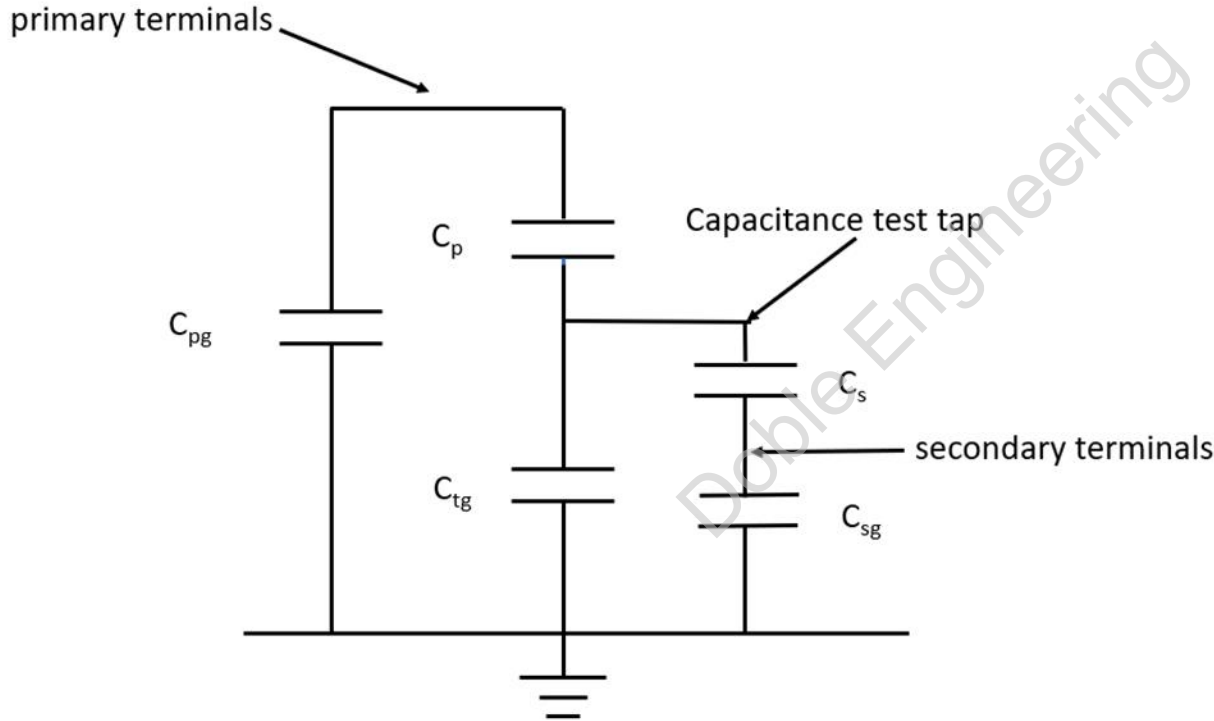
Dry Type CT Equivalent Circuit

C_p - capacitance between the HV primary terminal and capacitance test tap.

C_s - capacitance between the test tap and secondary winding terminal.

C_{sg} - stray capacitance from secondary terminals to ground.

C_{pg} - stray capacitance between the HV primary terminals and ground with tap guarded.

C_{tg} - stray capacitance between the test tap and ground.

C_{ps} - C_p in series with C_s .

C_{t-grd} - C_{tg} plus C_s with the secondary terminal grounded.

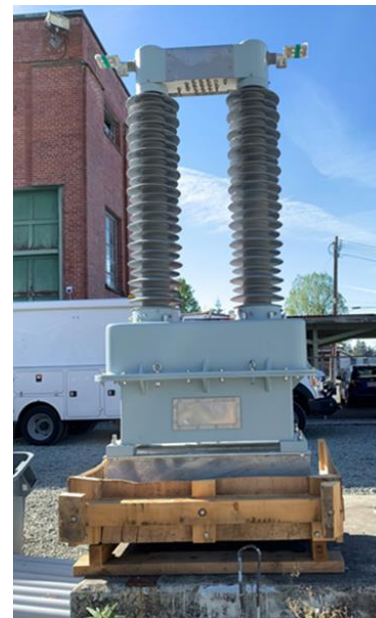
Simulated FAT Test Conditions (Base Floating)

Test Configurations with Base Floating to Simulate FAT Test Configurations

Test Mode	ENG	UST	GAR	Floating	FAT		Measured on Site		FAT & Site Differences	
					C (pF)	Tan δ (%)	C (pF)	PF (%)	Δ C	Δ PF
Simulating FAT C _p	H1&H2	Cap tap, X&Y, base	-	-	758	0.02	758	0.05	0.04%	143%
Simulating FAT C _s	Cap tap	X&Y, base	H1&H2	-	502	3.3	498	3.3	0.88%	-1.3%
Simulating FAT C _{ps}	H1&H2	X&Y& base	-	Cap tap	300	2.07	298	1.99	-0.5%	-2.1%

- The investigation tests identified the closest power factor/capacitance test configurations to match the FAT results.
- Updated test configurations were defined for future tests with the CT base in the grounded condition.
