USE OF CONVENTIONAL AND UNCONVENTIONAL TECHNIQUES TO IDENTIFY PARTIAL DISCHARGE ACTIVITY IN ISOLATED PHASE BUSBARS

Ami Singh, Michael Hughes-Narborough
SSE, Doble PowerTest

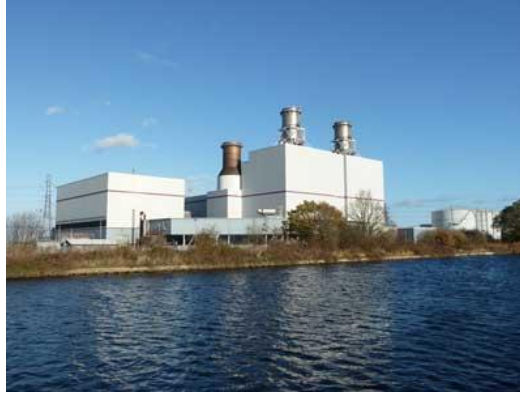
**CCGT site in North Lincolnshire, UK used in this case study
Figure 2**

The site that was chosen for this paper is a Combined Cycle Gas Turbine (CCGT) site located in North Lincolnshire, UK. It was commissioned in 1996 and consists of three units – two gas turbine (Units 1 and 2) and one steam turbine (Unit 3). The station was mothballed for approximately three years between 2012 and late 2015. The total capacity of the station is approximately 734MW. All of the units have two types of capacitive couplers permanently installed for PD monitoring; four 9nF couplers (three at the line end and one on the neutral) and six 80pF couplers at the line end to allow for time of arrival disturbance separation. Three of the 80pF capacitors are installed at the line terminal bushings of the generator, while the remaining three 80pF capacitors are installed at the terminal bushings of the excitation transformer, some 15 meters away from the capacitors installed at the generator end.

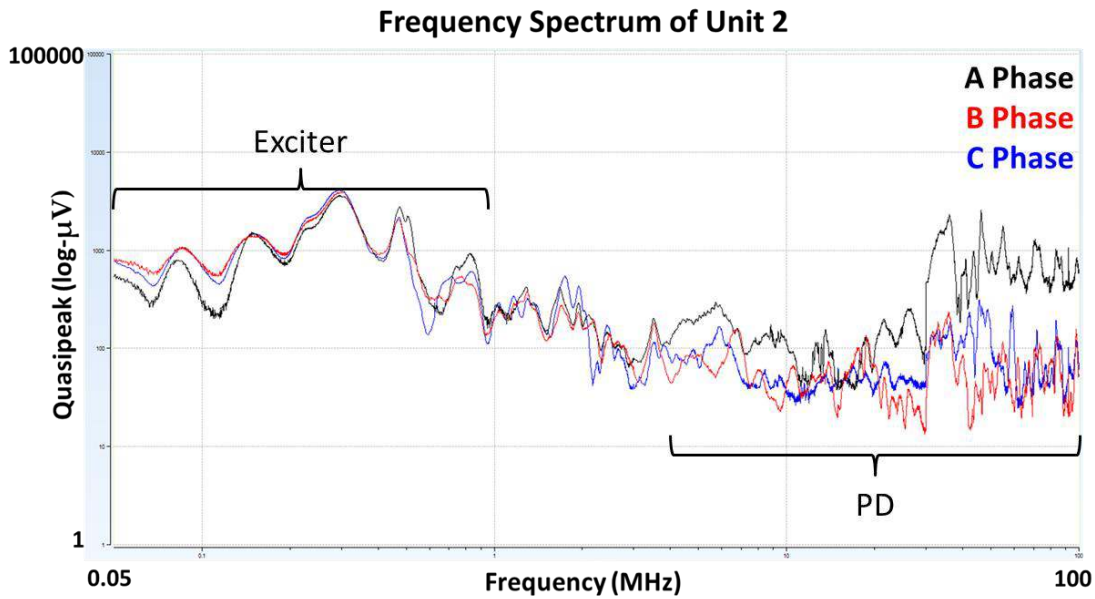
Unit 2 – EMI Frequency Spectrum Results
Unit in Service at the Time of Test, Connections to the C1, Machine Side, 80pF Couplers
Figure 10

The EMI frequency spectrum showed significant evidence of PD activity, especially in the IPB region of the spectrum. A comparison of time domain signatures measured around 34MHz can be found in Figure 11. It shows the substantial differences between discharge activity measured on the A phase compared to the other two.

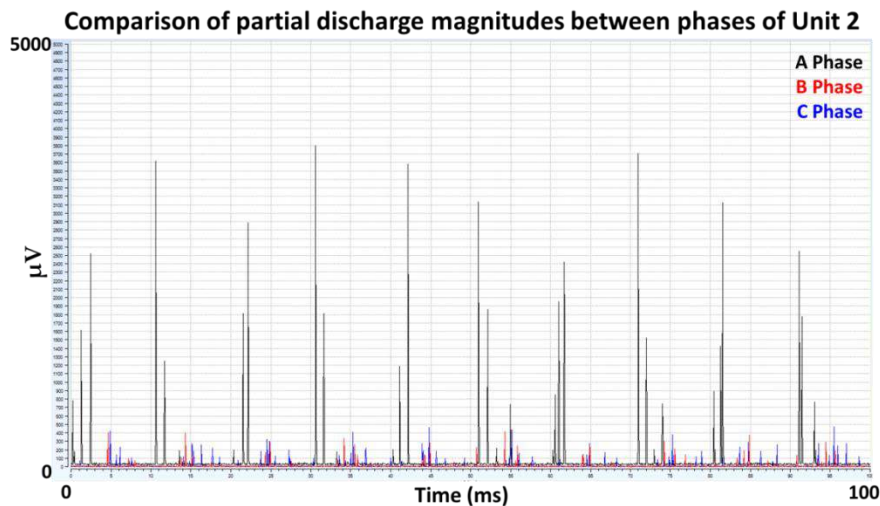
Comparison of Partial Discharge Magnitudes between Phases in Unit 2
Measured in the Time Domain at 34 MHz
Unit in Service at the Time of Test
Connections to the C1, Machine Side, 80pF Couplers
Figure 11

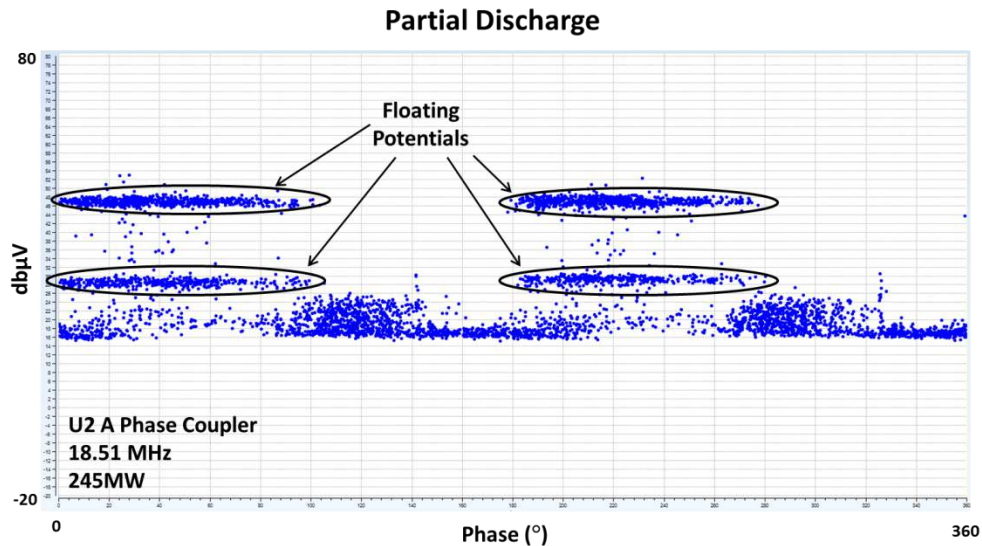
Further analysis in the time domain was performed through the use of PRPD plots, which appeared to show several floating potentials (Figure 12). This could be indicative of damaged IPB insulators or insulators not making proper contact with the centre conductor.

**PRPD Plot Measured at 18.51 MHz Measured from Unit 2 A Phase C1 Coupler
Figure 12**

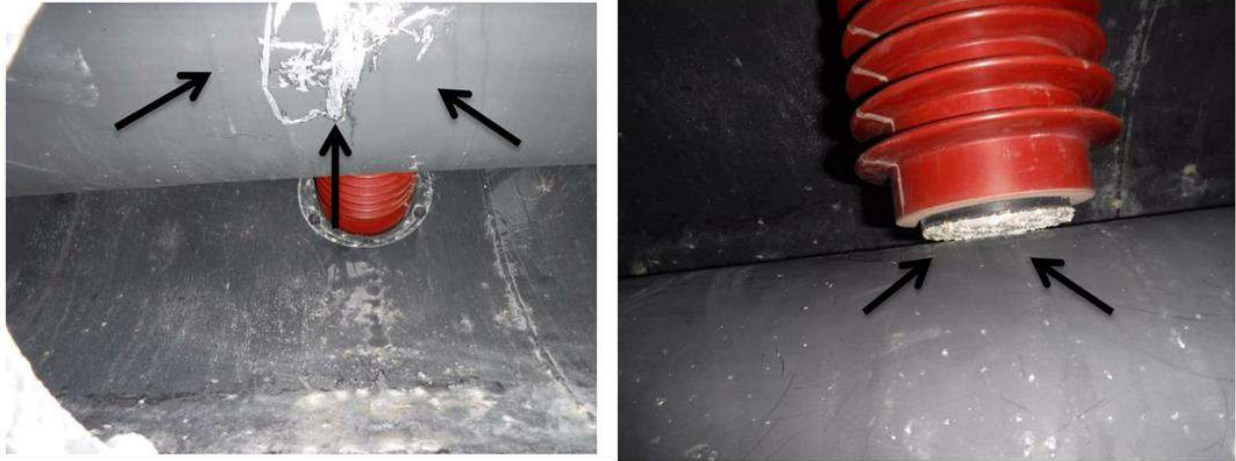
**Inside the A phase of Unit 2 IPB; Evidence of PD was Found on both the Bus and the Insulator heads
Figure 14**

Following the EMI testing, a mini outage was enforced on Unit 2 to investigate the condition of the IPB insulators close to the generator terminals (Figure 13). Evidence of PD activity was found on both the insulator heads and centre conductor on the A phase (Figures 14 and 15); whereas no such evidence was found in either B or C phases.

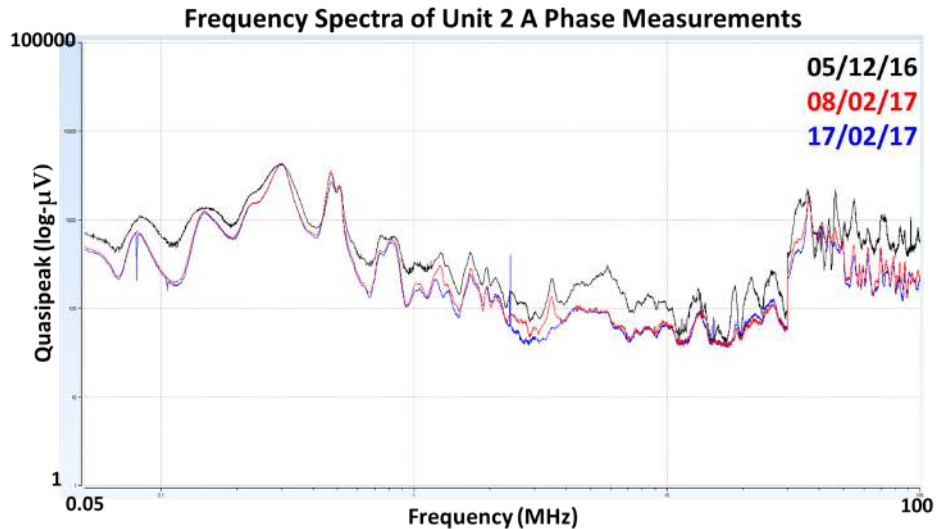
An important observation in Figure 16 is that a lower uplift in EMI spectra was recorded in the frequencies not associated with the IPBs (i.e. lower frequencies than approximately 30MHz) after performing repair

works on the IPB. This leads to a question that validates further research that does IPB associated activity extend lower than 30MHz.

**Overlay of Unit 2 EMI Frequency Spectra before and after Maintenance Activities were Performed
Figure 16**

Following this discovery, efforts were made by the site to clean the insulator heads. Subsequent EMI surveys, taken at similar loads to the original testing, show that these efforts have decreased the PD activity but not eliminated it (Figure 16). The initial maintenance effort included removal of the IPB support insulators on all phases between the generator and the GCB, and cleaning of the insulator surface contact areas (noted as insulator heads in Figure 15). The repeated effort in later February 2017 only focused on Phase A support insulators located 3-4 meters from the generator line terminal bushing. It was during the later February 2017 works it was found that some of the support insulators heads were not making good contact with the aluminium conductor. Site experience shows that it can be difficult to confirm if the three insulators at a particular location have made adequate contact with the conductor unless the support insulator at a location prior to the location being worked on is removed and used for inspection.
