GENERATOR MAINTENANCE UPDATE

W. Howard Moudy

Director of Operations – National Electric Coil

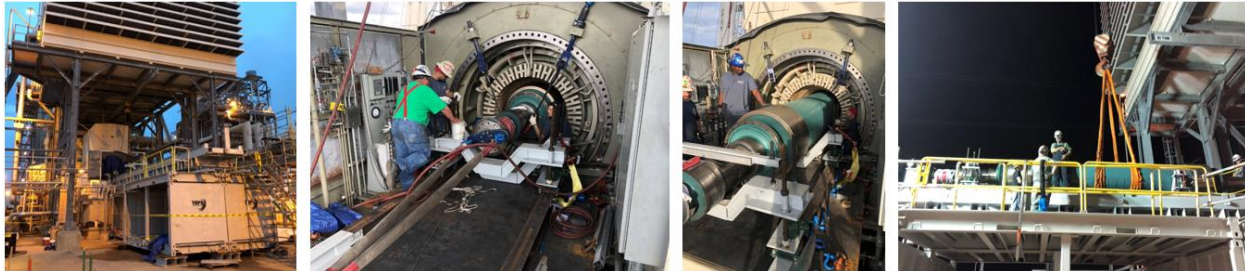
Generator Rotor Removal
Figure 1

Visual inspection has long been referred to as the most cost effective maintenance tool. Traditionally to gain appropriate access to perform visual inspection, the generator was disassembled and the rotor removed. Figure 1 is a pictorial progression of a generator rotor being removed.

Without a doubt, the access granted by removing the rotor provides the best overall access for visual inspection, but along with that access comes a significant cost in both money and time. Some circumstances justify the monetary cost and time due to known issues or urgently needed modifications. However, current day pressures to decrease maintenance cost and outage durations mandate other maintenance options be chosen when possible to conserve time and money without completely sacrificing insight gathered from inspection and testing.

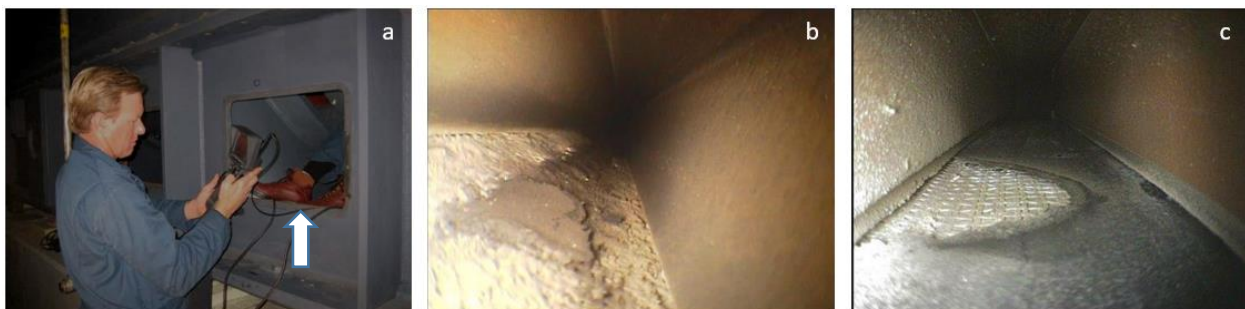
Generator Stator Borescope Inspection
Figure 2

The generator pictured in figure 2a is an AEROPAC model generator. This model along with a few other models from other OEM's, were not manufactured utilizing side slot ripple filler to secure the coil in the slot. Without compression and constant tension, coils can become loose in the slot and as coils move, a very aggressive deterioration condition called Spark Erosion (also referred to as Vibration Sparking) can develop and quickly progress to failure. The condition develops in the stator slot areas adjacent to the laminations.

Small borescopes can enter the stator core vents to observe the coil surface. Figure 2b shows the discovery of severe spark erosion activity. Without swift action to rewind using slot side ripple filler, to prevent future reoccurrence, the unit would most likely experience an in service failure. Figure 2c shows a classic Partial Discharge (PD) finding. PD is a well know deterioration mechanism that is much less damaging and progresses slower than Spark Erosion. Nevertheless, it is still important to identify, document, and trend the progression of PD deterioration. Areas having PD activity outside the slot can often be addressed remedially to arrest and help prevent further PD activity from occurring.

The access necessary to best use borescopes varies by model, but typically inspection covers on the stator frame sides or on the stator end bells will allow the access needed. Inner shrouds on the ends can sometimes be challenging. A quick study of cross sectional and end view generator drawings and also perhaps stator air flow diagrams can be most helpful to establishing the plan to deploy and inspect with a borescope. Specific access to perform an AEROPC model generator borescope core inspection is only the removal of an access covers on the lower side of the stator frame. Having a small nimble individual to shimmy into the inner area of the generator is most helpful too. See the shoes of the person inside the access way above the white arrow in Figure 2a. Generally speaking, this inspection takes about one shift to perform and is an excellent tool to track and trend Spark Erosion deterioration.

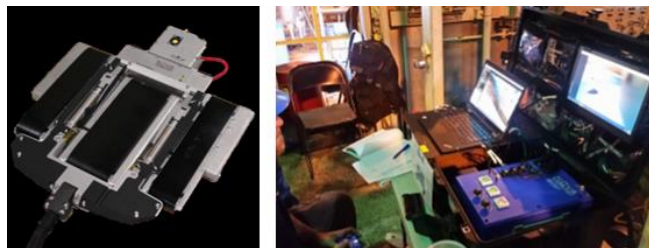
**Robot & Robot Control Station
Figure 5**

Robotic technology has also continued to rapidly evolve. Robots have incorporated advanced optics just as noted with borescopes. They have enhanced maintenance testing capabilities for stator slot wedge tightness and stator core inter laminar insulation testing. The biggest advantage of modern robotic technology is the ability to gather important visual insight and data without completely disassembling and removing the rotor. The robot device or trolley can be seen on the left in Figure 5 and the control station for the robot is pictured on the right.

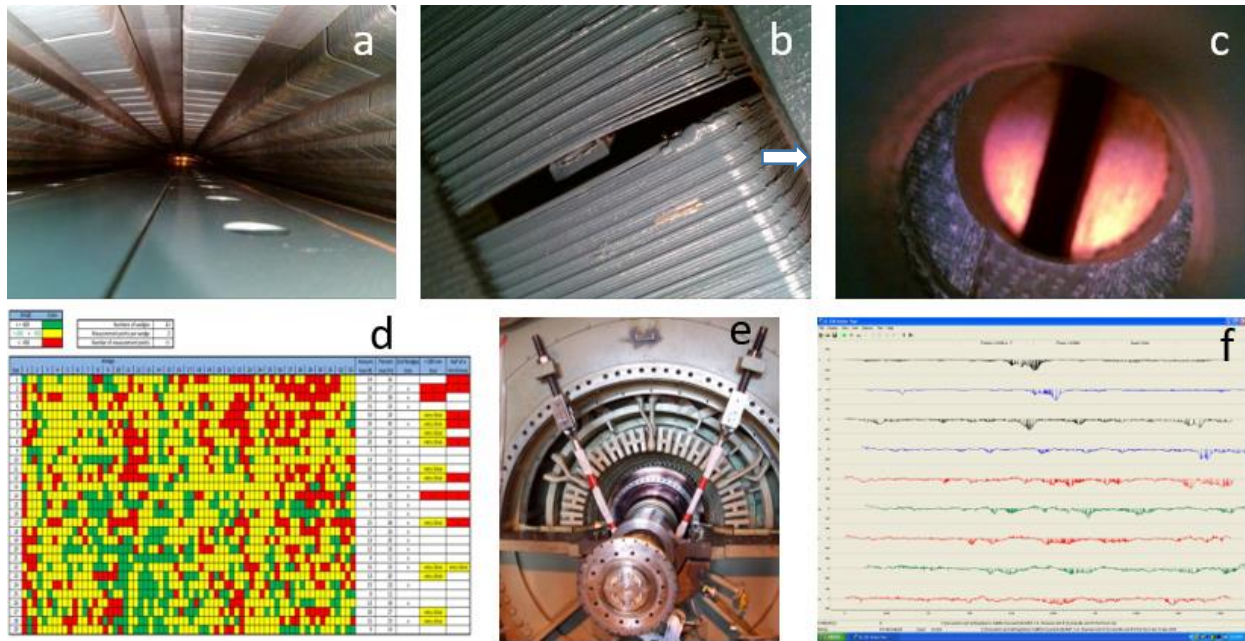
Robot Inspection & Testing
Figure 6

Visual inspection insight is gathered from three points of view as seen in figure 6a, b, & c. The clarity is very good and the color of objects very true, both very helpful characteristics to properly interpreting what is seen.

Figure 6c shows a specific rotor concern, looking through the wedge vent hole. The greenish filler seen in the area pointed to by the white arrow has migrated axially in the slot, partially blocking the cooling vent. The black area is the conductor stack cooling vent, and should be unobstructed relative to the retaining ring vent hole. This migration of the top filler is a known potential problem on this particular model of generator. Based on this finding, the user planned a future rotor out outage to address the condition with a proven rotor modification to prevent the top filler and amortisseur from migrating adversely.

A typical mapping from the digital stator slot wedge tap test can be seen in Figure 6d. The EICid report shown in Figure 6F is concerning as the peaks seen are well above the allowable 100 miliamp threshold established as the acceptance criteria.

Some disassembly of the generator is necessary to gain access to insert the rotor and umbilical cable between the stator step iron & rotor retaining ring nose then into the generator air gap. Figure 6e shows the exciter end of the generator with the upper end bell and inner shroud removed, that is sufficient to perform just the visual inspection and the digital wedge tap testing. To also perform the EICid test, it is necessary to have the same disassembly on the opposite end (turbine end) so that the trigger or excitation cable can be run through the air gap and completely around the stator core / frame.

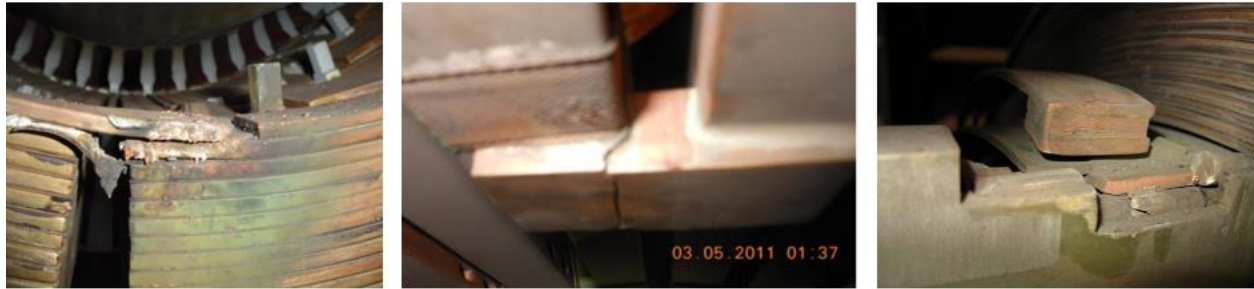
Rotor Pole to Pole Connector Failures
Figure 8

Figure 8 offers an example of a specific rotor component that has experienced infant mortality period failures across several OEM's and models. Rotor pole to pole crossover design configurations can vary greatly, as can be seen in Figure 8. Each of the failures occurred during the infancy period. The left photo is from a TLRI model. It was not the first of the model to fail, but from that failure the independent service provider, working with a number of users was able to identify the cause, solidify a solution, implement a temporary inspection protocol, and use trending to determine average cycles to failure to help users plan. Sharing these items at the next user group meeting lead to many other users proactively addressing and preventing what certainly would have been other unplanned outages during the infancy period. Another important note about pole to pole failures is that the failure contributors accelerate in their detrimental effect as cyclic activity increases.

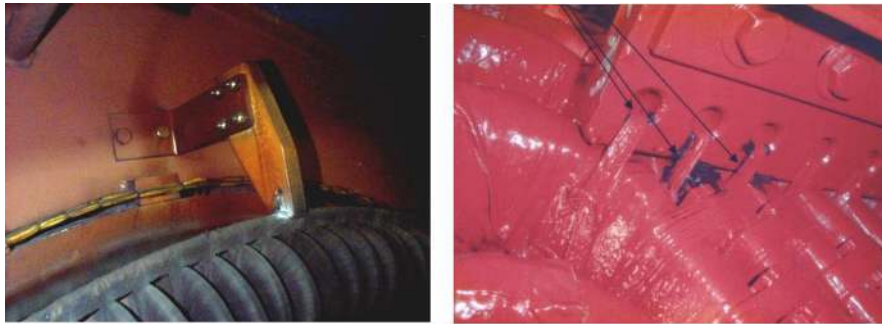
Examples of Dusting (L) and Greasing (R)
Figure 9

The left picture in Figure 9 shows “dusting” from components moving that produce a dust that is formed from the vase material of the components and their fretting movement. The right picture in Figure 9 shows “greasing”. Greasing is dust that collected oil from the internal generator environment. The combination of the oil and dust creates a material that looks very similar to standard grease. Dusting and greasing are both tell tail signs of vibrational movement.

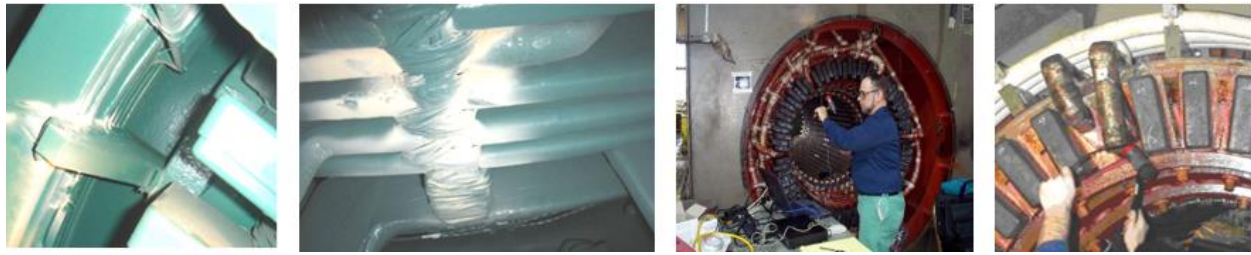
**Extreme Dusting and Bump Testing
Figure 10**

Resonance in generator components can be very concerning due to high levels of vibration that can be very violent. Experienced maintenance personnel may suspect the existence of a resonant condition when exceptional visual observations are found. Photos to the left of center of Figure 10 show such an observation. The good news is that Frequency Response and Modal Testing, more commonly referred to as Bump Testing, can be performed to confirm the resonant condition. The two photos to the right of center of Figure 10 show bump testing being performed. Bump testing primarily focuses on the end winding, phase connections and circuit rings and it identifies resonances that would be readily excitable by the electromagnetic forcing frequency. Users should establish an exclusion zone range for two pole generators ranging from 115 to 135 Hz for 60 Hz generators (95 to 115 Hz for 50 Hz generators). Note that the range

is higher above than it is below, twice the line frequency. The higher range makes allowance to prevent operational temperatures from allowing high tuned components from dropping into the critical range

Bump testing should be incorporated into the scope for stator rewinds and when major repairs or end winding modifications are performed. Machines having potential for a resonant stator condition should have a bump test performed as a bench mark, an considered for re-performance if the stator incurs a significant operational event.

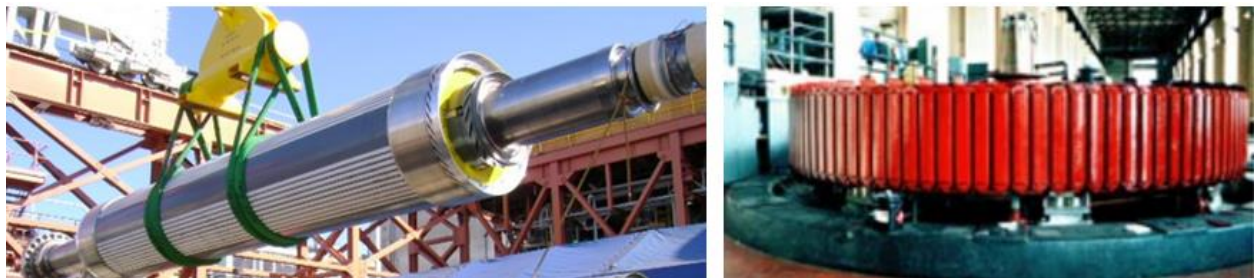
**Cylindrical – Turbo Rotor Design (left)
Salient Pole – Hydro Rotor Design (right)
Figure 13**

The cylindrical rotor designs of Fossil Turbo applications are discernably different from the Salient Pole rotor designs of Hydro applications. This design difference is self-evident from even a quick glance at the photos of Figure 13.

Hydro Salient Pole rotor designs have been well proven from over a century of reliable service, but to help ensure reliability, maintenance attention is necessary especially regarding the rotor coils, amortisseur system, and the system securing the salient poles to the rotor. Cylindrical rotors also need maintenance attention to ensure reliability, some are addressed in other sections of this paper.
