WINDING RESISTANCE ISSUE DURING TRANSFORMER BUSHING REPLACEMENT

Andrew Stenabaugh
Ontario Power Generation

Ed teNyenhuis
Hitachi Energy

ABSTRACT

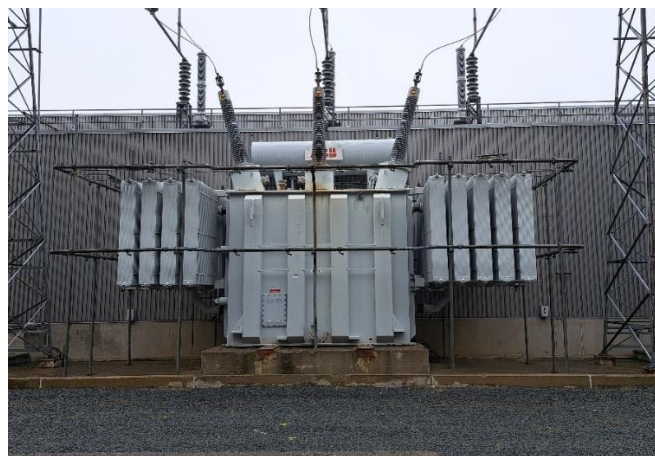
**Transformer T1
Figure 3**

Both transformers developed minor oil leaks which appeared to be originating at the mounting bases of the high voltage and low voltage bushings. OPG engaged ABB/Hitachi to complete an inspection of both transformers. From their inspection, ABB/Hitachi determined that the low voltage bushings and gaskets required replacement along with the high voltage bushing gaskets and some ball valves. OPG opened a project to repair the transformers. The scope of the project included replacement of the low voltage bushings, high voltage bushing gaskets, replacement of leaking ball valves and other leaking gaskets along with complete electrical testing of the transformer once the work was complete. The project was completed on Transformer T2 in 2018 and on Transformer T1 in 2021.
