Arc Flash Incident Due to Faulty Substation Ground

Lyndal Cost, Alabama Power Co

92nd International Conference
of Doble Clients

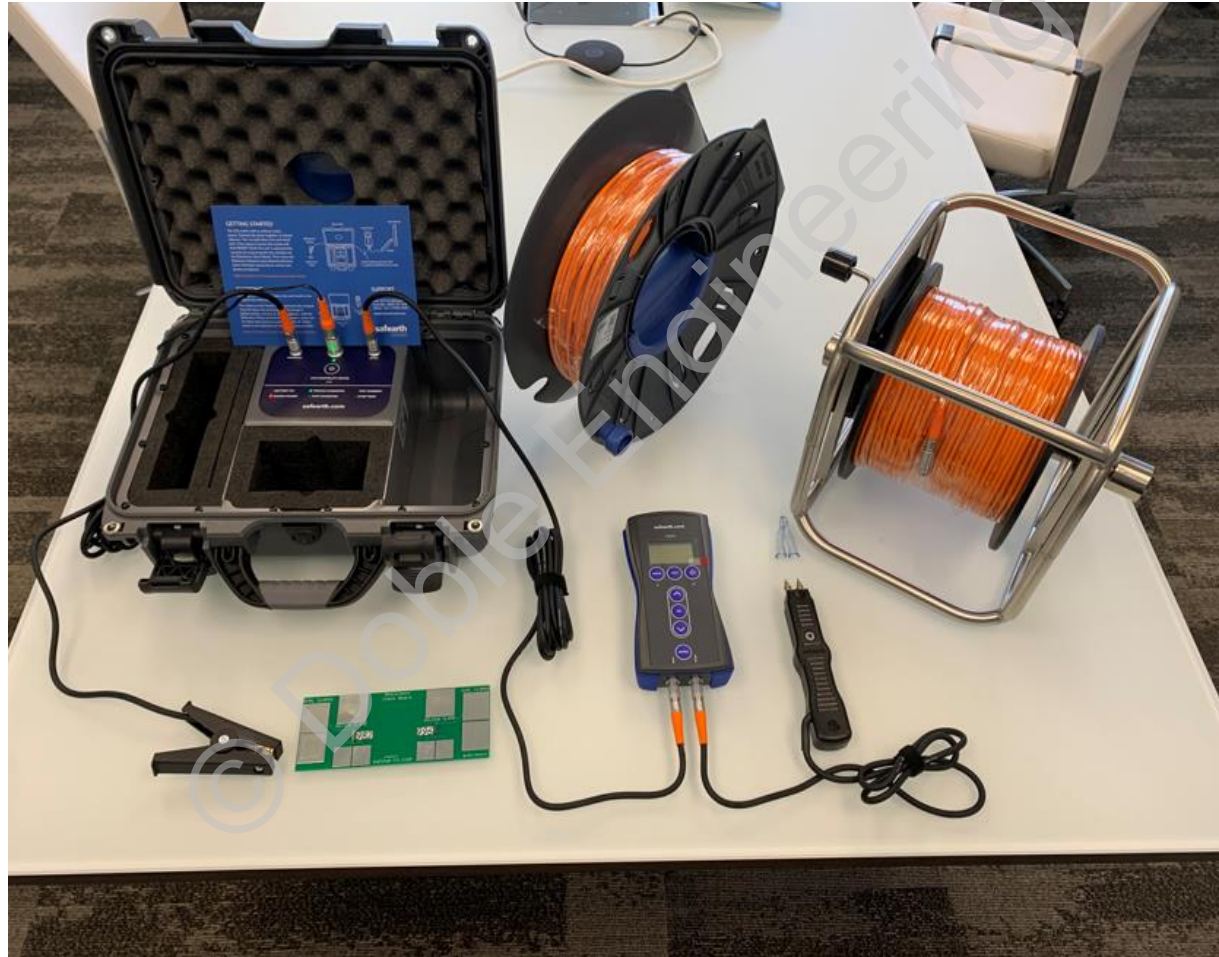
Ground Test Equipment

- Implemented new preventative maintenance inspection activity on a recurring basis
 - ✓ Ground Grid Testing of all substations within four years beginning with the highest short circuit locations.
 - ✓ All stations will be tested within four years, then routine testing will occur every eight years.
 - ✓ “For Cause” testing must be completed after construction projects, copper theft, direct lightening strike, or when TPGs are accidentally energized.
