Switching It Up: A New Innovative 3-Way GOAB Switching Structure

Nick Choi, P.E. – Transmission Reliability Engineering
Hunter Boggs, P.E. – Transmission Line & Asset
Engineering

92nd International Conference
of Doble Clients

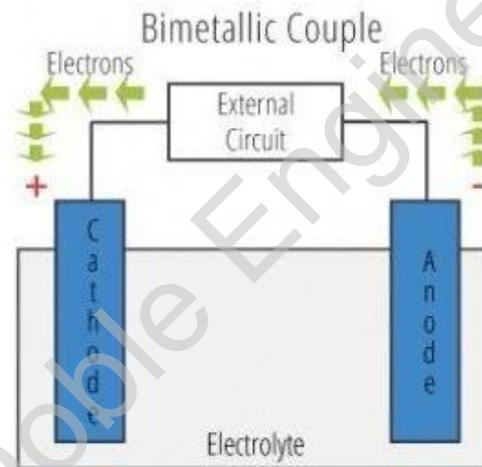
Galvanic corrosion (so called bi-metallic corrosion) occurs when two dissimilar metals are in contact in the presence of an electrolyte.

LCRA investigation team concluded the interrupter operating arm failure was caused by the design allowing galvanic corrosion to take place at the operating arm pivot joint.

Root Cause : Design - absence of separator between bronze and aluminum material at the pivot assembly.

Contributing Cause : Design - the pivot joint assembly is exposed to rainwater.

Galvanic Corrosion Prevention can be achieved with a design improvement.

- Selecting metals with similar potentials
- Eliminate physical contacts between two dissimilar metals.
- Prevent exposure to electrolyte/rainwater.

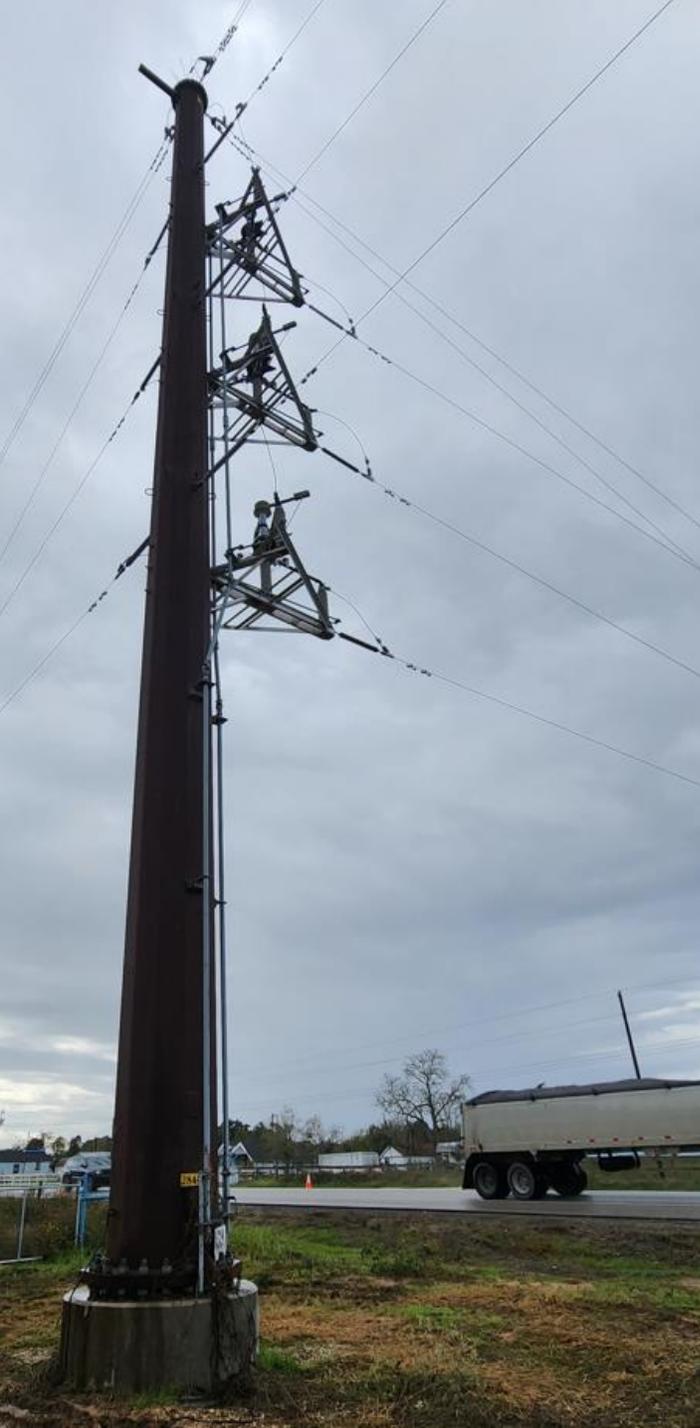
Traditional 3-WAY Transmission Switching Structure includes **one** or **more** switches that cannot support annual switching routines.

- **Unavailable Switches** - Unable to support annual routine switch exercise due to radial load drop/customer outage. Switches come to bind/seize and become unavailable to function as switches.
- **Safety concerns** - operating seized switches can result in component failures and fallen object events.
- **Unfavorable for operations** - a switching activity results in a power flow interruption. This is not ideal for operations.

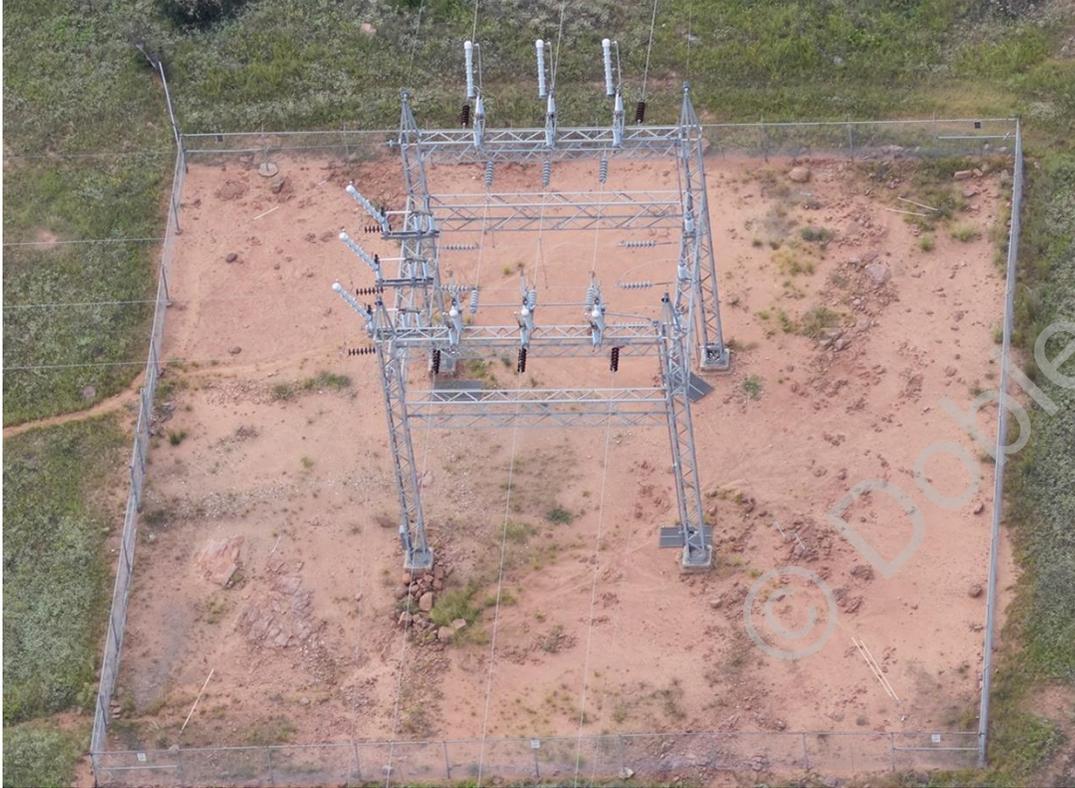
< 3-WAY Box Structure Example >

3-WAY Box Structure was unfeasible to replace the existing 3-WAY Switching Structure due to its size and real estate concerns.
