Catastrophic Failure of ASEA Type IMBE-170 A4 Current Transformer

Hugo Simard, Rio Tinto
Jordan Beaudoin, Rio Tinto
Long Pong, Doble

**92nd International Conference
of Doble Clients**

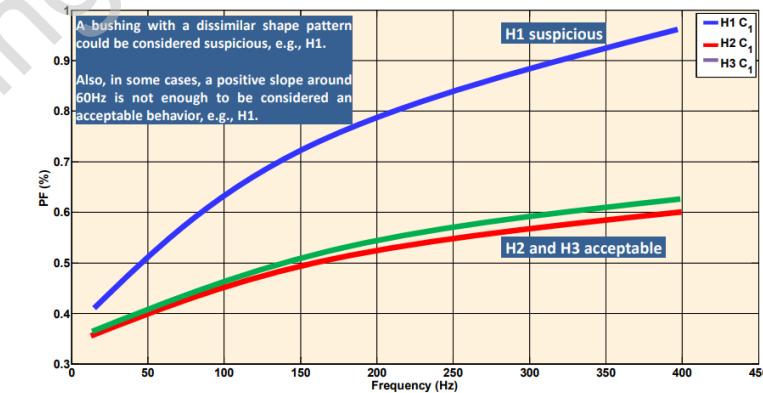
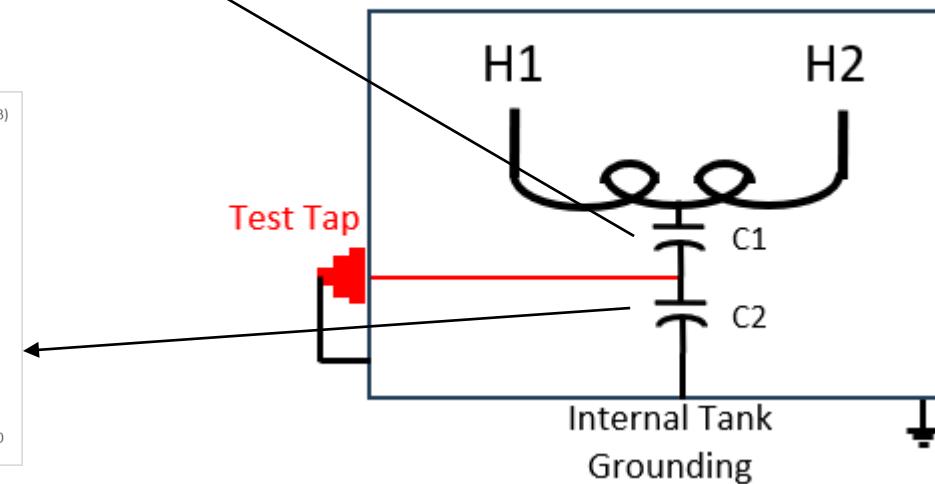
VFPF Applied to Bushings – Pattern 4

Roberto Borges, Fundamentals of Variable Frequency Power Factor (VFPF) Test and Analysis, Doble 2023
