# Managing OIP Transformer Bushings on Eskom & NTCSA's Transformers: Standardization and Replacement Challenges

Khayakazi Dioka, Eskom NTCSA

## 92<sup>nd</sup> International Conference of Doble Clients

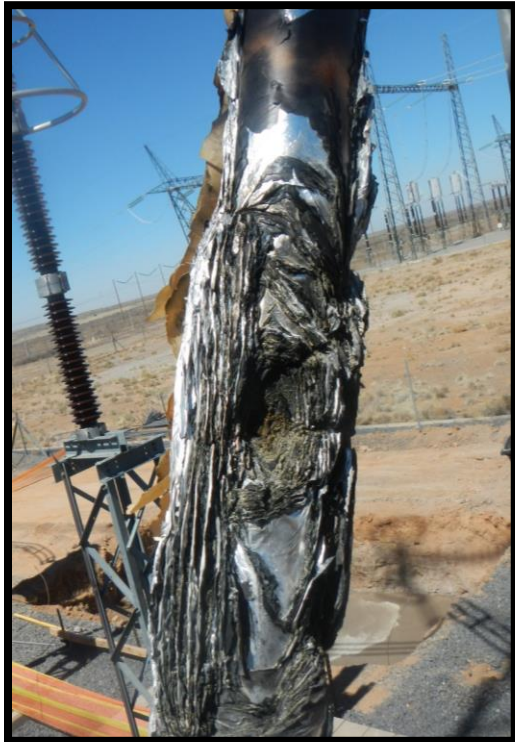
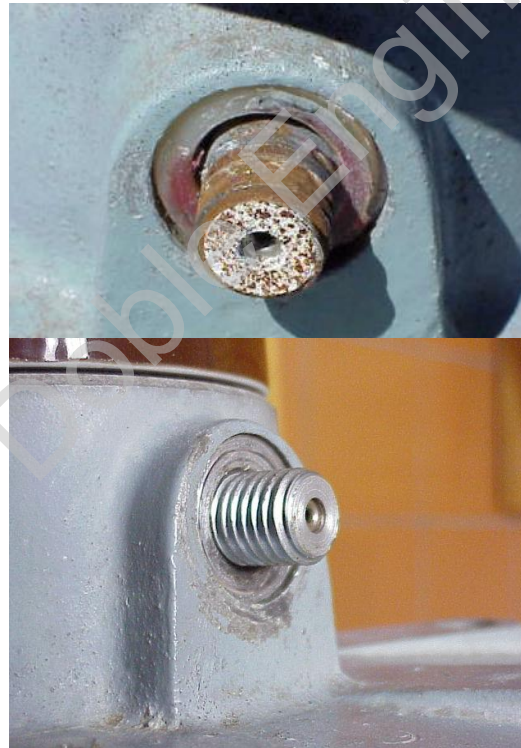
- Known defective OIP bushings were replaced through national projects, particularly for 400kV, and 275kV transformers.
- Other bushings, e.g., 132kV, 88kV, were modified to extend their service life.

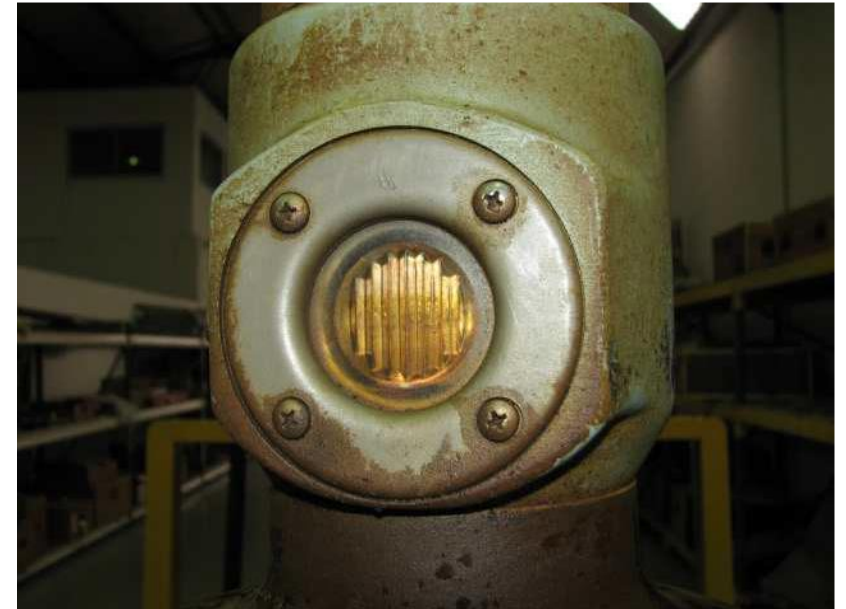
## Managed through different technical instructions – Specific bushing type

- Test point modifications – screw on cap seizes and cannot be removed – fitting lock-nut and dust cap
- Inspection and test

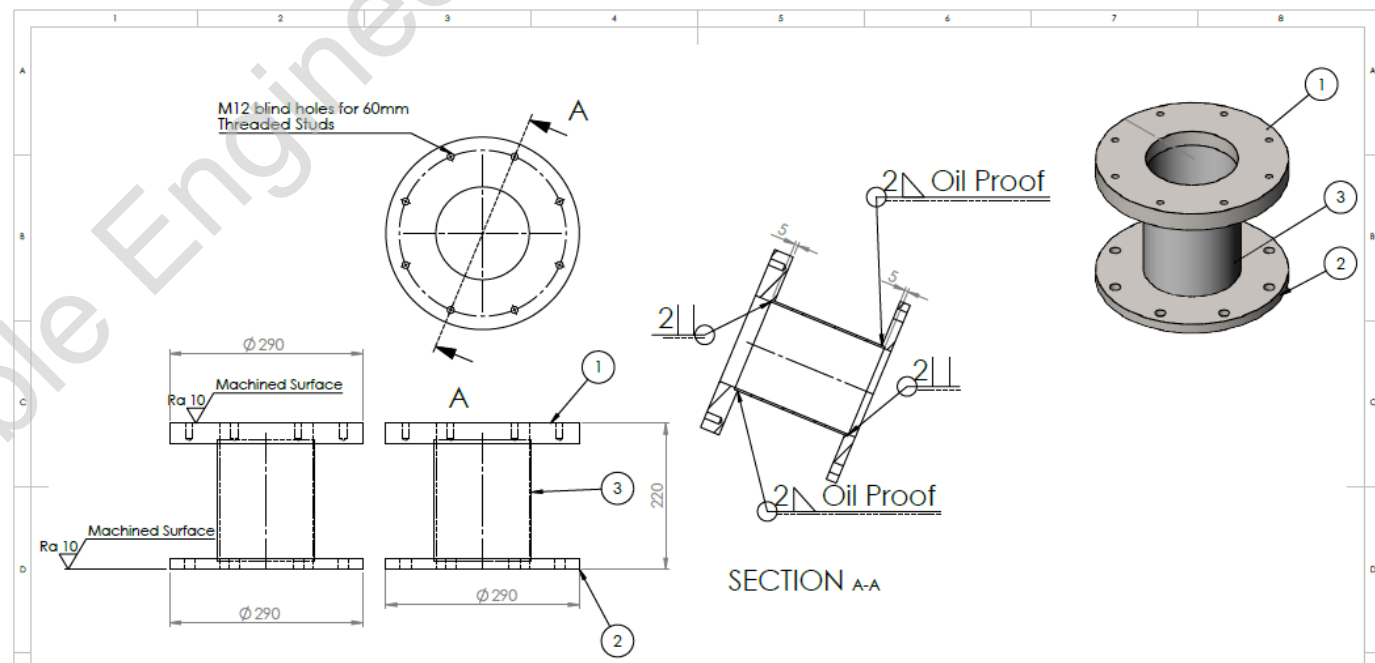
Typical design modifications include;

- manufacturing of adaptor flanges to be rewelded on existing flanges
- manufacturing new solid rods (conductors), or machining replacement conductor to required lengths
- cutting of exit leads to be connected into shortened conductor
- manufacturing an adaptor turret where the replacement bushing is longer than an existing bushing

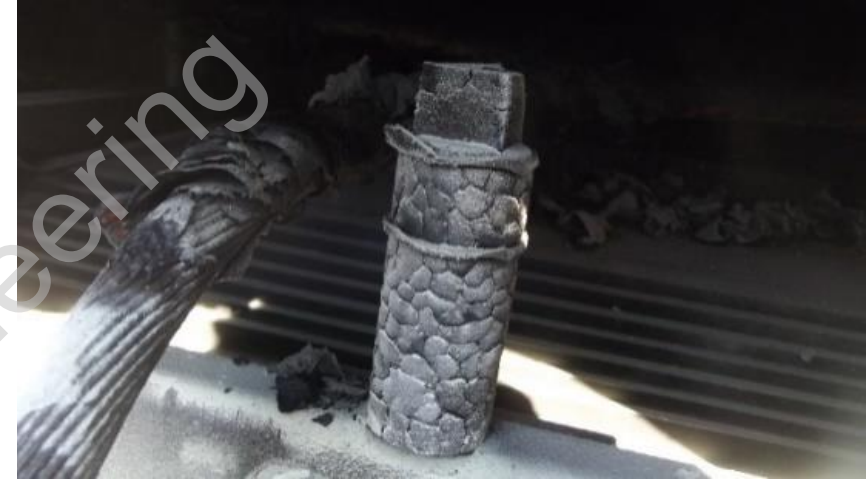
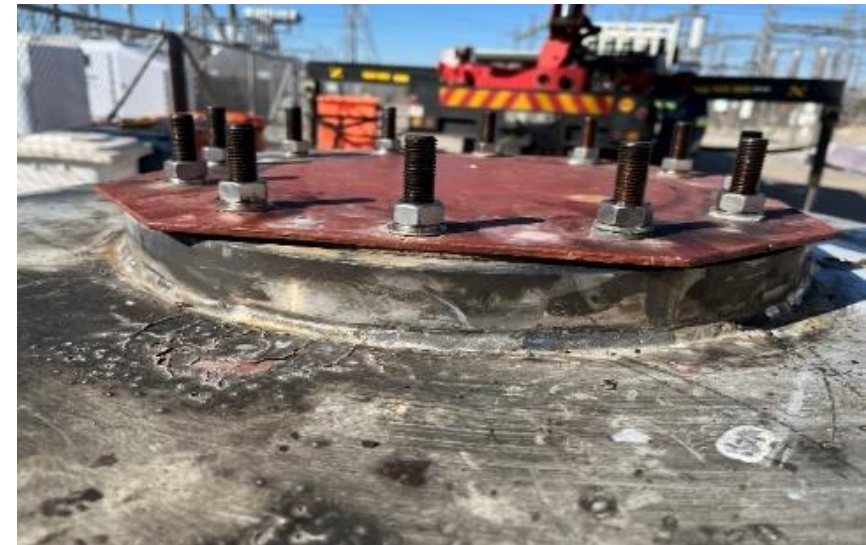
- **Prolonged outages** – testing, modifications, and full commissioning (full drain/partial drain).
- **Intrusive work management** – quality issues, human error effect e.g., transformer severe incident
- **Quick depletion of inventory** – fail one, replace three, slow procurement process.
- **Skill availability** – testing and installation
