TRANSFORMER TECHNOLOGY MAG

Part 2 Bushings Design, Maintenance and Monitoring

Managing Bushings: From Statistics to Singularities – Where to Focus?

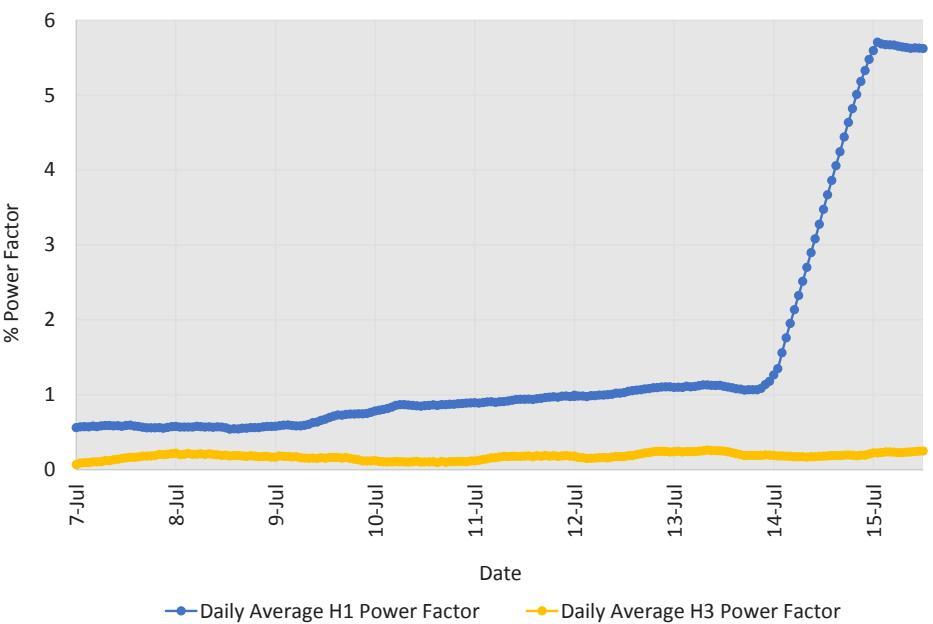
Figure 2. Case 1 - Monitoring detects rising power factor trend

Less than four months later, the bushing monitor indicated an elevated power factor on one of the original GE bushings. The rise in the daily trend reported for the two remaining GE Type U bushings is shown in Figure 2. A rising trend had occurred after the return to service, and an offline test confirmed that the bushing had elevated power factor of 1.36%. The capacitance had increased by just 2 pF against the nameplate value of 398 pF. The bushing was thus replaced.

The approach described in the original paper that outlined this case [4] is useful, and it involves identifying a bushing of interest through standard testing, but then applying monitoring to track the deterioration directly. A response plan is necessary to make sure that intervention is undertaken when alarms are issued. However, for the two bushings which were replaced it is interesting to note the following:

- the original suspect Type U bushing remained in service for more than 10 months while being monitored and issued no alarms;
- the subsequent Type U deterioration of the second bushing took place over less than 4 months to issue the alert.

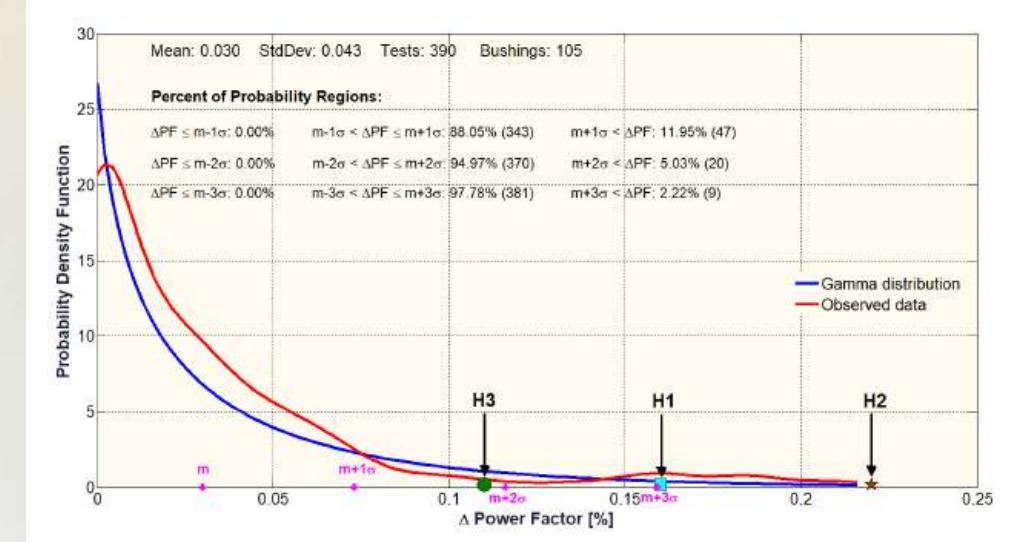
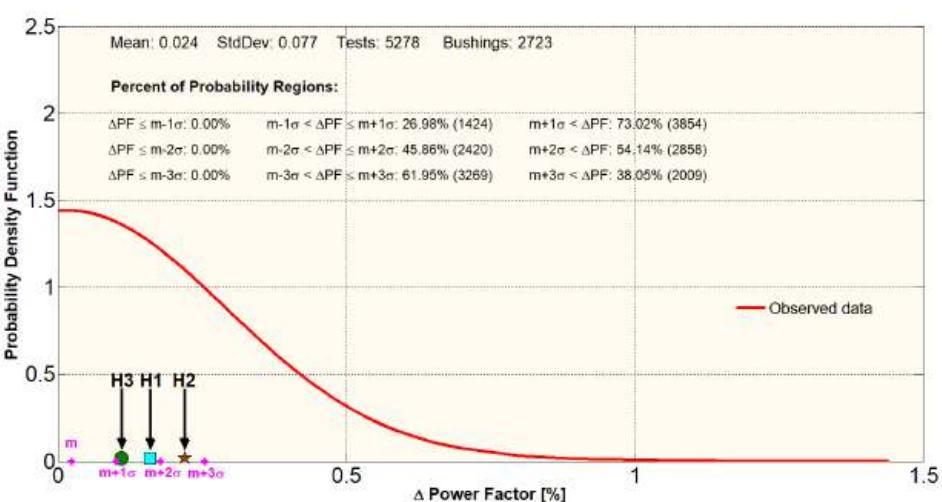
Figure 3. Case 2 - Bushing statistical analysis using utility's database population

A utility electrical testing group obtained power factor test results for three ABB, 69 kV, type AB bushings, which seemed 'a little high' at ~0.5%. The utility compared the three results against their own database of 390 test results from 105 individual bushings. The delta values were calculated with respect to the first power factor measurement of each of the bushings. Figure 3 shows the distribution of delta values found, in red, and the gamma function resulting with the best fit, in blue. Bushings H1 and H2 are more than three standard deviations from the expected value (i.e. the mean), with only 2.22% of the population expected to lie in this region. They do appear to be outliers in the utility's database.

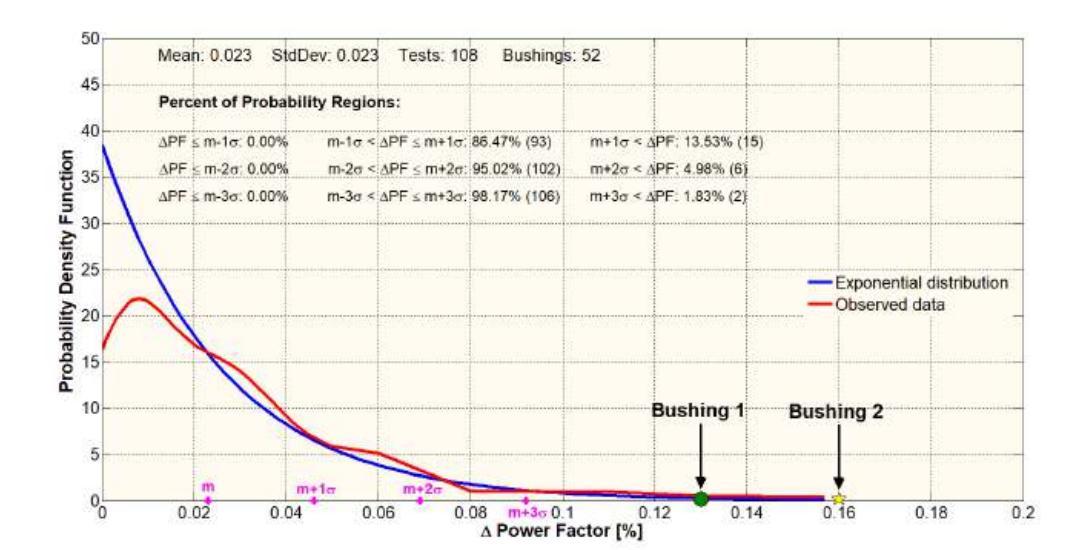
for the utility: maybe they should focus their attentions on those two? Figure 5 shows the actual C1 delta between nameplate and test results distribution, in red, and the exponential model (best fit), in blue. The two bushings of interest are outside of three standard deviations from expectation – so acceptable results in terms of absolute C1 power factor values, but outliers in the utility population.

Consequently, the two bushings are outliers in terms of the utility population but are not with reference to the larger Doble database population. But the fact that the larger distribution is very compressed, with ~96.5% of test results being below one standard deviation from the mean, indicates that the two bushings are anomalous - they are unusual, and the history for this type of bushing would imply that they should be prioritized for replacement, and/or condition monitoring should be considered to track their condition online.

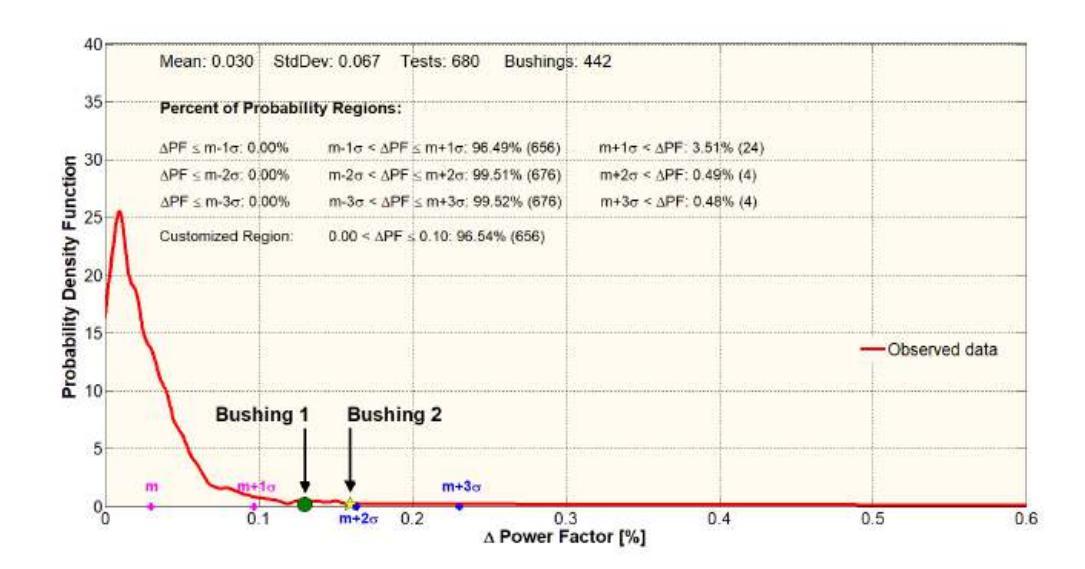
Figure 6. Case 3 - Bushing statistical analysis using entire Doble's database population

Figure 6 shows the same analysis but using the entire Doble database population (442 bushings and 680 data points). The two bushings have C1 delta power factor values which are just outside of one standard deviation from expectation.
